Final Reclamation and Stormwater Inspection

September 13, 2017

Operator: NGL WATER SOLUTIONS DJ LLC - 10373

Inspection Photos
Location Name: CONQUEST SWD #1-8
API: 05-123-16804

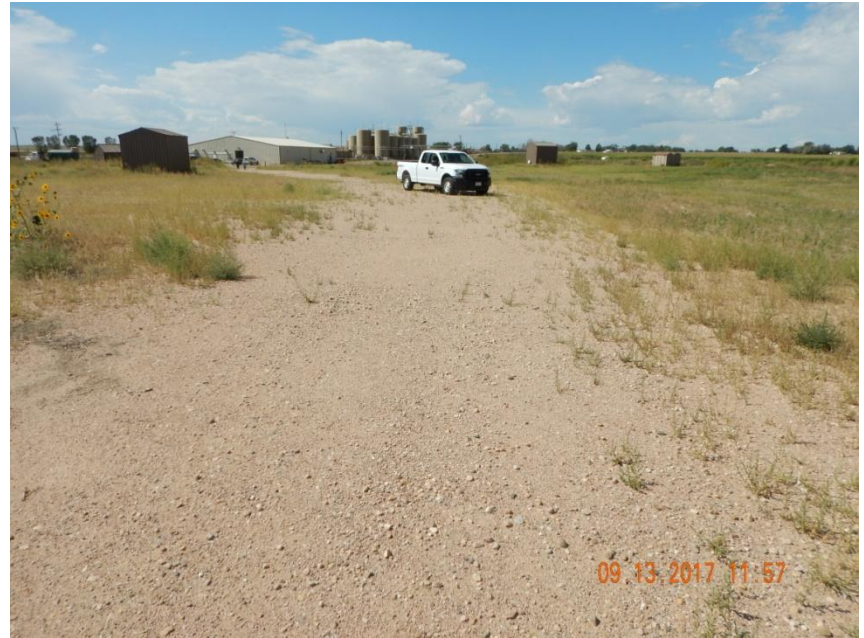
Photo 2. Photo taken from an access road off CR 53, facing West. Access road is no longer in use per Weld County requirements as described by an Operator representative. Access road will have to be reclaimed per Rule 1004.

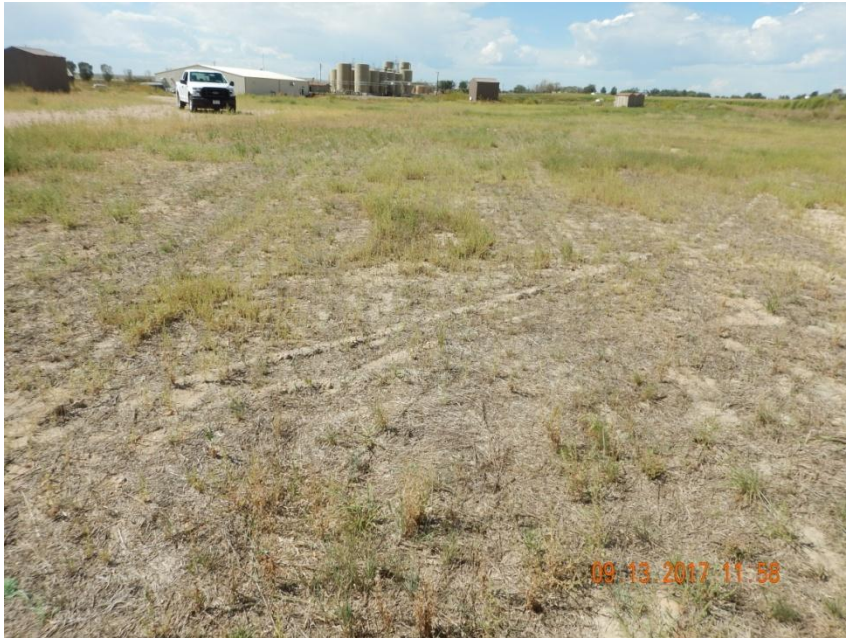
Photo 3. Photo taken from the eastern reclamation area, facing West. Bare patches with little to no germination were observed throughout the reclamation area. Germination is not uniform throughout the reclamation area and was mostly dominated by Russian thistle, an annual undesirable weed. Most of the green foliage in the photo is that of Russian thistle.

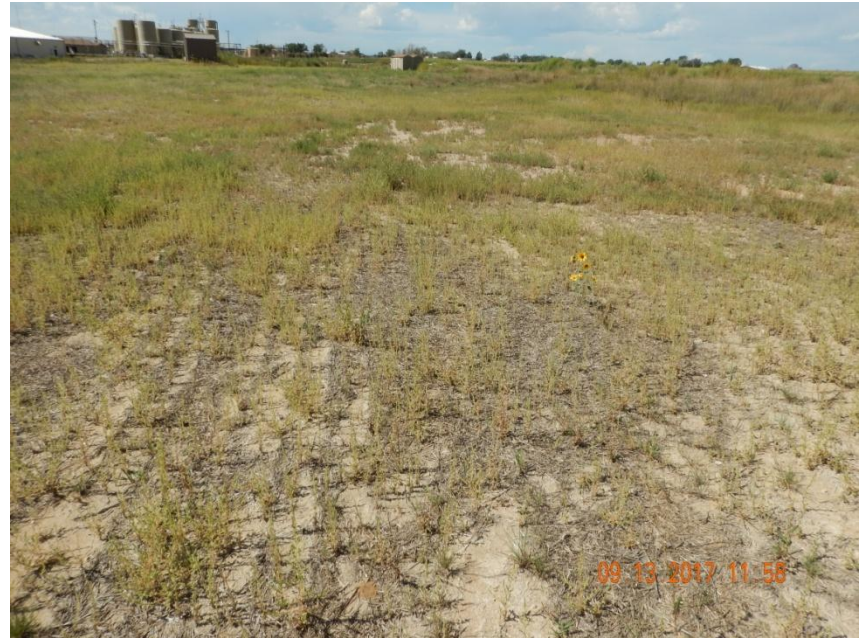
Photo 4. Photo taken from the approximate central reclamation area, facing West. Photo illustrates little to no germination throughout the reclamation area. Most of the green foliage in the photo is that of Russian thistle.

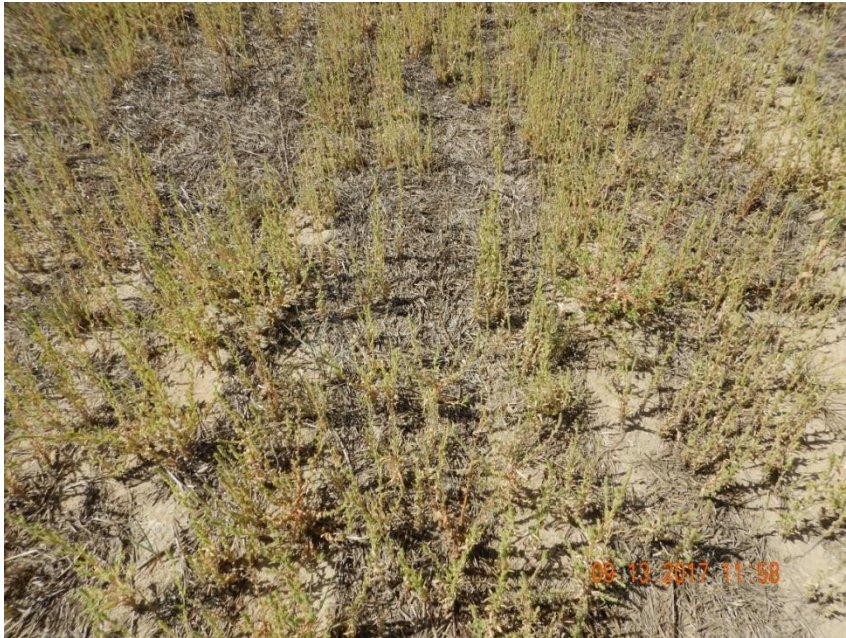
Photo 5. Close up photo taken from the previous photo location. Photo illustrates no to little germination. The green foliage in the photo is that of Russian thistle.

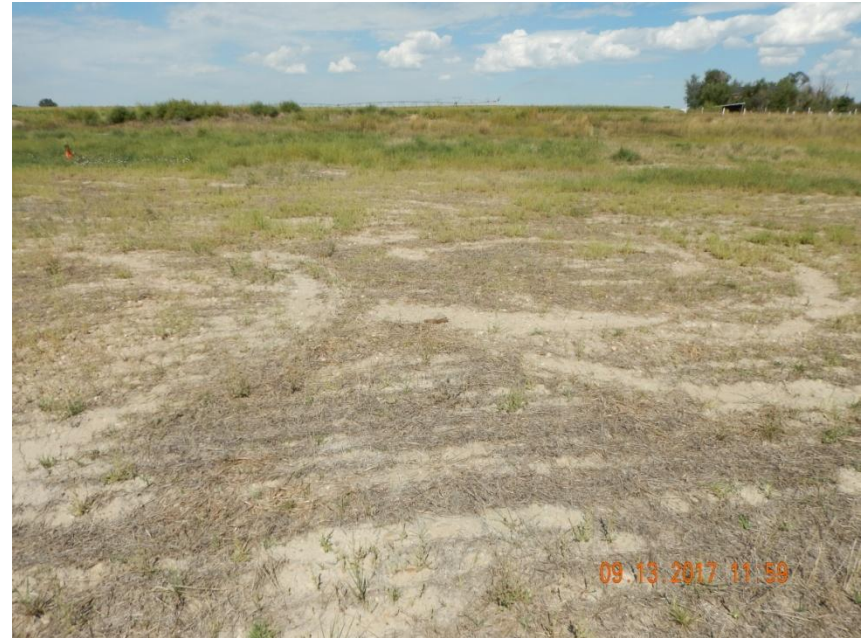
Photo 6. Photo taken from the south-central reclamation area, facing North. Photo illustrates little to no germination throughout the reclamation area.

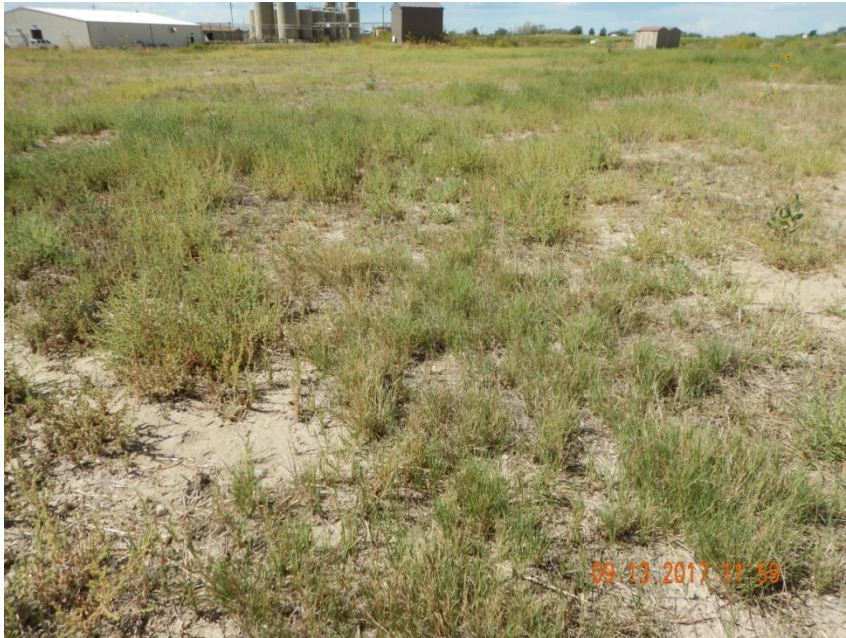
Photo 7. Photo taken from the western reclamation area, facing West. Photo illustrates a patch of desirable vegetative growth mixed with Russian thistle.

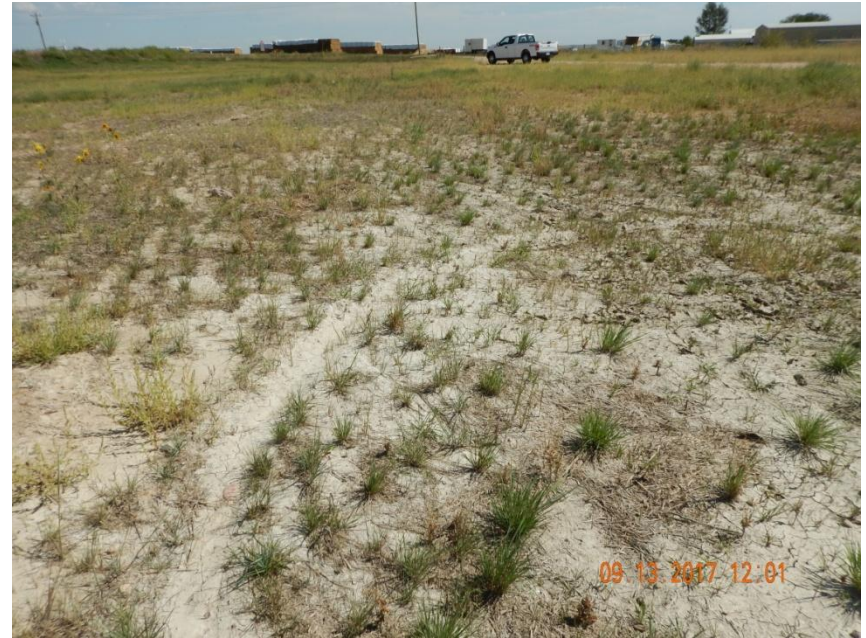
Photo 8. Photo taken from the western reclamation area, facing East. Photo illustrates a portion of desirable germination establishment but not uniform.

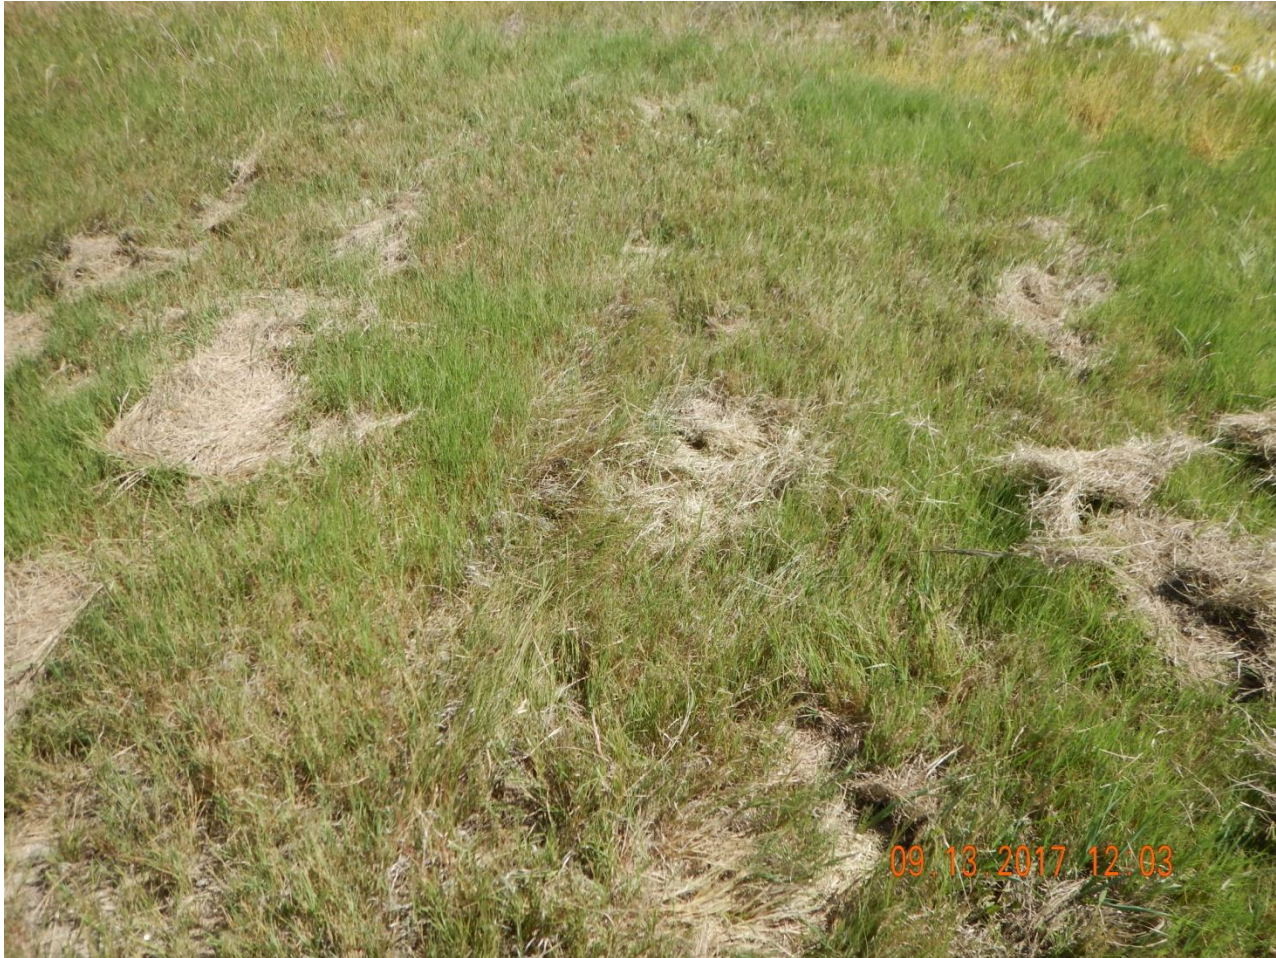
Photo 9. Reference photo taken just west of the western reclamation area. This location was recently mowed but illustrates the vegetative growth that is not reflective throughout the reclamation area.
