Final Reclamation and Stormwater Inspection

Operator: BARRETT CORPORATION* BILL- 10071

API: 05-123-23966

Inspection Photos
Location Name: 70 RANCH #22-3
API: 05-123-23966

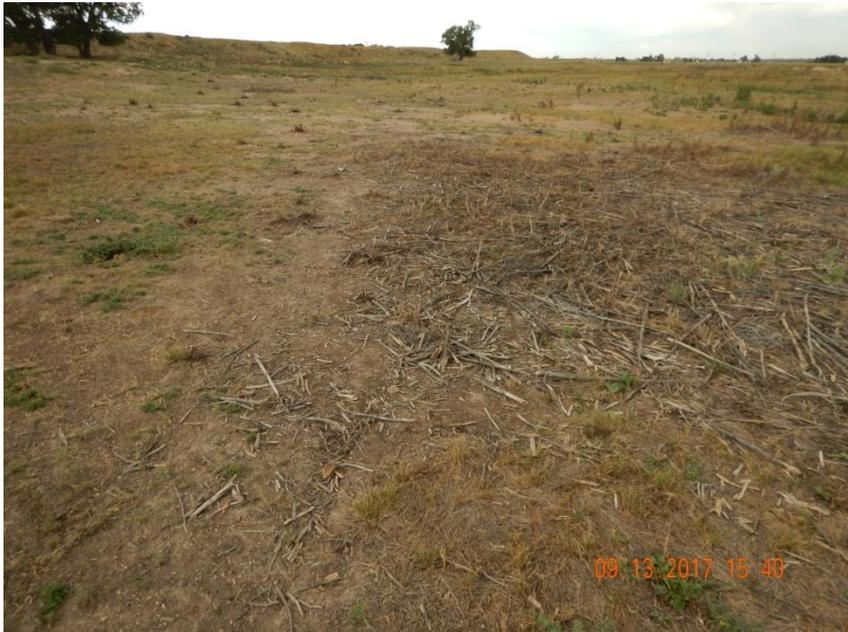
Photo 1. Photo taken from the approximate center of the location, facing North. Little to no germination of desirable species was observed throughout most of the reclamation area. Operator may need to perform additional reclamation activities in the future if the location does show more germination establishment. Active prairie dog colony observed throughout the adjacent areas.

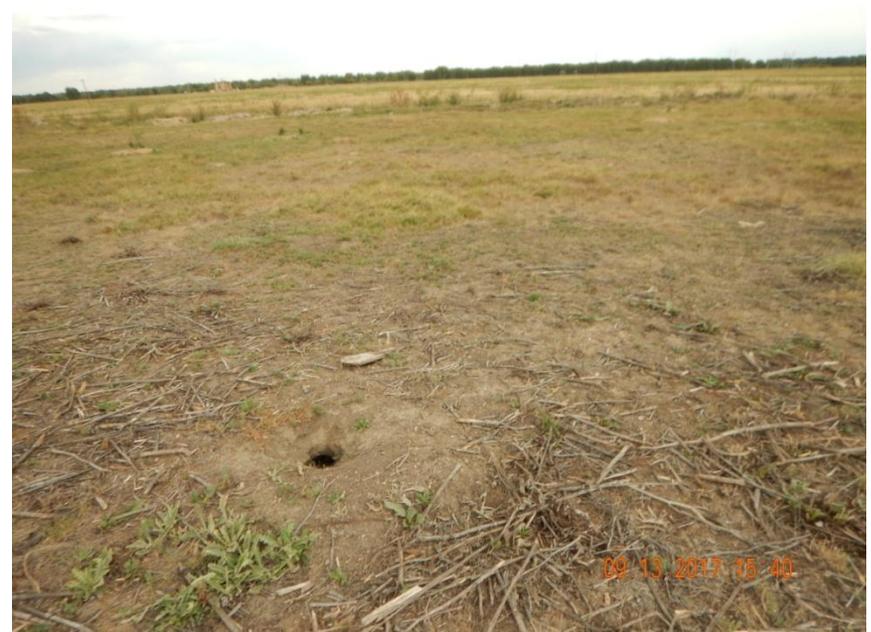
Photo 2. Photo taken from the approximate center of the location, facing East. Little to no germination of desirable species was observed throughout most of the reclamation area. Operator may need to perform additional reclamation activities in the future if the location does show more germination establishment.

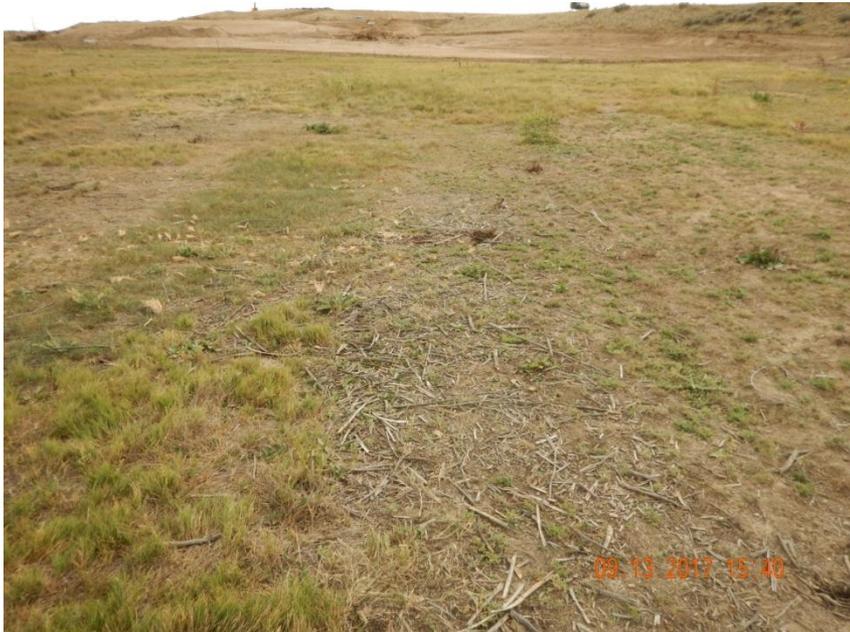
Photo 3. Photo taken from the approximate center of the location, facing South. Little to no germination of desirable species was observed throughout most of the reclamation area. Operator may need to perform additional reclamation activities in the future if the location does show more germination establishment.

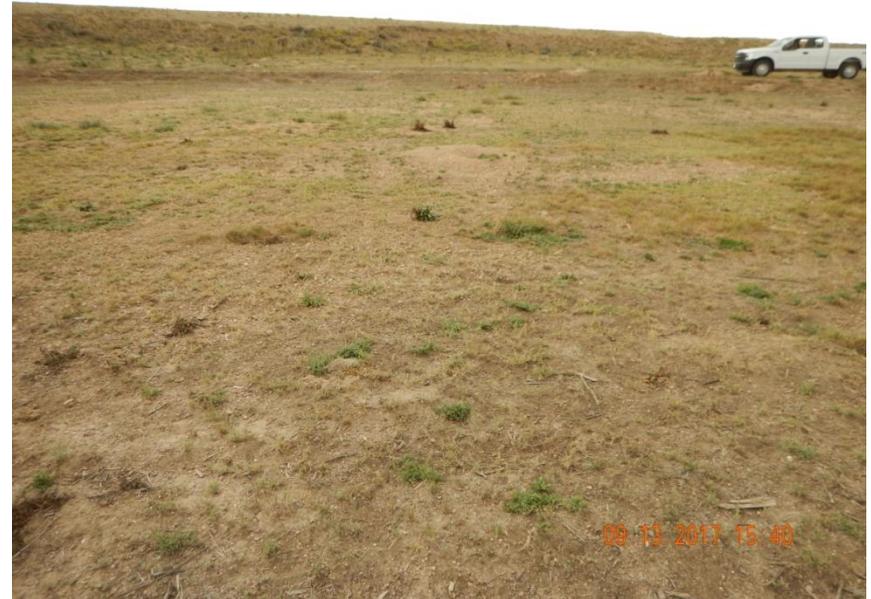
Photo 4. Photo taken from the approximate center of the location, facing West. Little to no germination of desirable species was observed throughout most of the reclamation area. Operator may need to perform additional reclamation activities in the future if the location does show more germination establishment.

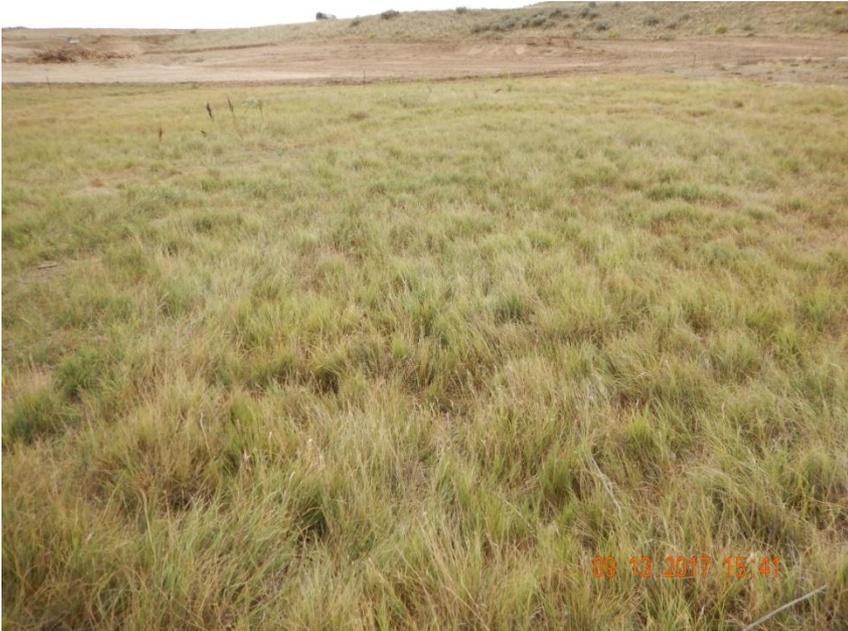
Photo 5. Reference photo taken just south of the reclamation area, facing South. Photo illustrates the vegetative growth in the reference area is not reflective throughout the reclamation area.
