# Final Reclamation and Stormwater Inspection

September 13, 2017

Operator: BARRETT CORPORATION\* BILL- 10071

API: 05-123-23965

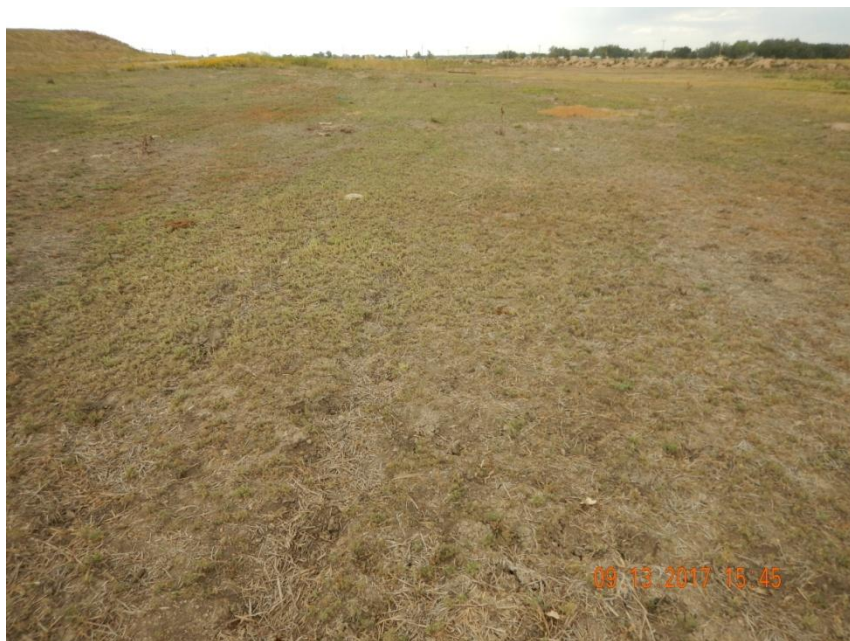
**Photo 1.** Photo taken from the approximate center of the location, facing North. Little to no germination of desirable species were observed throughout most of the reclamation area. Operator may need to perform additional reclamation activities in the future if the location does show more germination establishment. Active prairie dog colony observed throughout the adjacent areas.

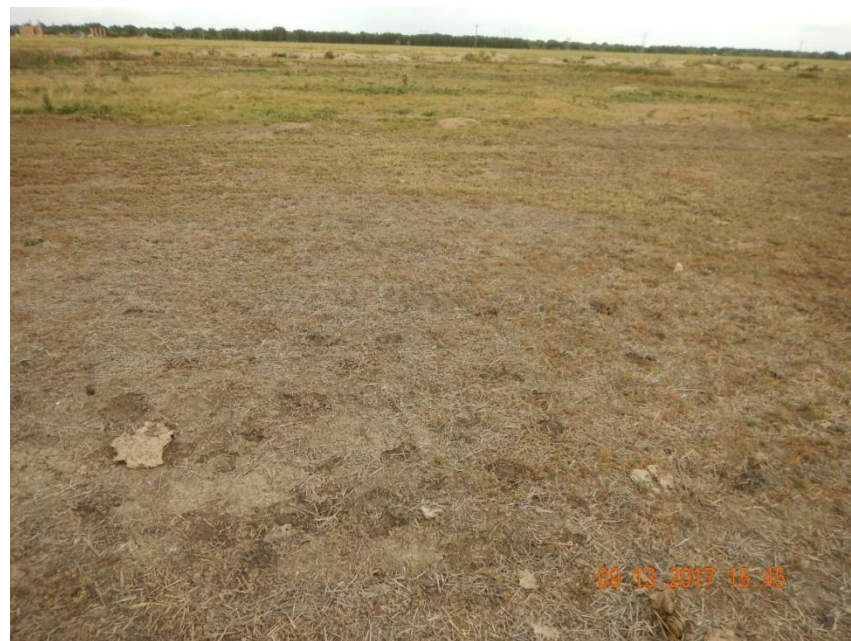
**Photo 2.** Photo taken from the approximate center of the location, facing East. Little to no germination of desirable species were observed throughout most of the reclamation area. Operator may need to perform additional reclamation activities in the future if the location does show more germination establishment.

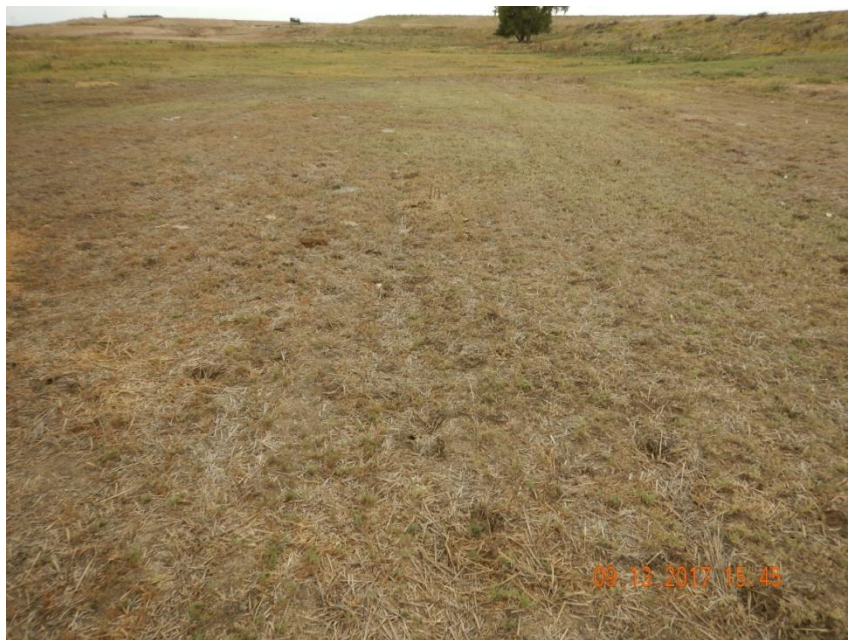
**Photo 3.** Photo taken from the approximate center of the location, facing South. Little to no germination of desirable species were observed throughout most of the reclamation area. Operator may need to perform additional reclamation activities in the future if the location does show more germination establishment.

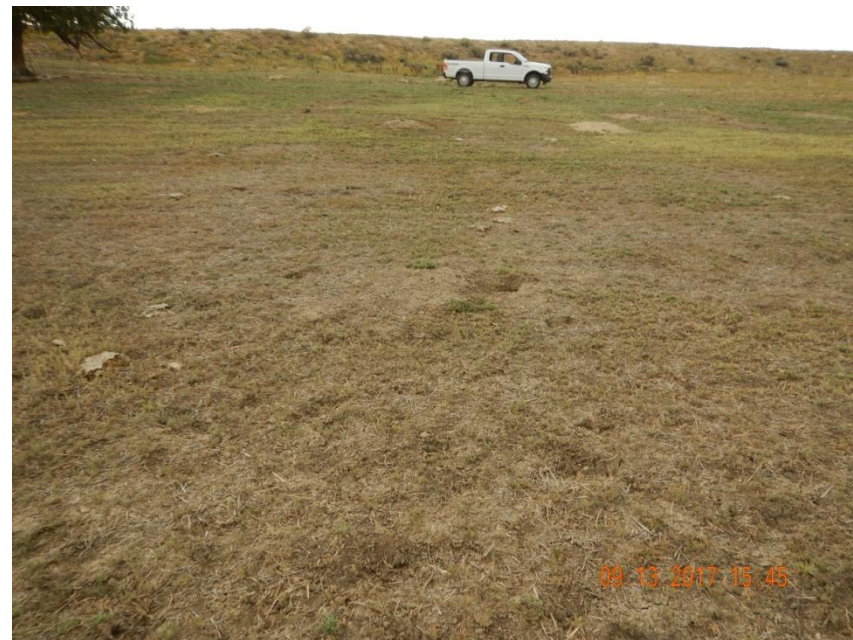
**Photo 4.** Photo taken from the approximate center of the location, facing West. Little to no germination of desirable species were observed throughout most of the reclamation area. Operator may need to perform additional reclamation activities in the future if the location does show more germination establishment.

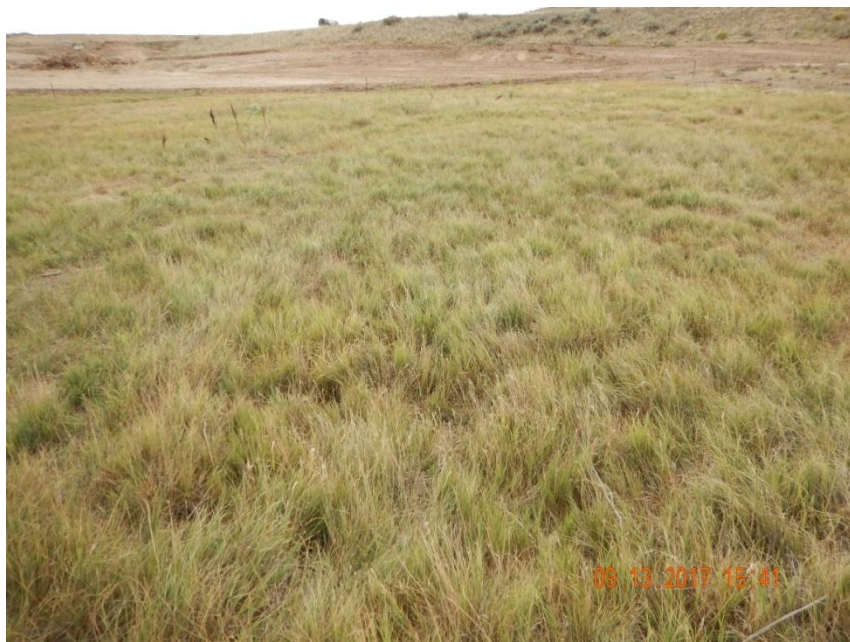
**Photo 5.** Reference photo taken south of the reclamation area for API 123-23966, facing South. Photo illustrates the vegetative growth in the reference area is not reflective throughout the reclamation area.
