Inspection Photos

Operator: PETRO-CANADA RESOURCES (USA)

Location ID: 311664

Inspection Doc. Number: 682502567

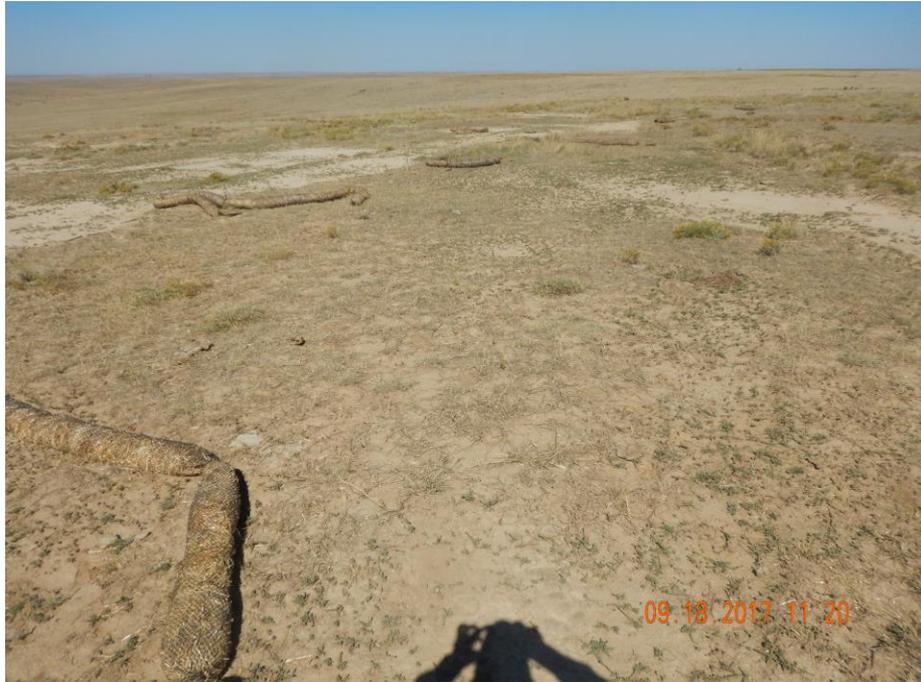
Photo 1: Photo taken from the east end of the northern degradation area. Photo shows no stormwater management, or reclamation activities have been conducted per corrective actions and per FIU manager. See doc. #2227506

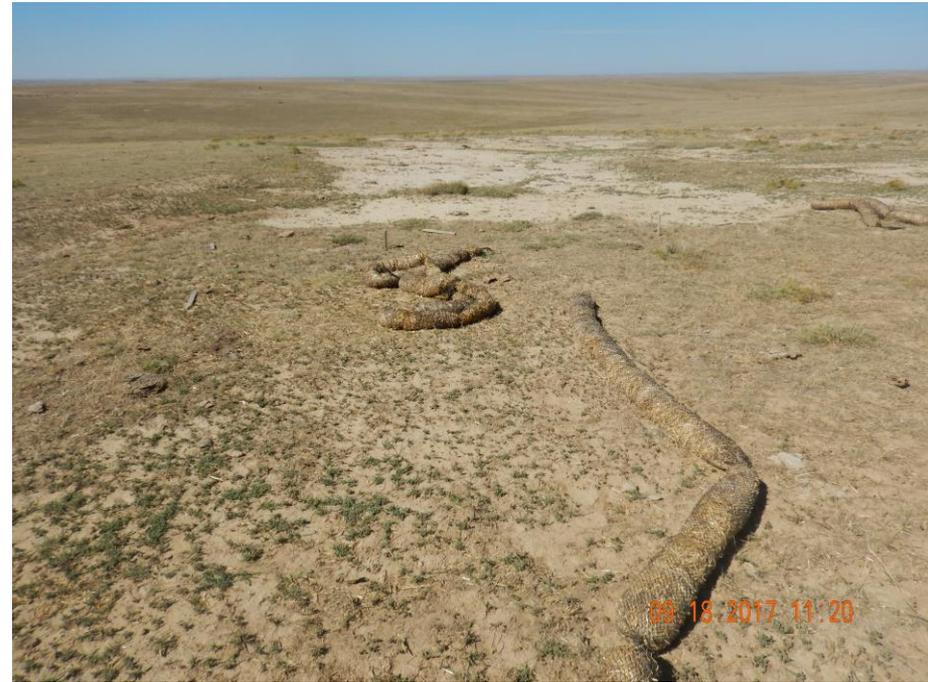
Photo 2: Photo taken from the east end of the northern degradation area. Photo shows no stormwater management, or reclamation activities have been conducted per corrective actions and per FIU manager. See doc. #2227506

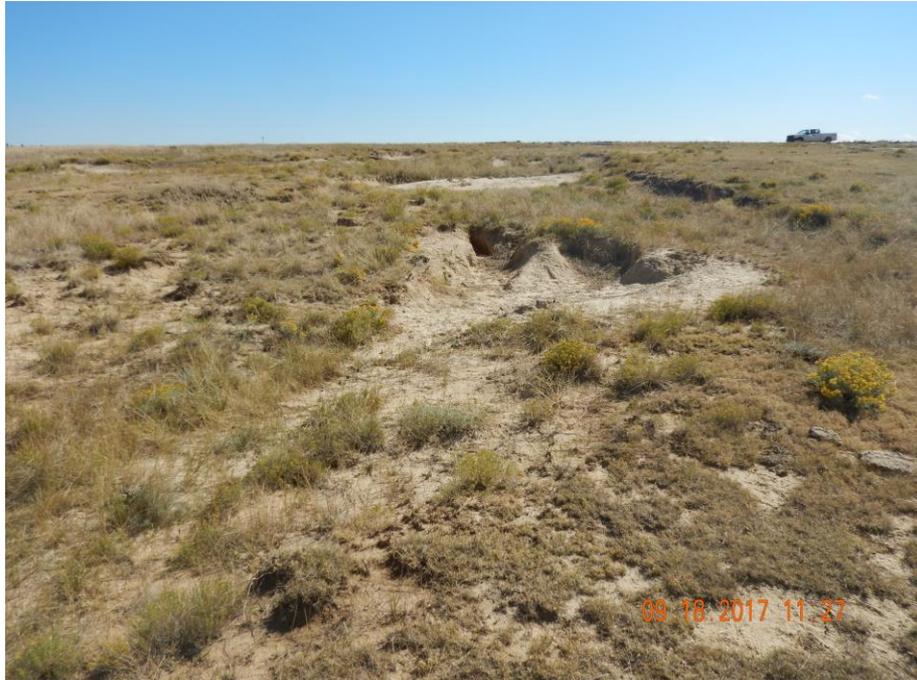
Photo 3: Photo taken from the northern degradation area. Photo shows no stormwater management, or reclamation activities have been conducted per corrective actions and per FIU manager. See doc. #2227506

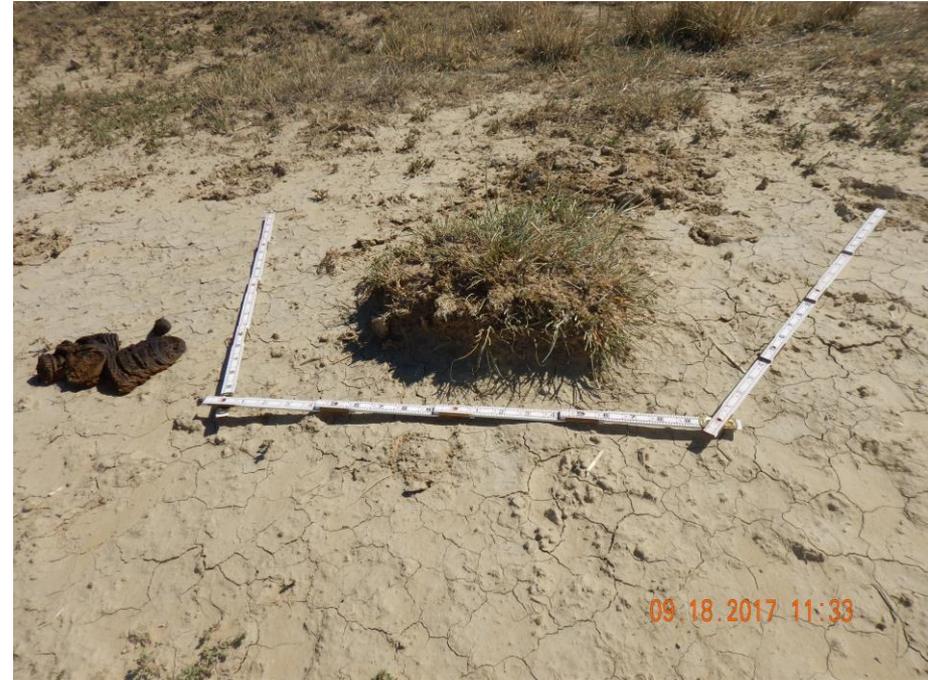
Photo 4: Photo taken from the northern degradation area. Photo shows pedestal formations occurring due to stormwater degradation. Pedestals form when stormwater (or wind erosion) erodes away un-stabilized areas of soil around vegetation.

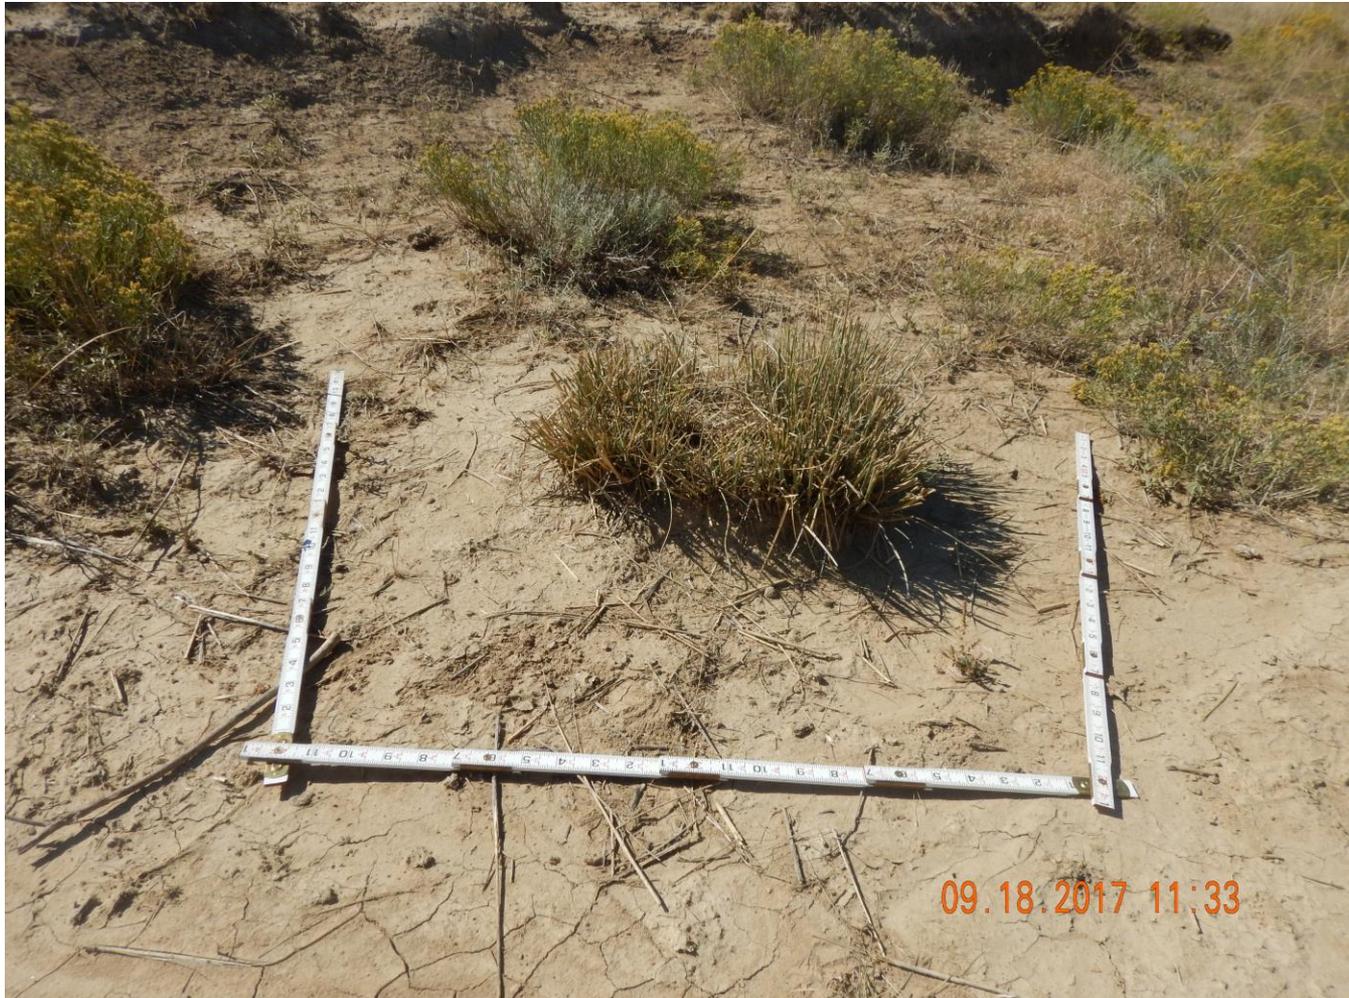
Photo 5: Photo taken from the northern degradation area. Photo shows pedestal formations occurring due to stormwater degradation. Pedestals form when stormwater (or wind erosion) erodes away un-stabilized areas of soil around vegetation.
