# Inspection Photos

Operator: PETRO-CANADA RESOURCES (USA)  
INC - 72085

Location ID: 376781

Inspection Doc. Number: 682502569  
Adams County, CO

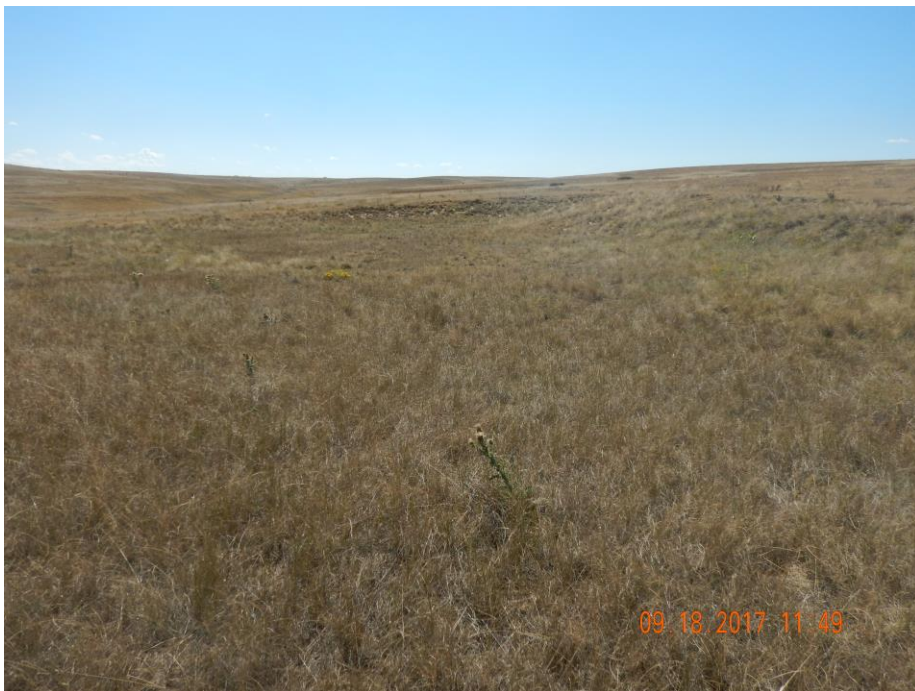
**Photo 1:** Photo taken from pad location, facing south. Photo shows corners of the pad requiring reclamation work to be conducted.

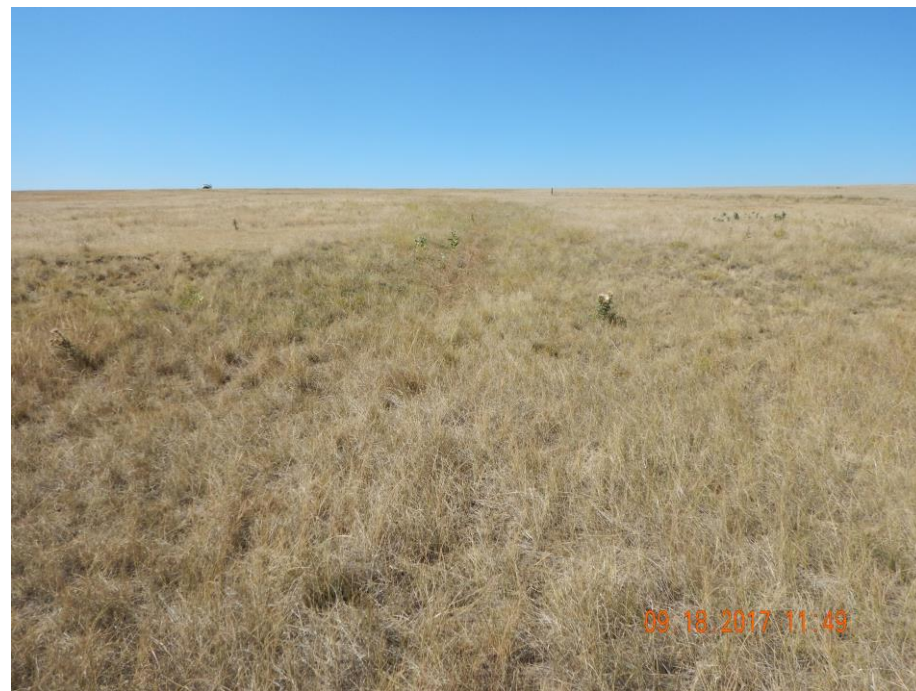
**Photo 2:** Photo taken from the pad location, facing west. Portions of the road. Portions of the road where stormwater degradation evident requires additional reclamation and stabilization.

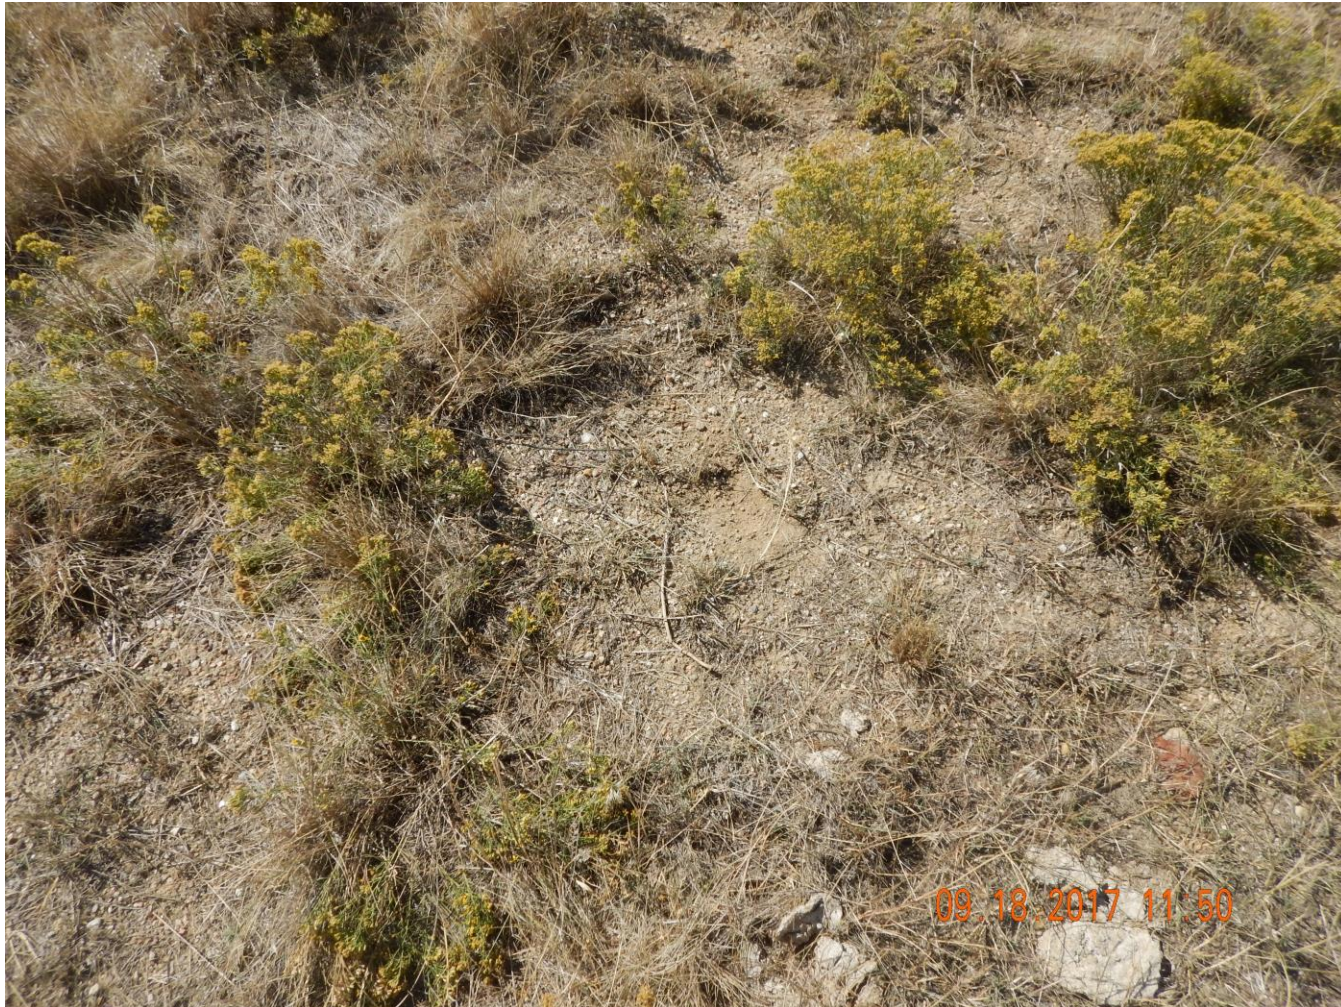
**Photo 5:** Photo taken from the well location. Photo shows vegetation at the well does not meet reclamation standards. .
