Inspection Photos

Operator: PCR OPERATING LLC - 10657

Location ID: 313784

Inspection Doc. Number: 682502594

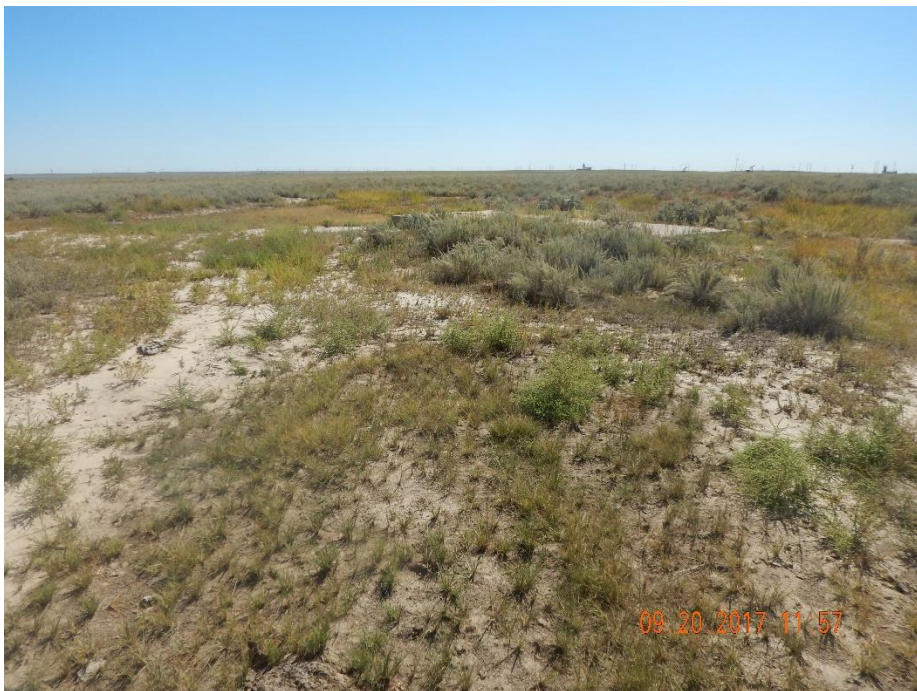
Photo 1: Photo taken from the northwest end of the location, facing southeast. Photo shows location does not meet reclamation requirements. Concrete pumping unit remains on location. Location has not achieved vegetative requirements.

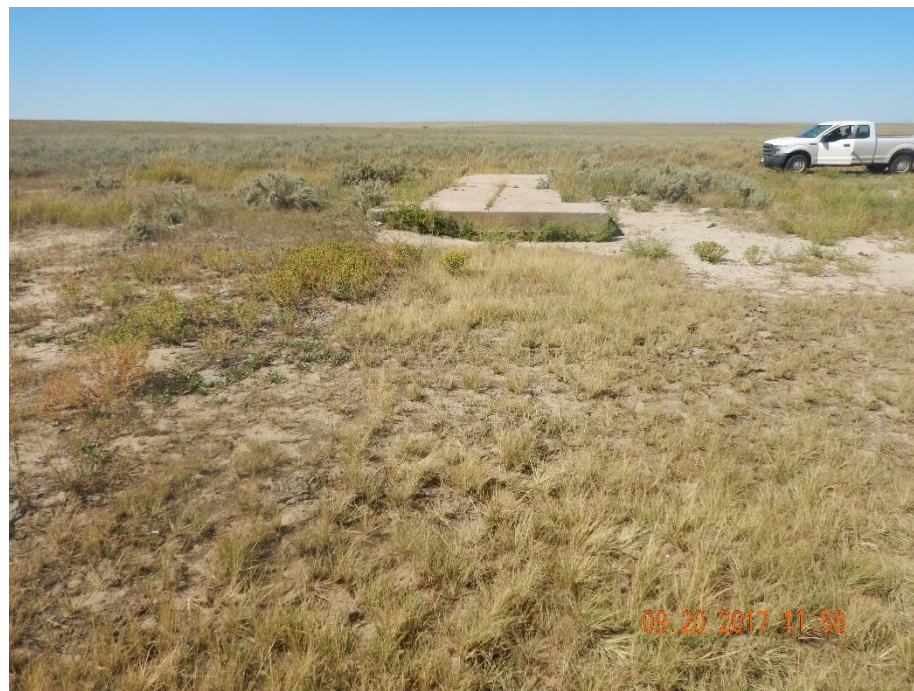
Photo 2: Photo taken from the east end of the location, facing west. Photo shows location does not meet reclamation requirements. Concrete pumping unit remains on location. Location has not achieved vegetative requirements.

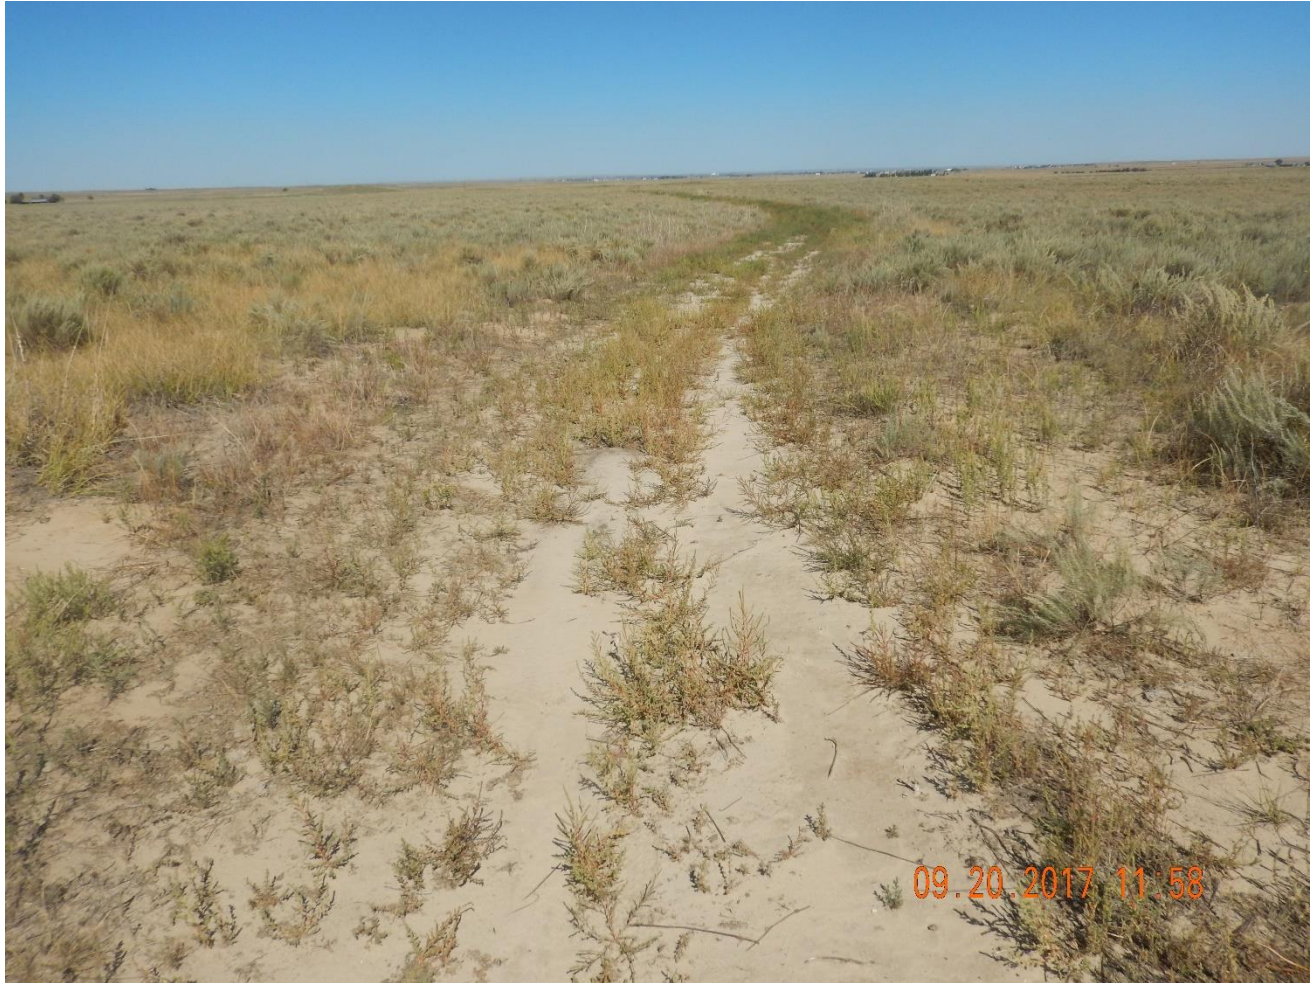
Photo 3: Photo taken from the north end of the location, facing north. Photo shows access road has not been reclaimed in accordance to COGCC 1000 series requirements.
