Figure 2
Erickson Birckle P25-4JI -
Tank Battery
Facility Layout &
Analytical Results

Legal Location: NWNW, Sec 25, T3N R67W
County: Weld
Land Use: Non-Cropland
Topography: 0-3% Slopes
Run-Off Risk: Very low
Soil Type: Bankard sandy loam

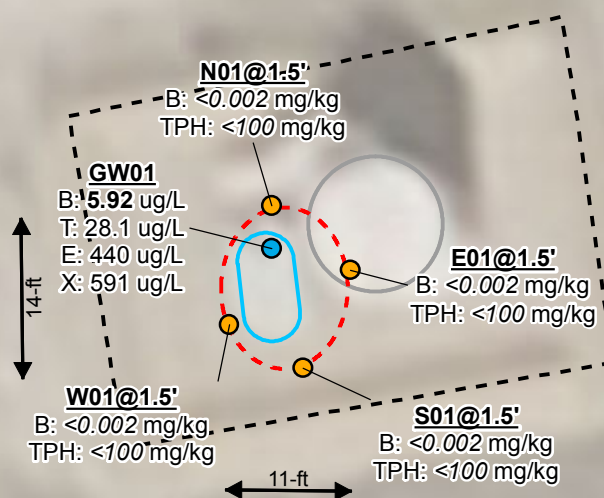
REVISED	BY	COMMENT
9/20/2017	BJB	Figure 2

- Soil Sample
- Groundwater Sample
- Former Crude Oil Tank
- Former Produced Water Tank
- Existing Equipment
- Secondary Containment
- Excavation Extent

Bold values exceed COGCC Table
910-1 allowable concentrations
