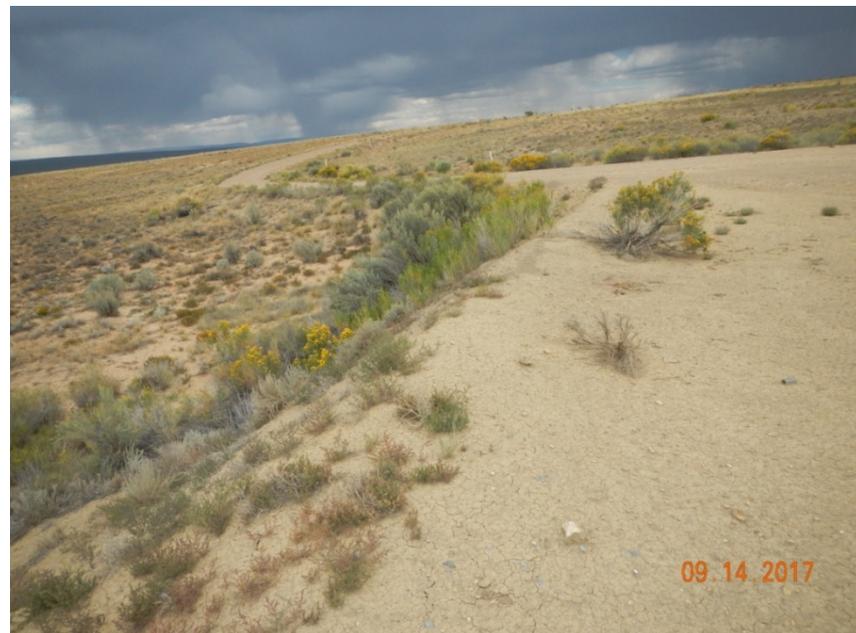
Photo 2: View of the northern portion of the project area from the northwestern corner facing eastward. Revegetation is progressing with grasses and shrubs such as western wheatgrass (*Pascopyrum smithii*), dropseed (*Sporobolus sp.*), and rubber rabbitbrush (*Chrysothamnus nauseosus*).

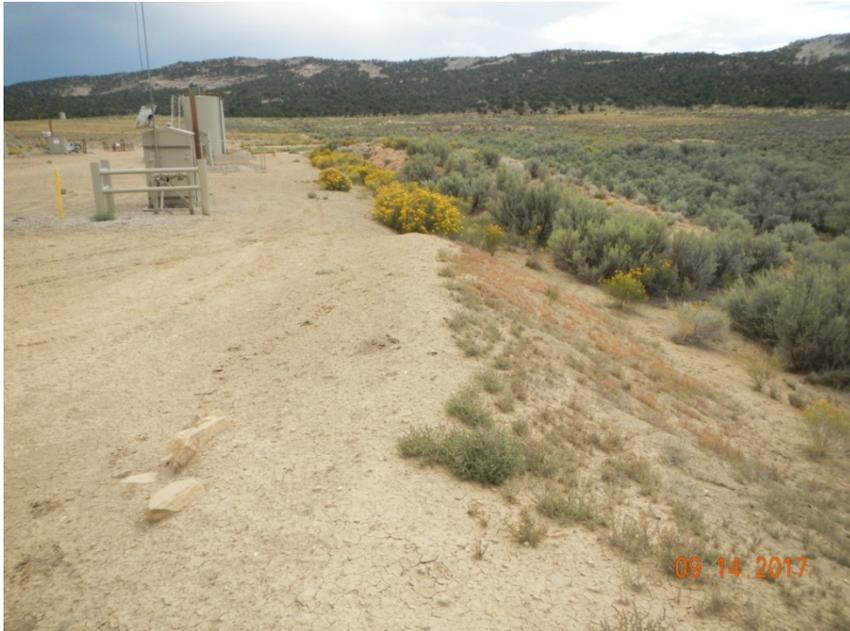
Photo 3: View of the western portion of the project area from the northwestern corner facing southward. Revegetation is sparse in portions of the northern and western fill slopes.

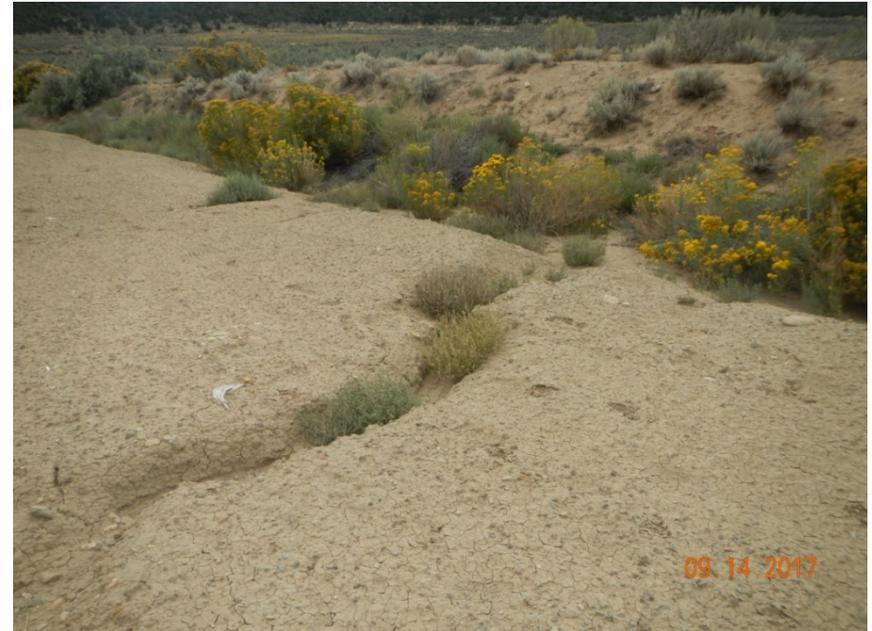
Photo 4: View of erosional channel forming within the western portion of the project area.
