Construction and Stormwater Inspection

September 27, 2017

Operator: 8 NORTH LLC - #10575

Inspection Photos
Location Name: Darlene East /29-N Pad
Location ID: 452153

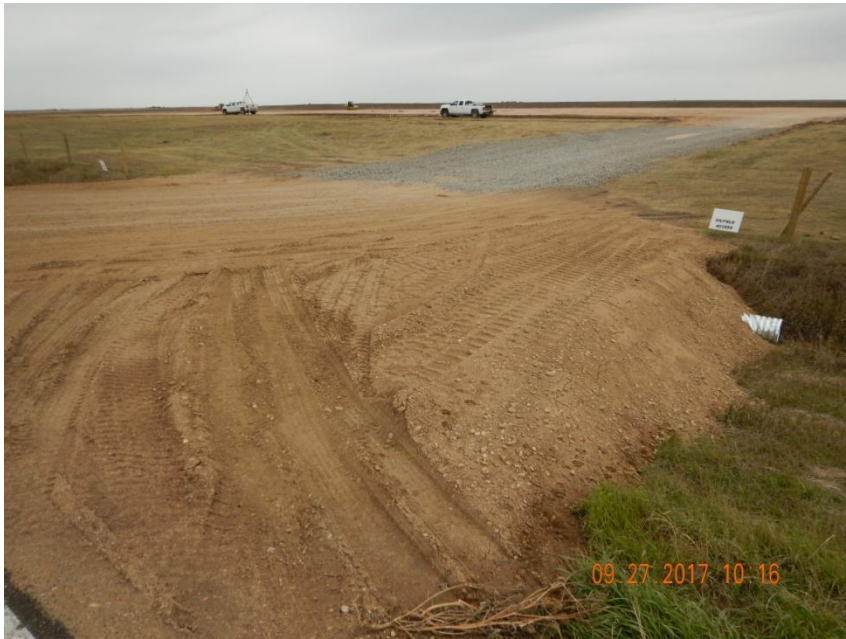
Photo 1. Photo taken from the entrance of location, facing Northwest. Tracking pad devices have been installed at the entrance.

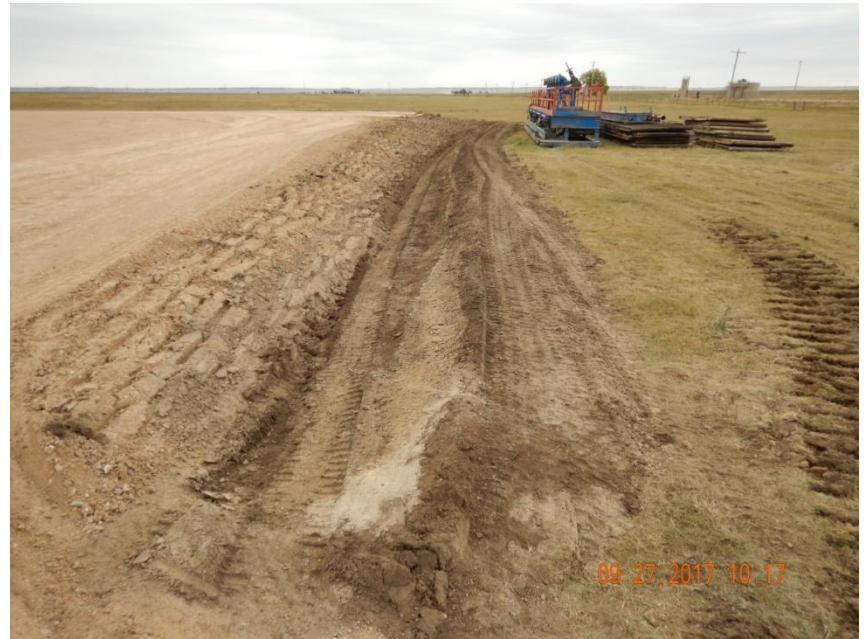
Photo 2. Photo taken from the southeastern location, facing East. Temporary BMP's (ditch and berm) have been installed.

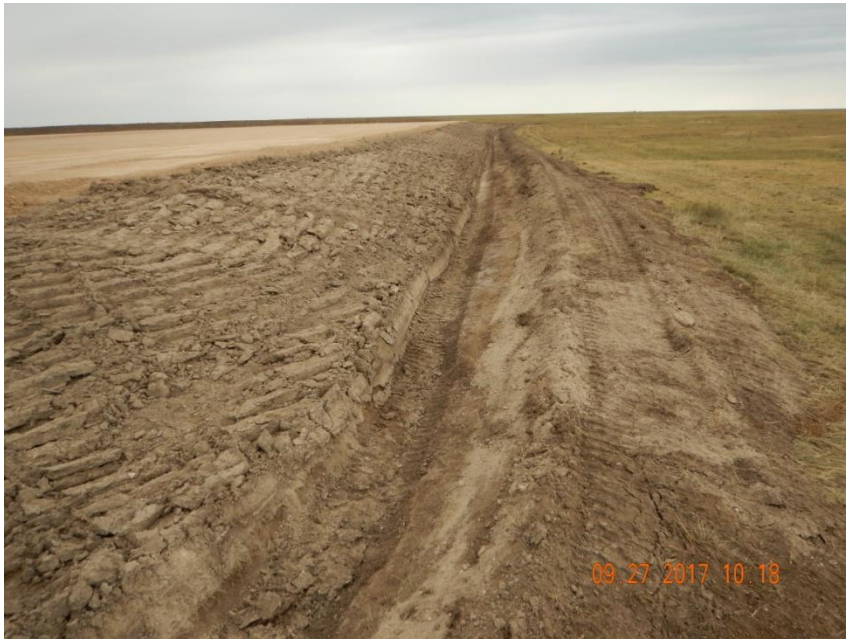
Photo 3. Photo taken from the southeast location, facing North. Temporary BMP's (ditch and berm) have been installed.

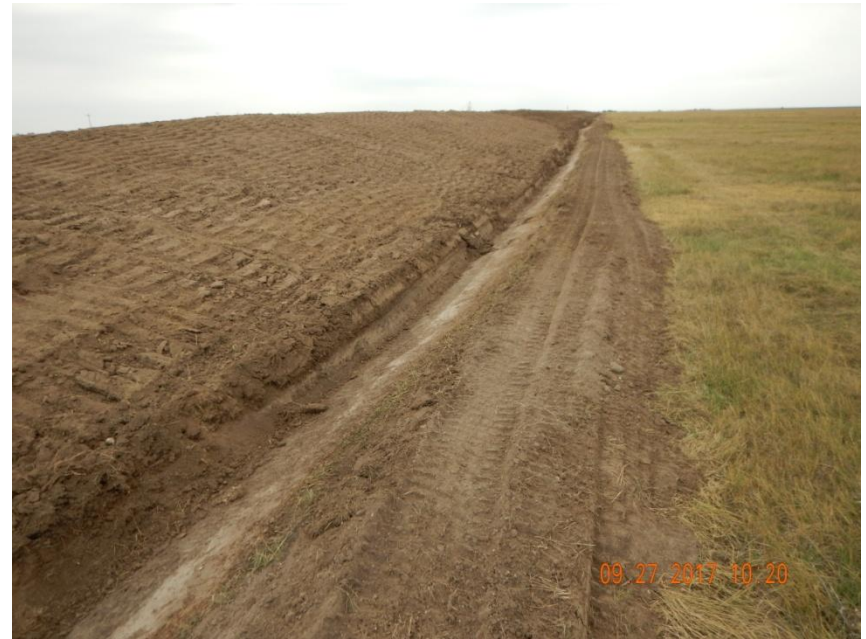
Photo 4. Photo taken from the northeastern location, facing West. Temporary BMP's (ditch and berm) have been installed. Appears topsoil has been temporarily stabilized and stored along the northern location.

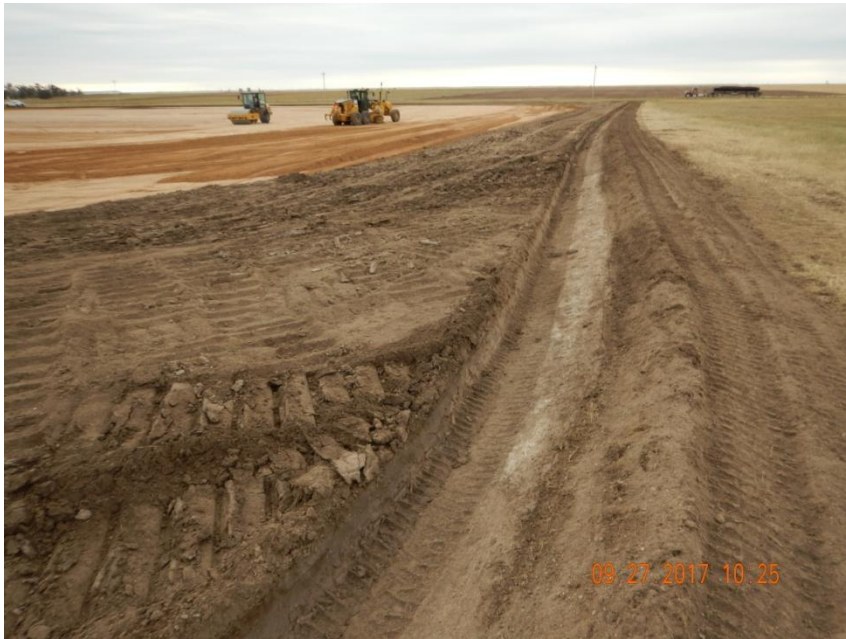
Photo 5. Photo taken from the northwest location, facing South. Temporary BMP's (ditch and berm) have been installed.

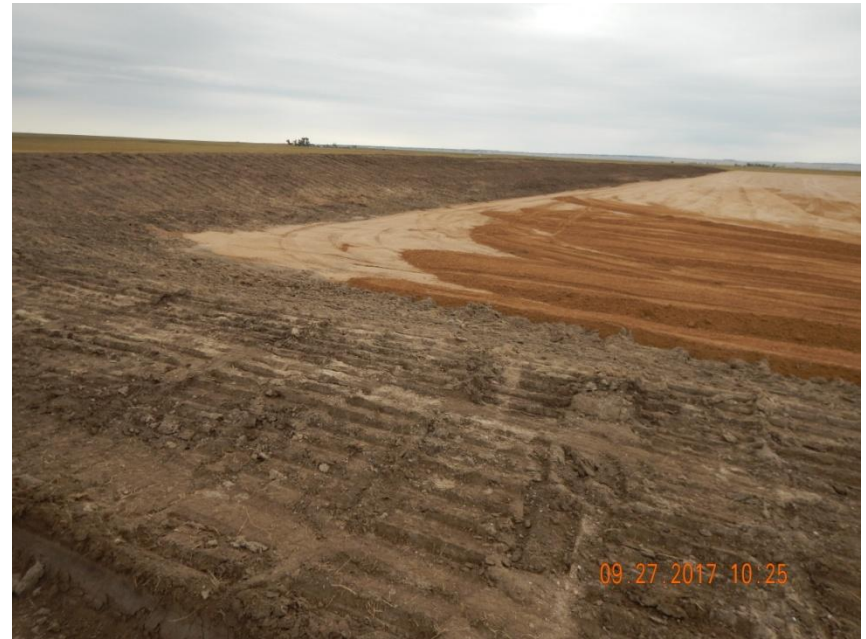
Photo 6. Photo taken from the northwest location, facing East. Appears topsoil stockpile has been temporarily stabilized as well as cut slope areas.
