Stormwater Inspection

September 27, 2017

Operator: FIFTH CREEK ENERGY OPERATING COMPANY LLC- #10629

Location ID: 444164

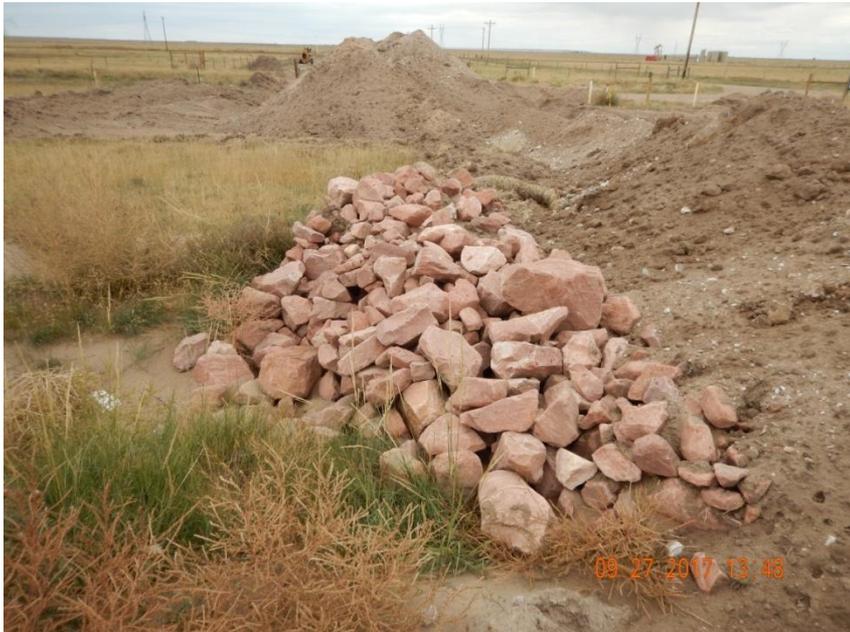
Photo 1. Photo taken from the southeast location, facing East. Appears Operator may have installed a sediment trap but pipeline disturbance has damaged BMPs.

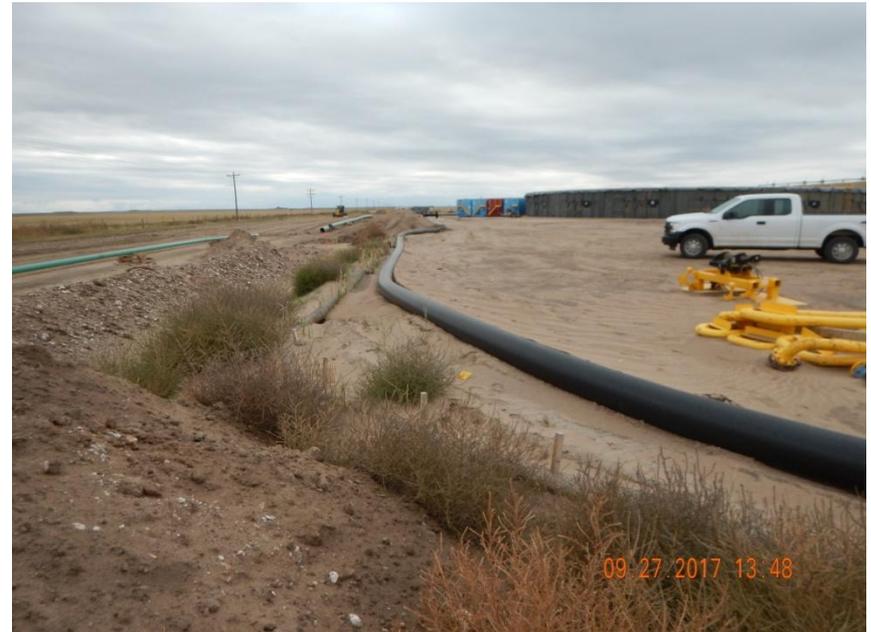
Photo 2. Photo taken from the southeast location, facing West. Photo illustrates pipeline construction and disturbance. Temporary BMPs (straw wattles) appear to be installed between the water line and the unconsolidated soil material.

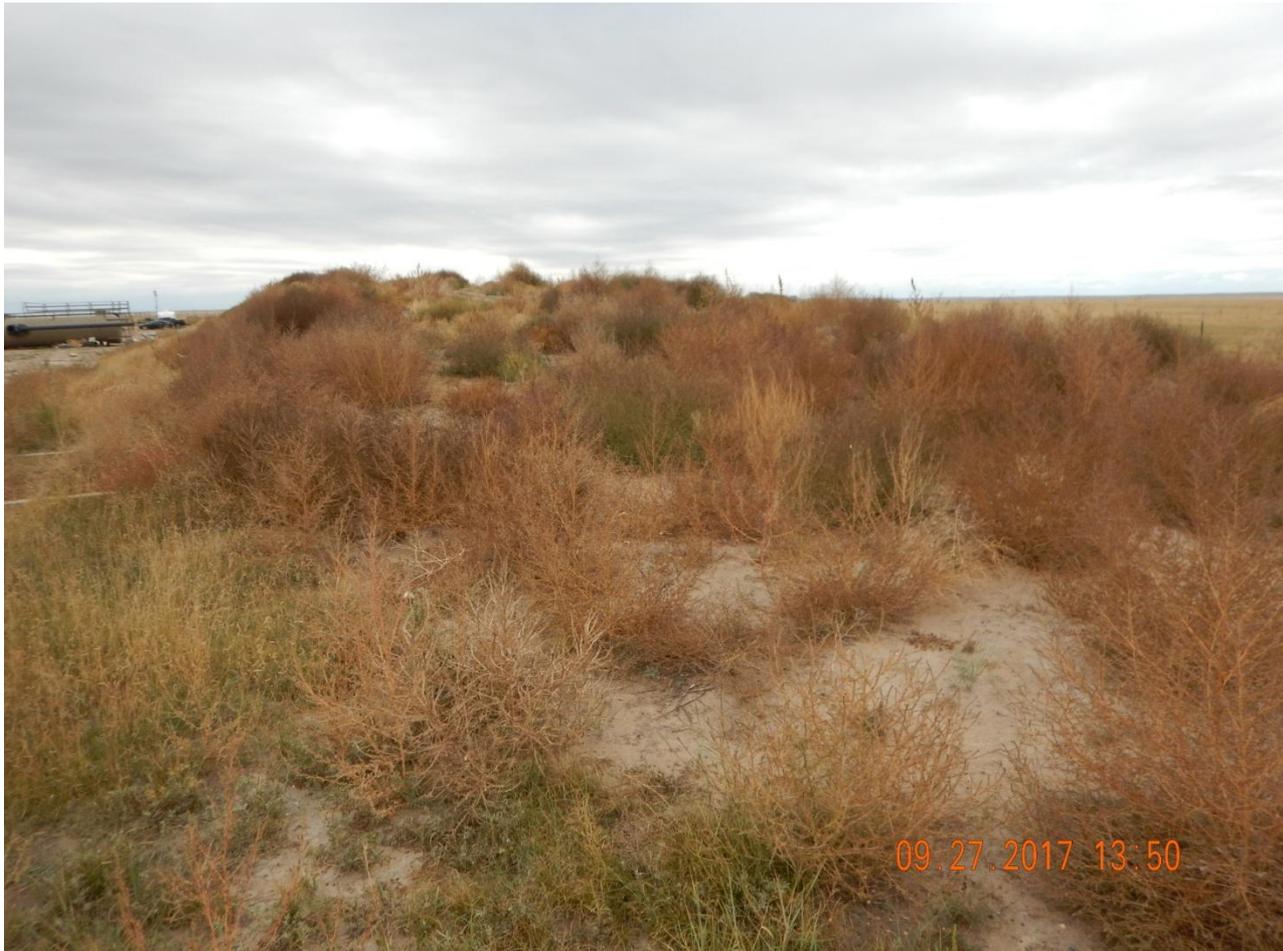
Photo 3. Photo taken from the eastern topsoil stockpile, facing West. Russian thistle has established throughout the stockpile which is not protective of topsoil per Rule 1002.c. and Russian thistle is considered weed debris which needs to be controlled per Rule 603.f.

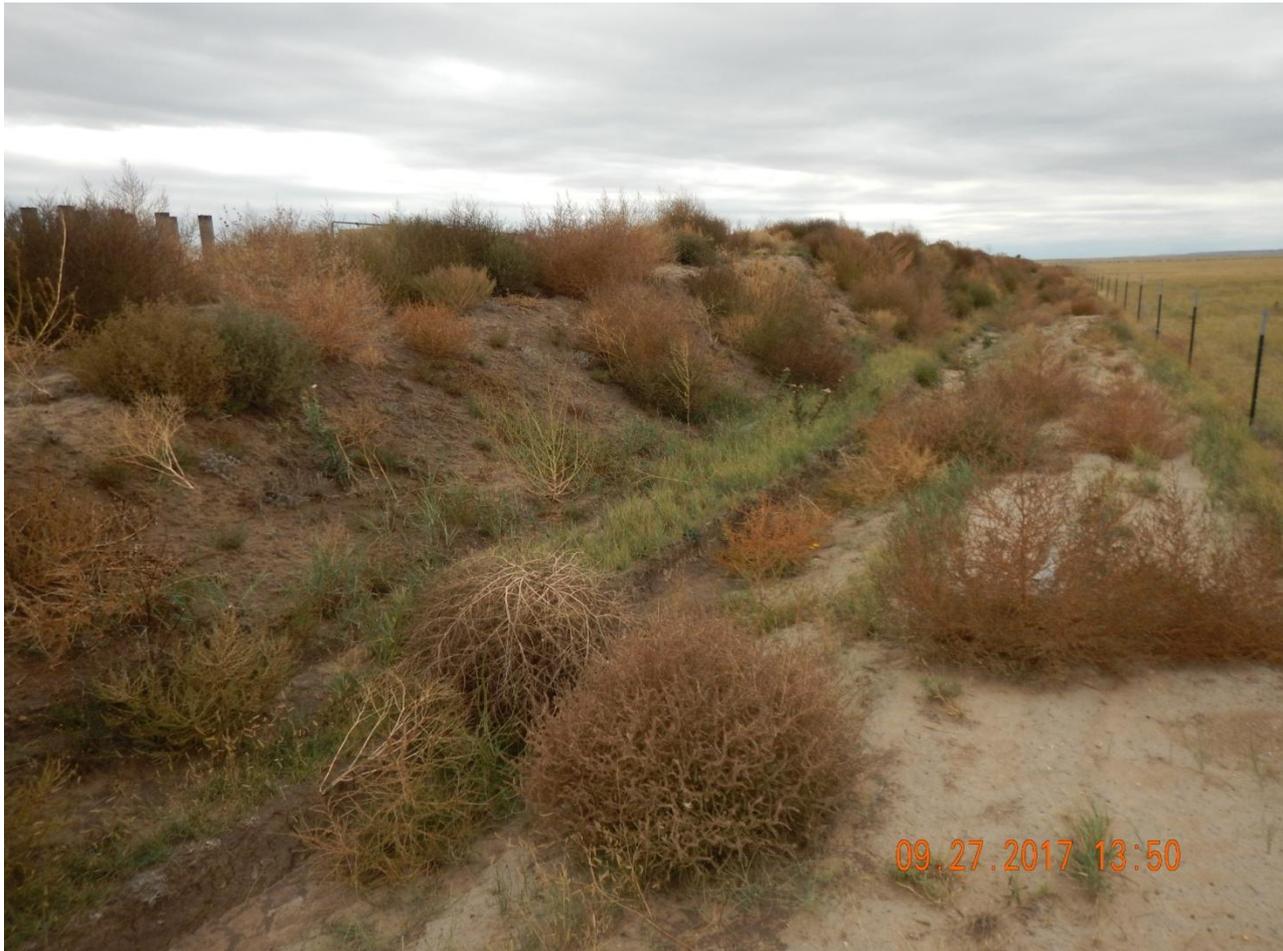
Photo 4. Photo taken from the eastern topsoil stockpile along the north-facing side, facing West. Russian thistle has established throughout the stockpile which is not protective of topsoil per Rule 1002.c. and Russian thistle is considered weed debris which needs to be controlled per Rule 603.f.

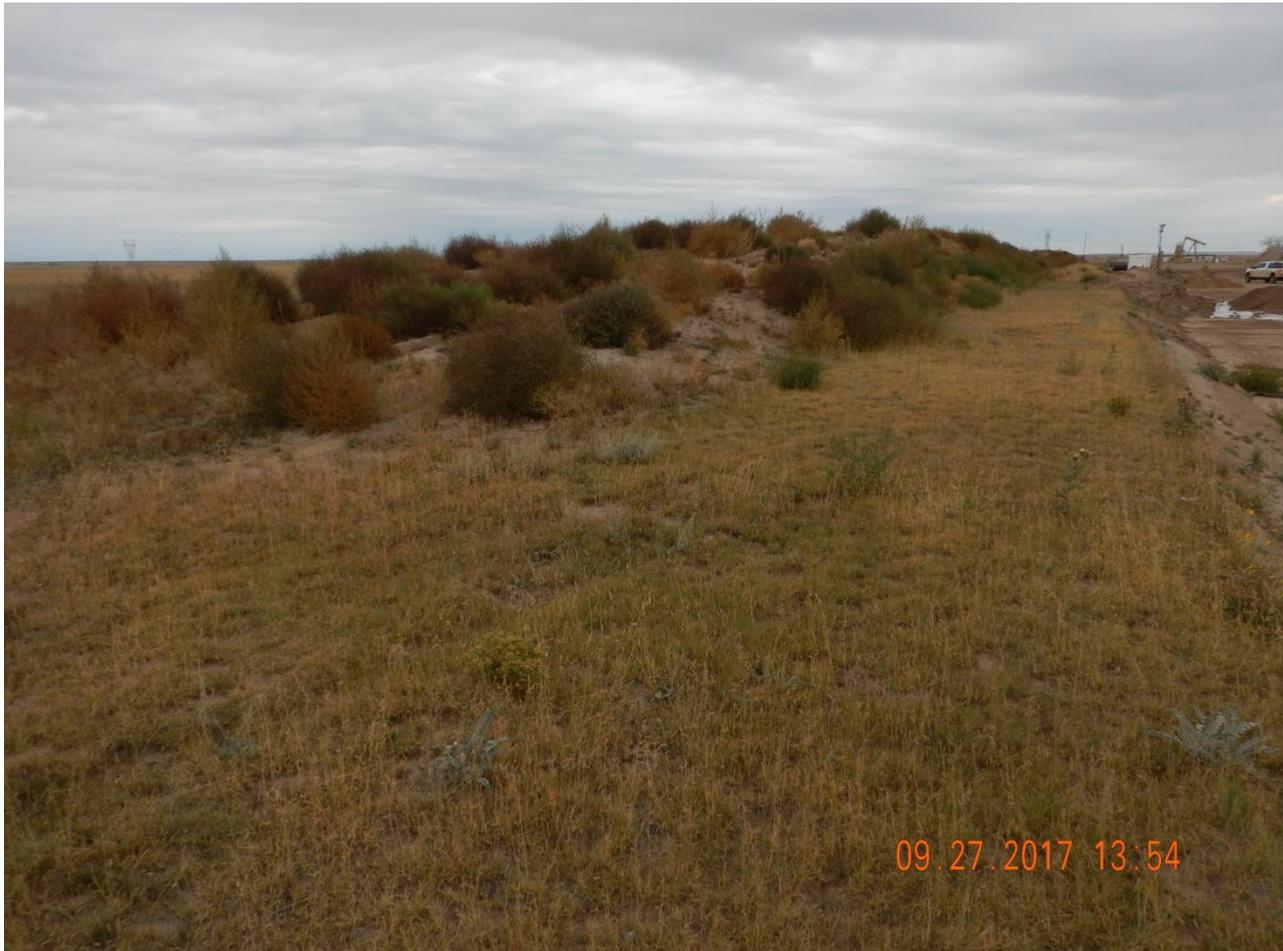
Photo 5. Photo taken from the western topsoil stockpile along the south-facing side, facing East. Russian thistle has established throughout the stockpile which is not protective of topsoil per Rule 1002.c. and Russian thistle is considered weed debris which needs to be controlled per Rule 603.f.

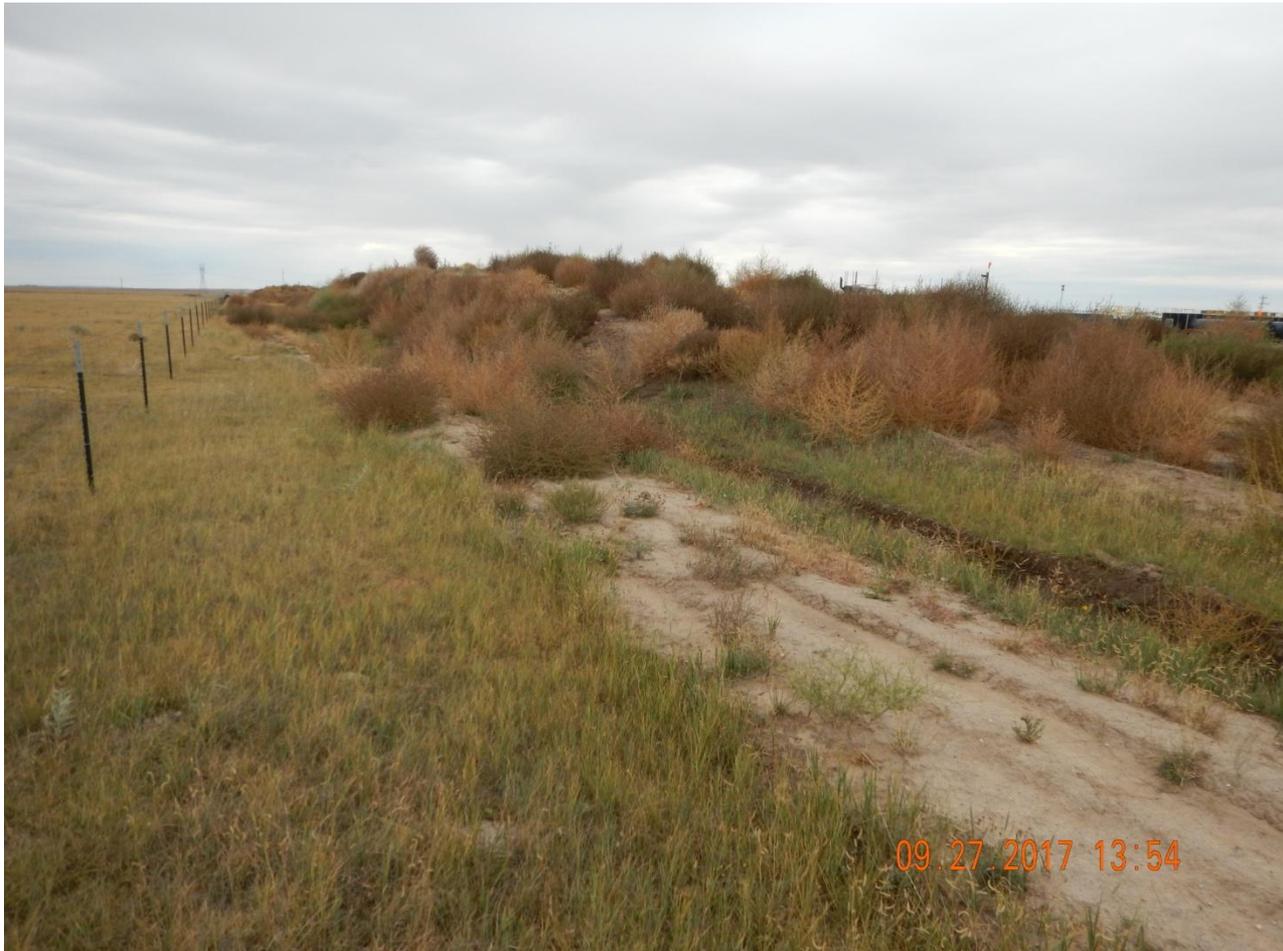
Photo 6. Photo taken from the western topsoil stockpile along the north-facing side, facing East. Russian thistle has established throughout the stockpile which is not protective of topsoil per Rule 1002.c. and Russian thistle is considered weed debris which needs to be controlled per Rule 603.f.
