Inspection Photos

Operator: PDC ENERGY INC - 69175

Location ID: 330004

Inspection Doc. Number: 682502626

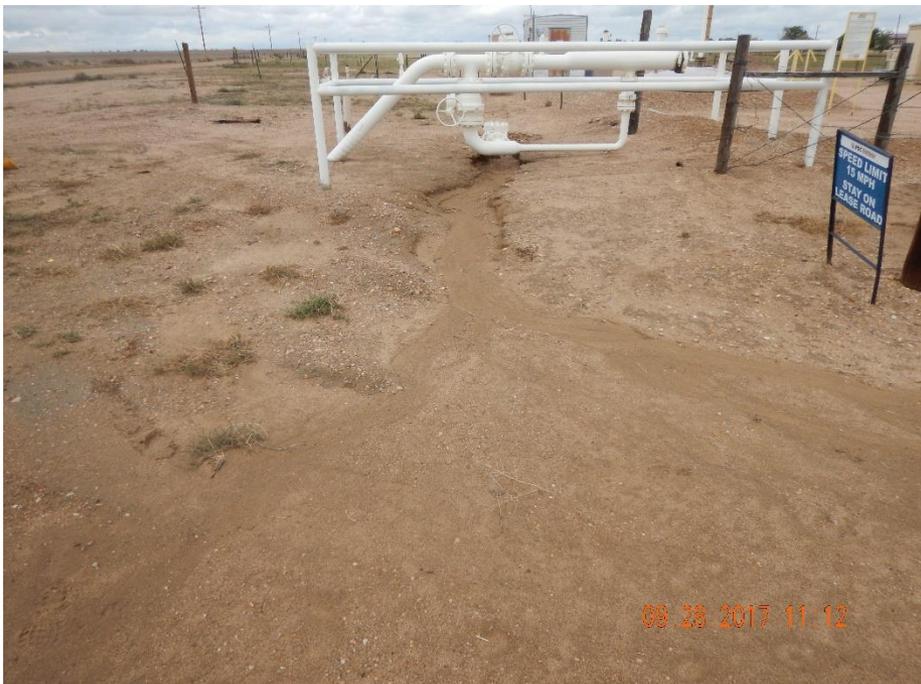
Photo 1: Photo taken from the northeast end of the battery location, facing west. Photo shows stormwater erosion degrading the location.

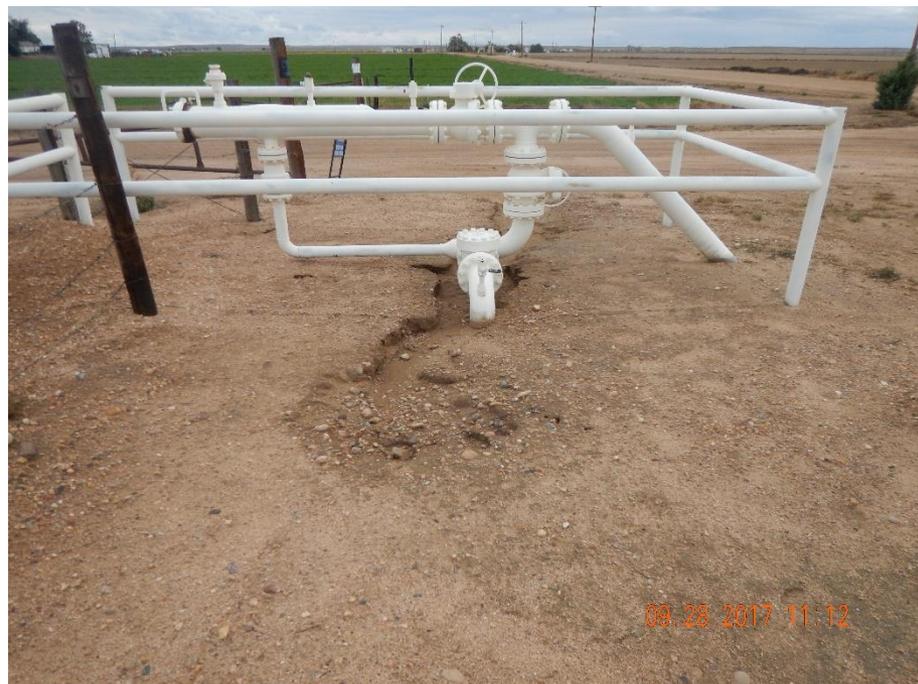
Photo 2: Photo taken from the northeast end of the battery location, facing east. Photo shows stormwater erosion degrading the location.

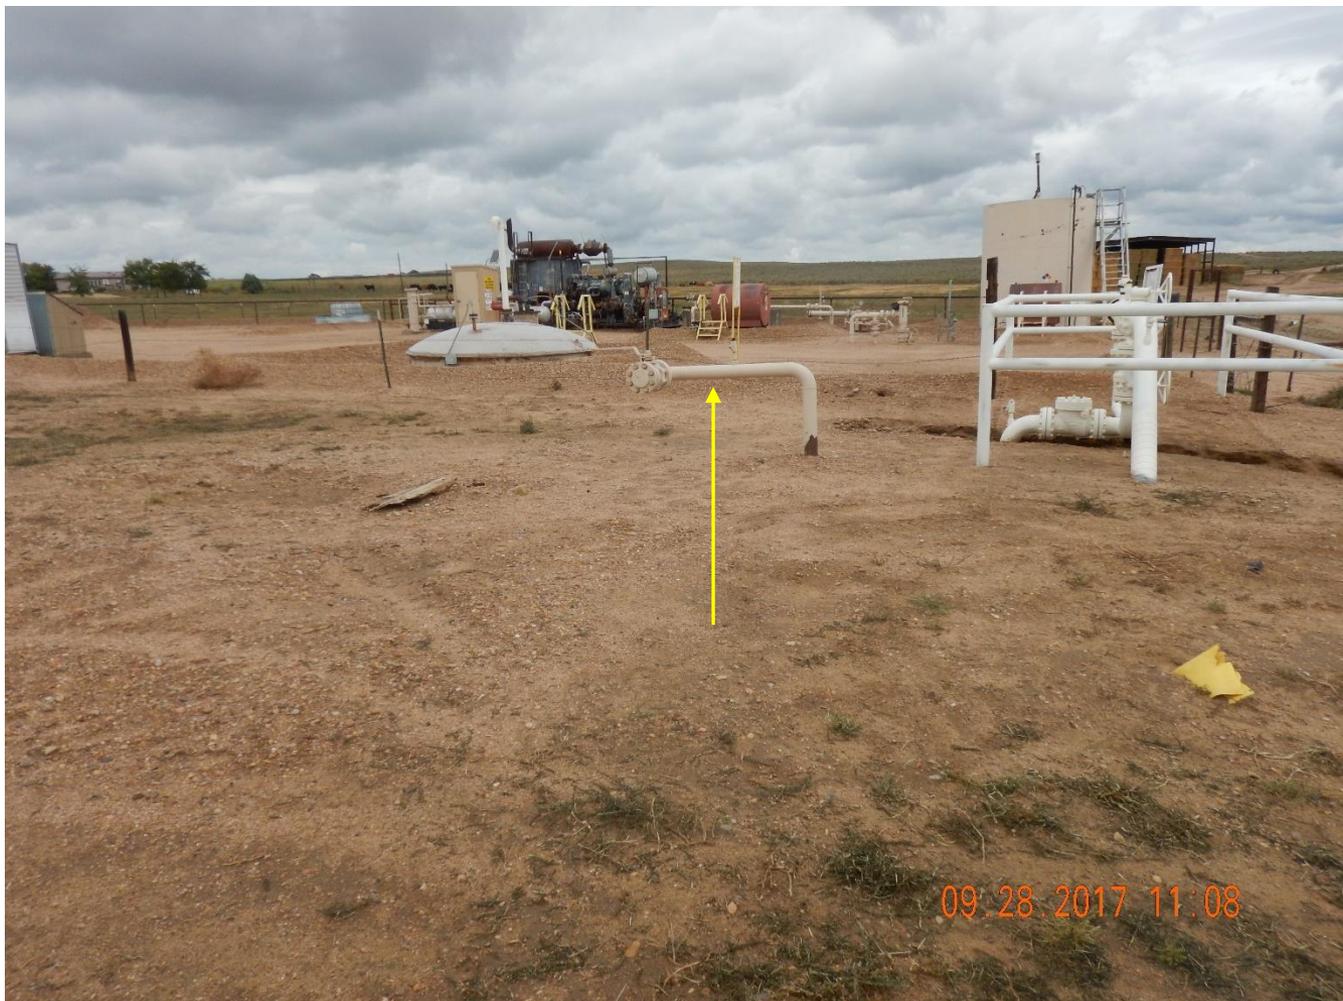
Photo 3: Photo taken from the former battery location, facing north. Inspection doc. #675103866 noted that the meter sheds had been removed, but pipe riser equipment associated with the meter sheds still remain. Photo shows riser equipment has not been removed per the corrective actions.
