Inspection Photos

Operator: NOBLE ENERGY INC - 100322

Location ID: 323427

Inspection Doc. Number: 682502632

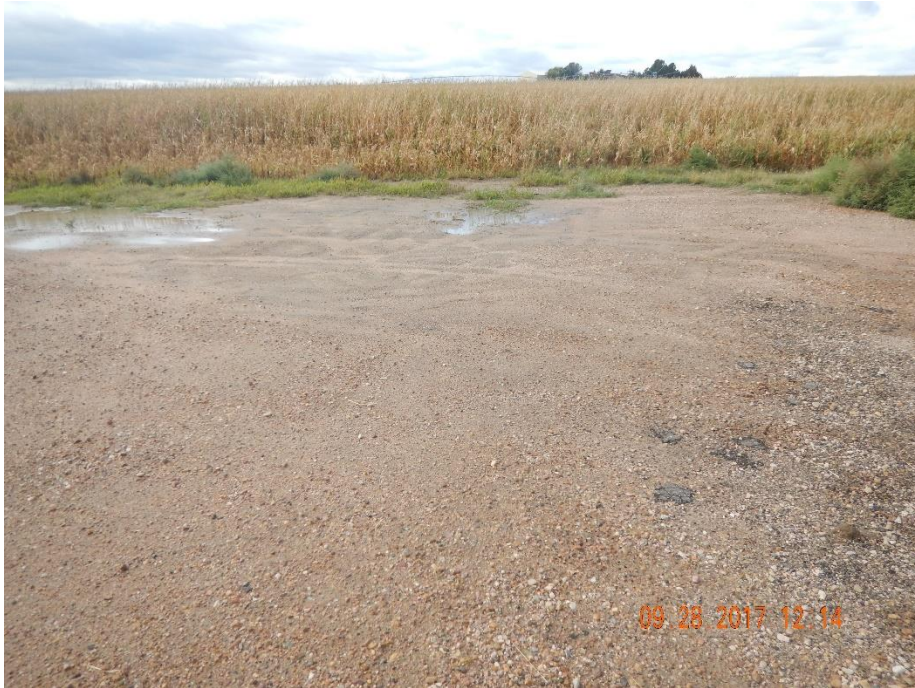
Photo 1: Photo taken from the southeast end of the former battery location, facing west. Photo shows battery location remains unreclaimed; gravel remains, location/access road has not been returned to its designated final land use. No 502.b variance to not perform reclamation at the battery and access road has been submitted by operator or approved. Location and access road remain subject to COGCC 1000 series reclamation requirements.

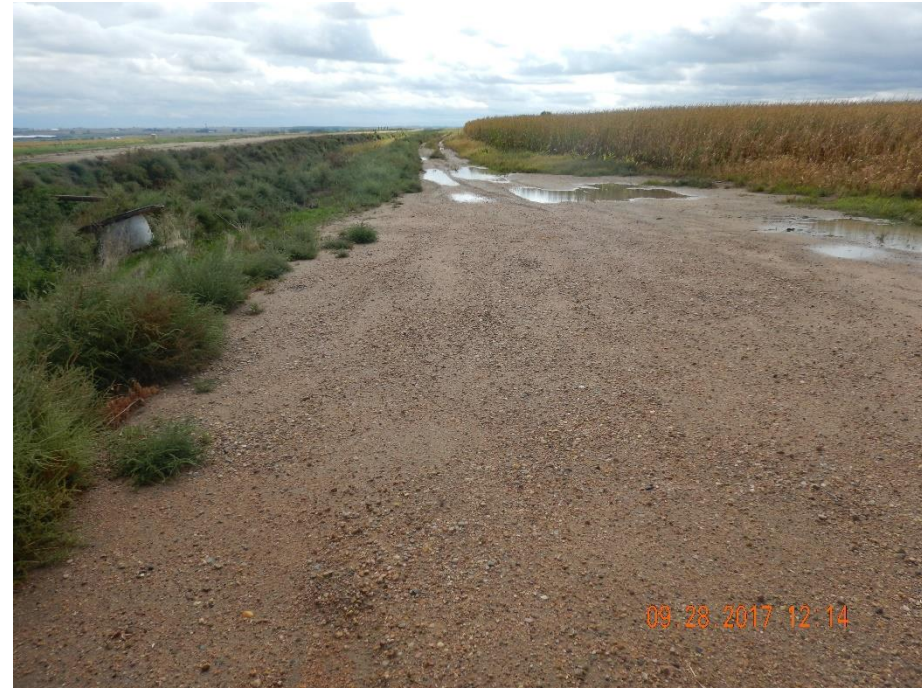
Photo 2: Photo taken from the southeast end of the former battery location, facing south. Photo shows battery location remains unreclaimed; gravel remains, location/access road has not been returned to its designated final land use. See Photo 1 for additional comments.

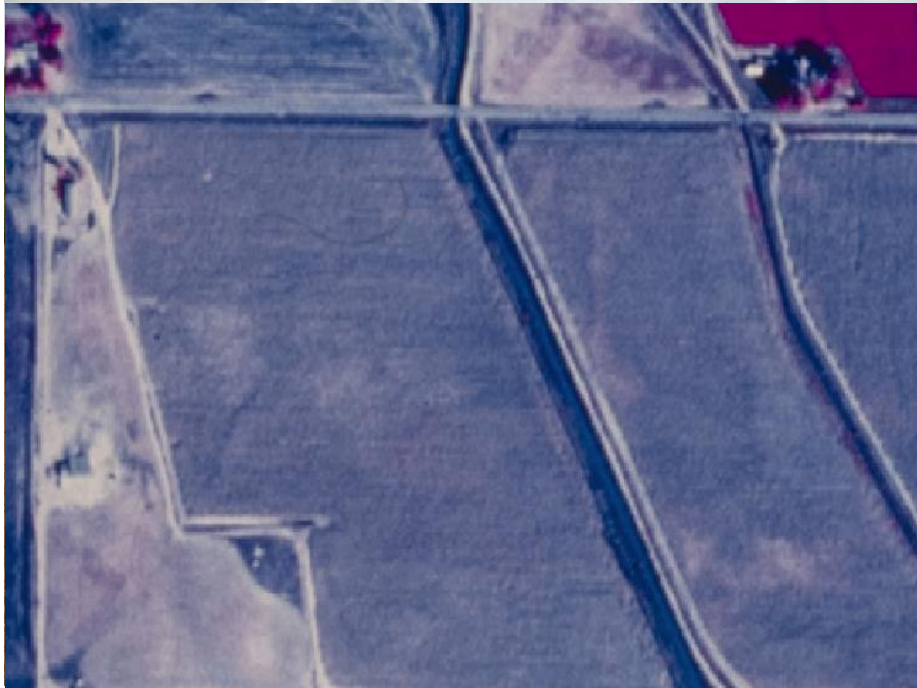
Photo 3: 1984 USGS aerial imagery. Well was spud 1986. Photo shows location prior to oil and gas activities. Photo shows access road and battery location did not pre-exist oil and gas activities.
