Inspection Photos

Operator: NOBLE ENERGY INC - 100322

Location ID: 327399

Inspection Doc. Number: 682502634

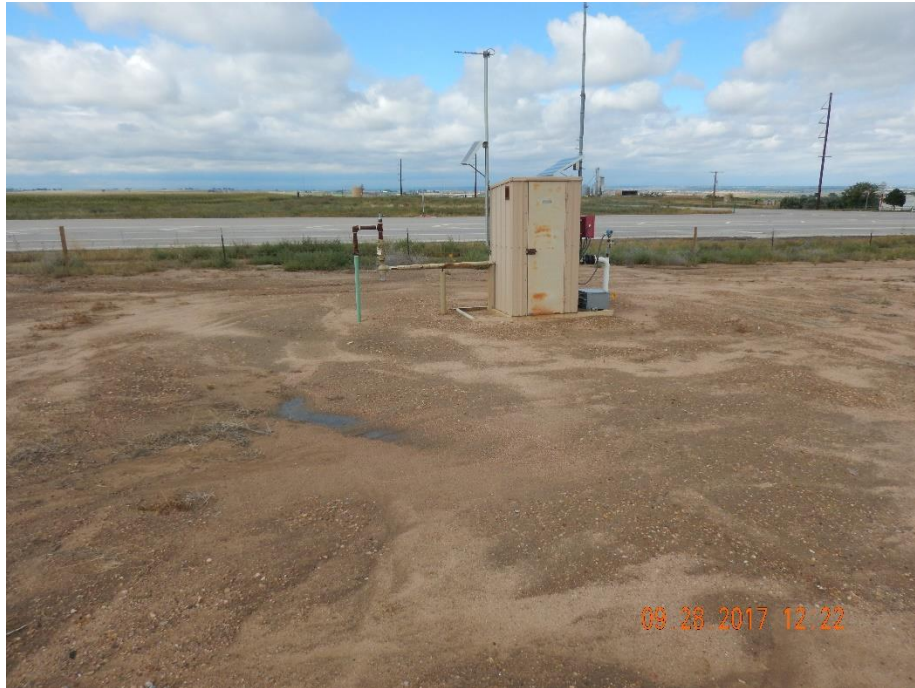
Photo 1: Photo taken from the east end of the former battery location, facing west. Inspection #682502381 and #675103877 documented that equipment (meter shed) has not been removed per reclamation requirements. Photo shows meter shed and related equipment have not been removed per corrective actions.

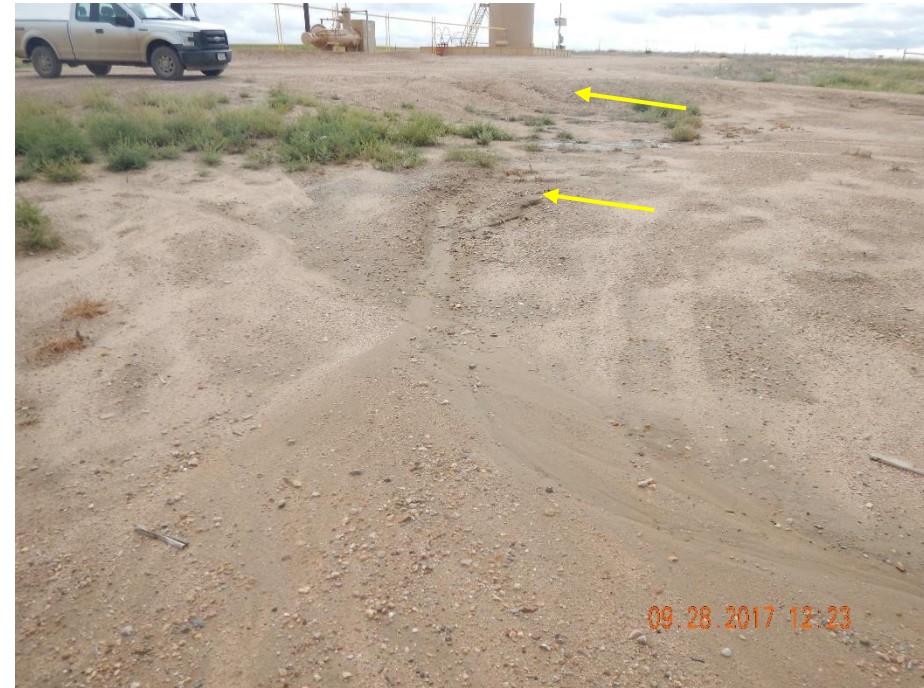
Photo 2: Photo taken from the former battery location, facing southeast towards the active Broomfield tank battery. Photo shows stormwater runoff from the active battery is causing erosion degradation on the slopes, as well as erosion degradation at the former Freedom tank battery. COGCC rule 1002.f requires stormwater management until final reclamation has passed.

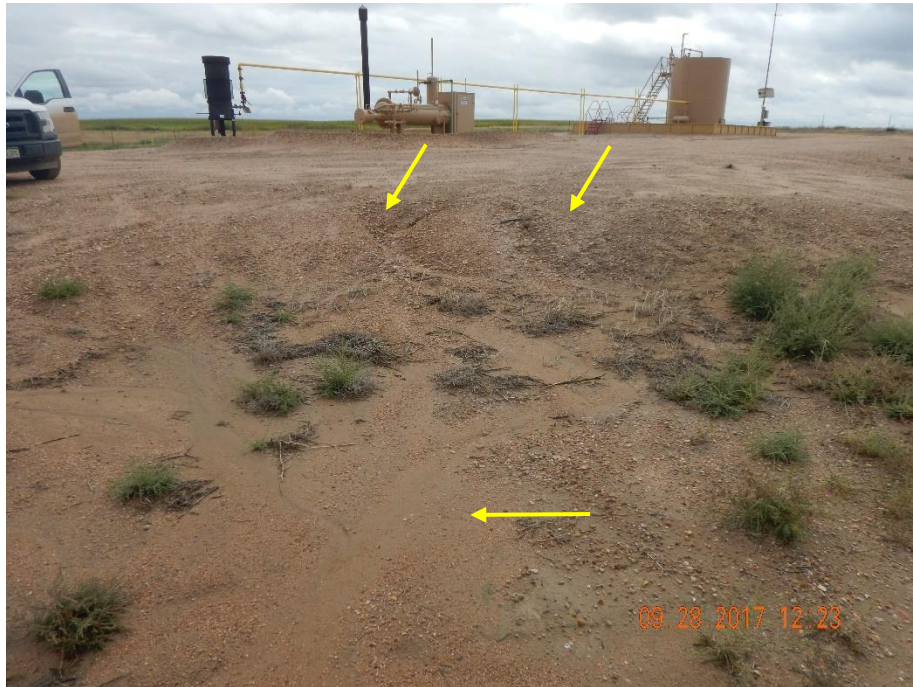
Photo 3: Photo taken from the east end of the former battery location, facing southeast towards the active Broomfield tank battery. See comment under photo 2

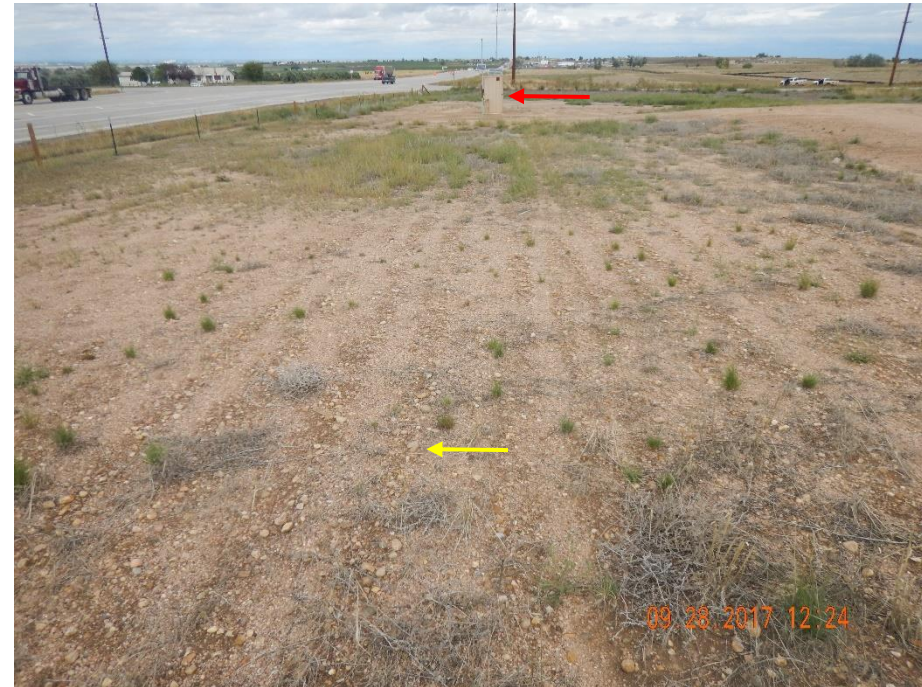
Photo 4: Photo taken from the south end of the former tank battery location, facing south. Red arrow indicates meter shed equipment remaining. Photo shows areas of the battery where striations in the soil are evident, indicating reclamation activities appear to have been attempted at one point prior to the inspectors previous visits. However, gravel remains and if any revegetation activities have been conducted, they have been unsuccessful.

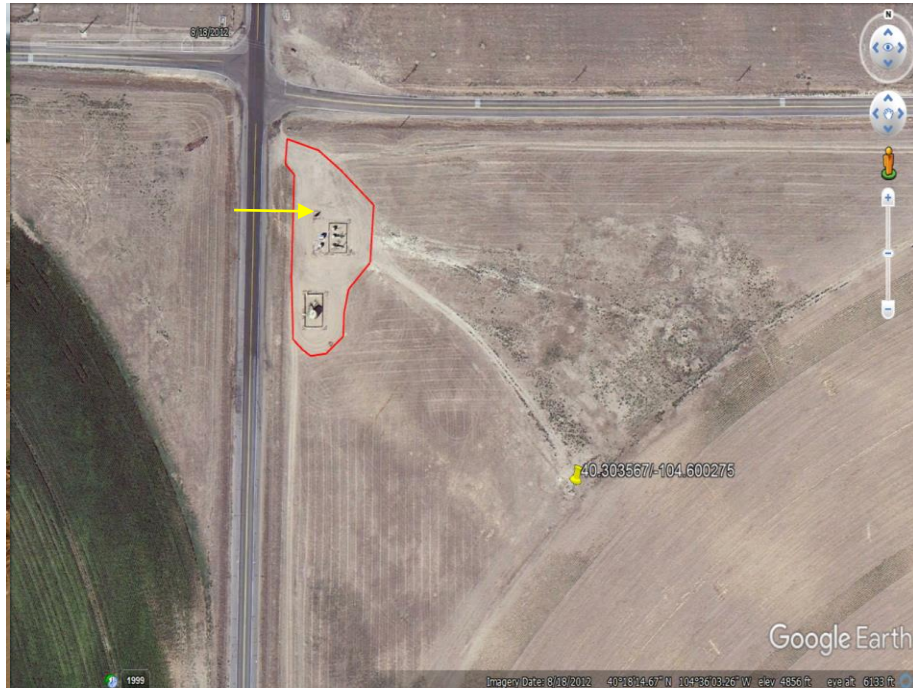
Photo 5: 2012 aerial imagery. Photo shows former battery location and well. Yellow arrow indicates location of the meter shed remaining (see photo 1).

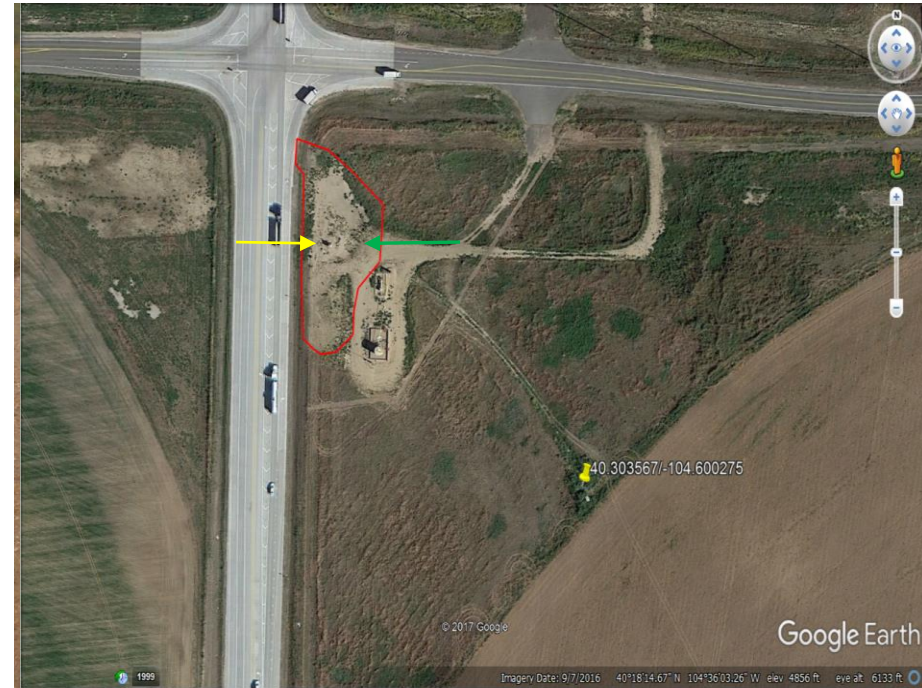
Photo 6: Current (2016) available aerial imagery shows area of the former battery location. Yellow arrow indicates location of the meter shed remaining (see photo 1). Green arrow indicates areas where erosion degradation had been observed.
