Final Reclamation and Stormwater Inspection

October 3, 2017

Operator: Blue Chip Oil Inc- 8840

Inspection Photos
Location Name: SLOAN #3
API: 05-123-14512

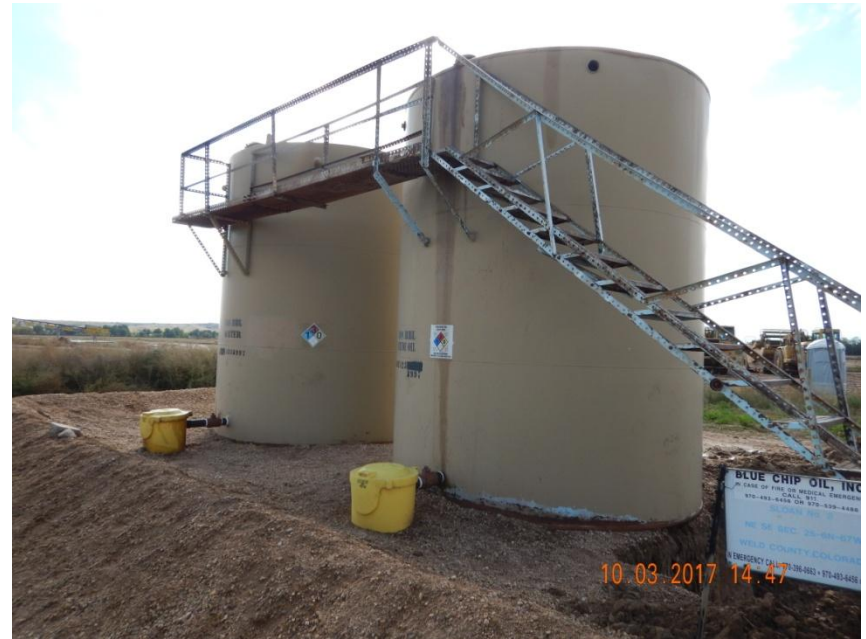
Photo 2. Photo taken from the battery location, facing South. Equipment still at location needs to be removed per Rule 1004.a.

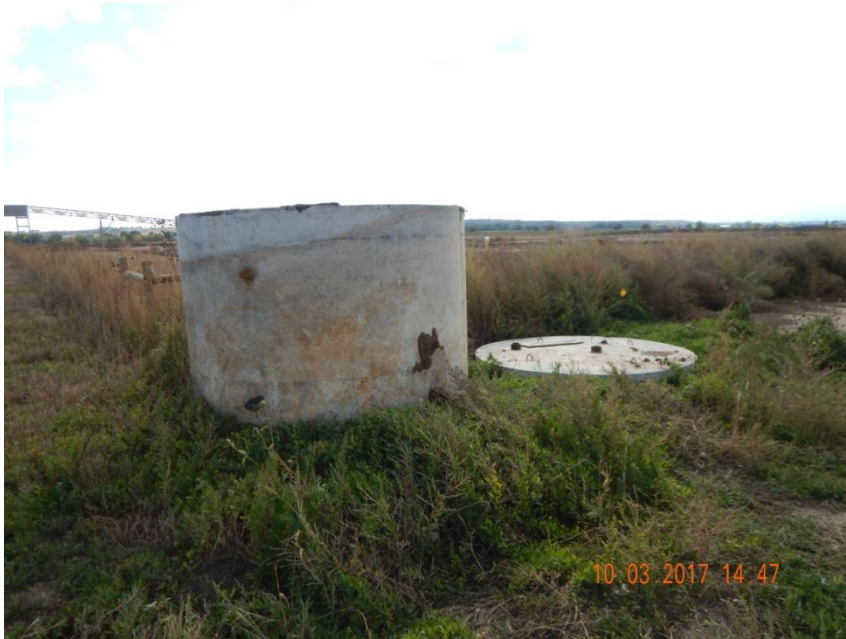
Photo 3. Photo taken from the battery location, facing Southeast. Equipment still at location needs to be removed per Rule 1004.a.

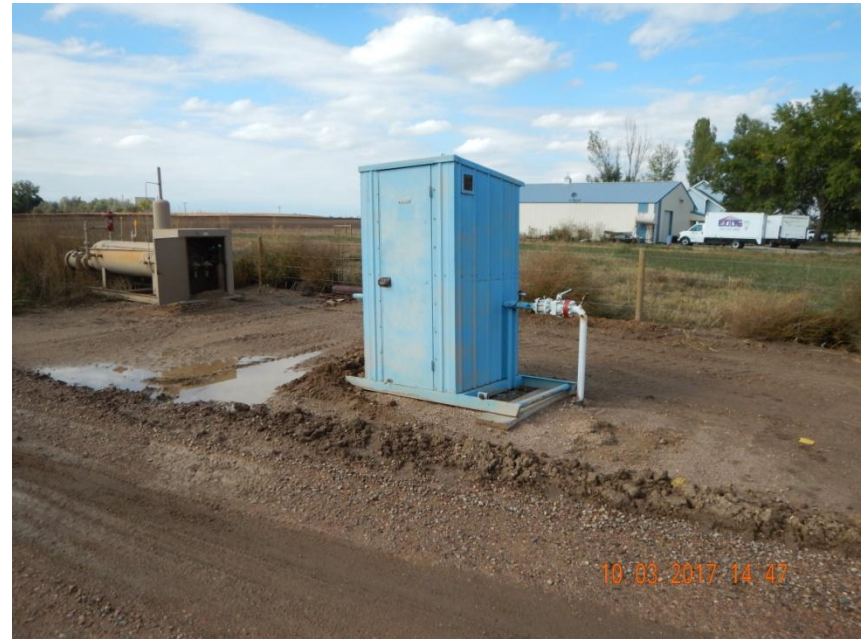
Photo 4. Photo taken from the battery location, facing Northwest. Equipment still at location needs to be removed per Rule 1004.a.

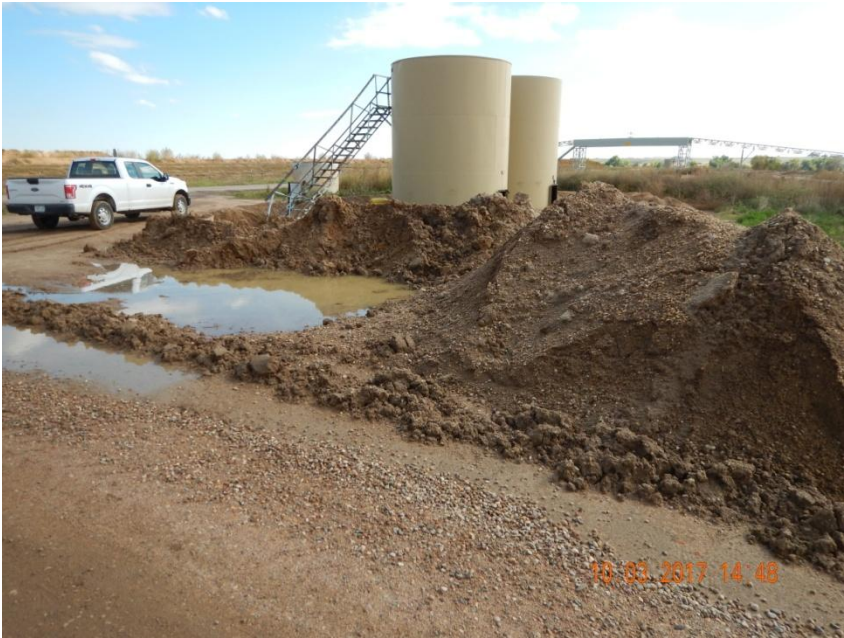
Photo 5. Photo taken from the western battery location, facing Southeast. Did not observe any stormwater BMPs during the removal of equipment.

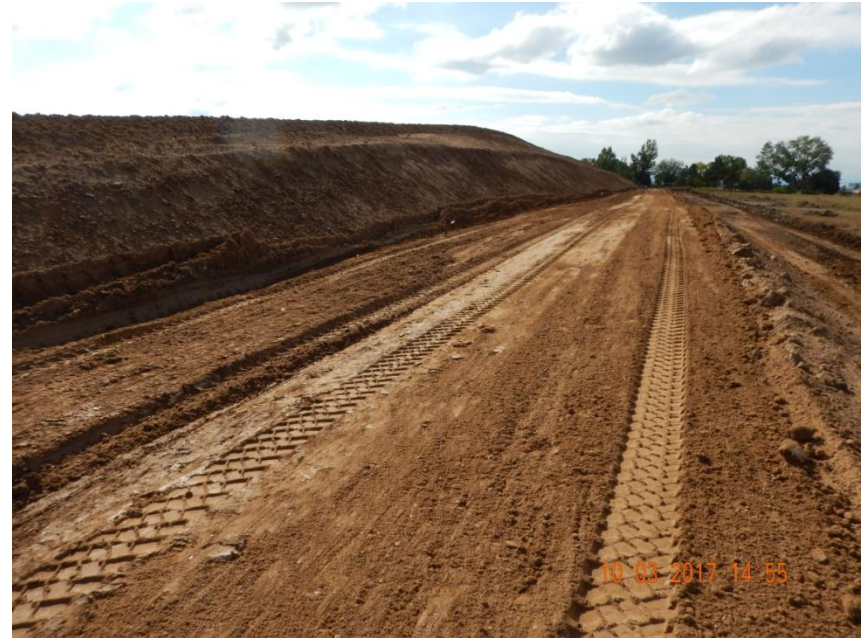
Photo 6. Photo taken from the approximate well location, facing West. Stockpile from mining operations is located on top of well location.

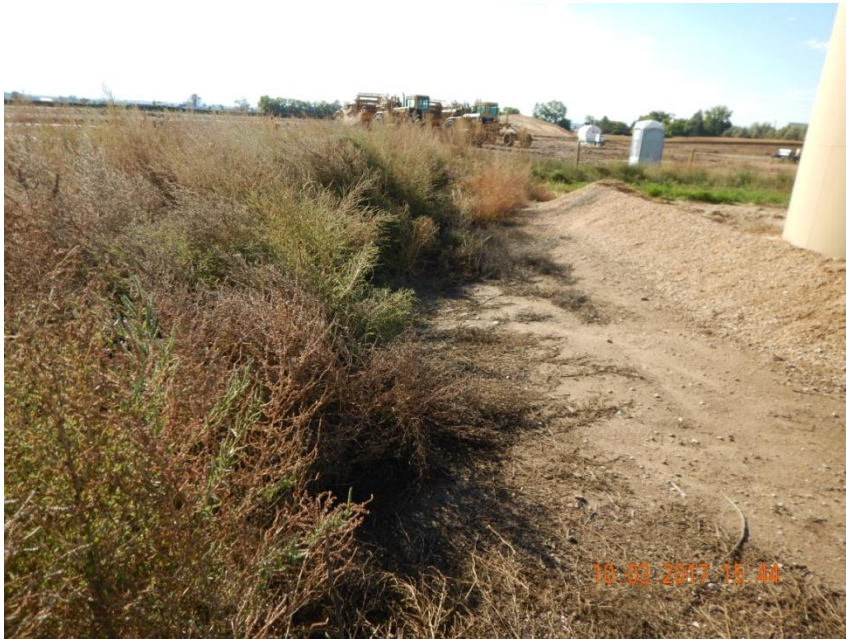
Photo 7. Photo taken from the southern battery location, facing West. Comply with Rule 603.f. Russian thistle observed along the southern and northern battery location.

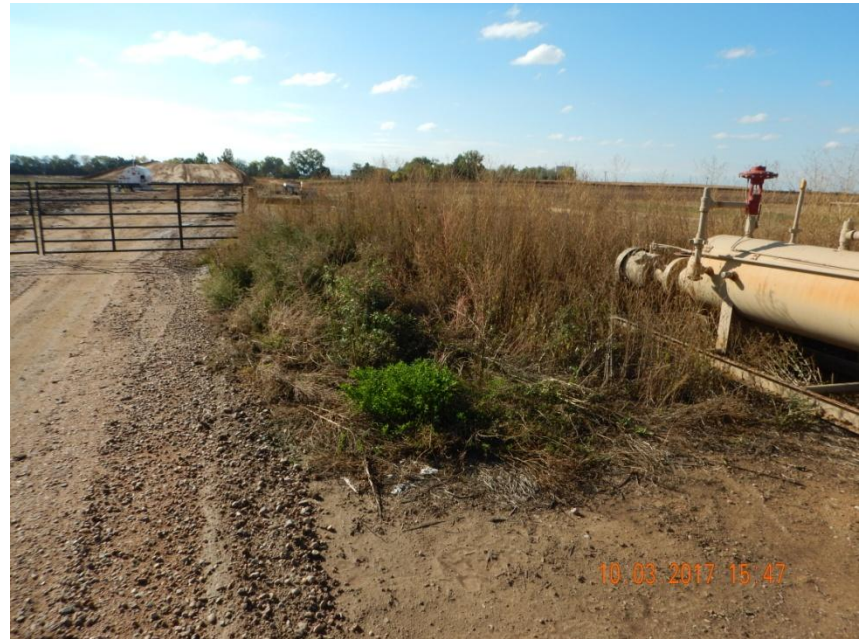
Photo 8. Photo taken from the northern battery location, facing West. Comply with Rule 603.f. Russian thistle observed along the southern and northern battery location.
