Final Reclamation Inspection

Operator: CHESAPEAKE OPERATING LLC- 16660

API: 05-123-31242

Inspection Photos
Location Name: STATE #1-17-1
API: 05-123-31242

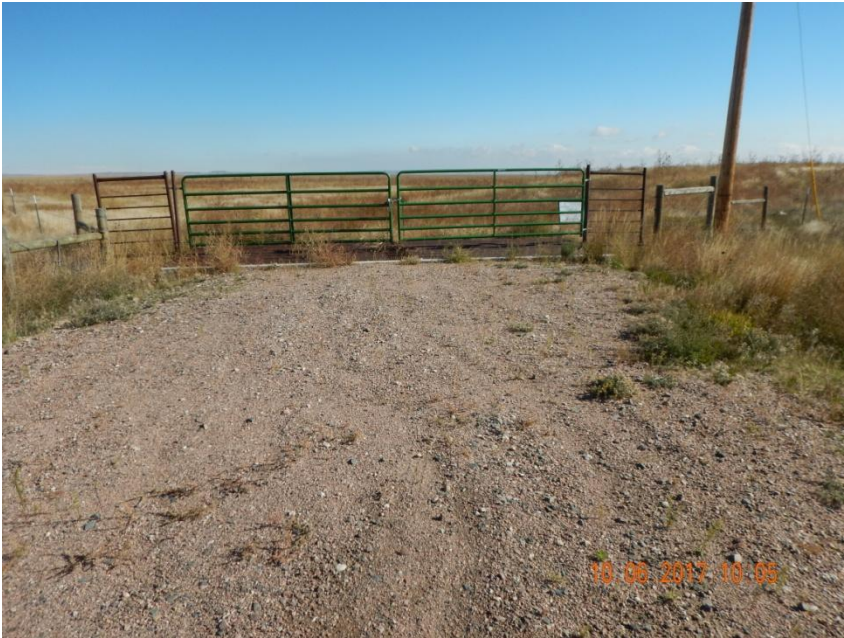
Photo 1. Photo taken from the entrance of the well location, facing North. Appears the approach, gate, and cattle guard have been left at location.

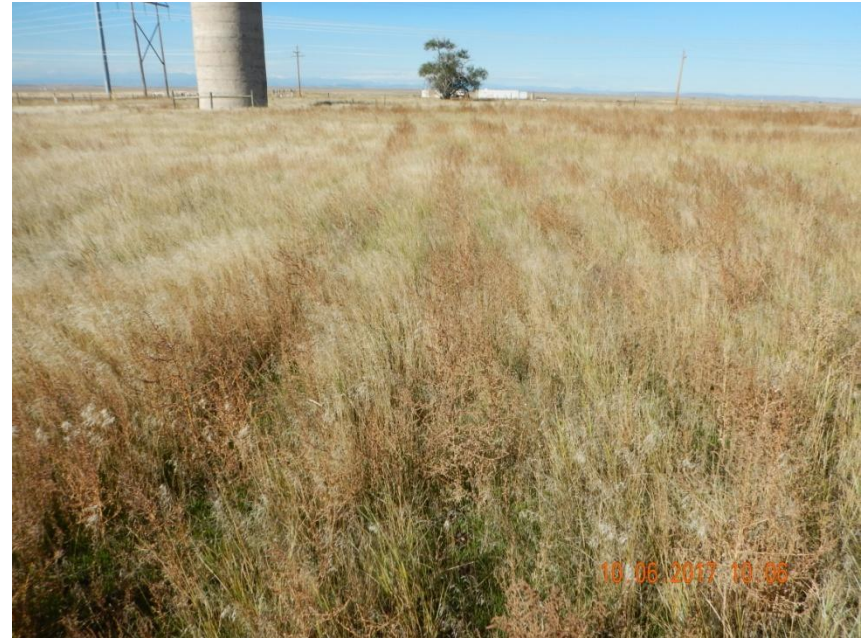
Photo 2. Photo taken from the southwestern well location, facing West. Cheatgrass (*Bromus tectorum*) and Russian thistle (*Salsola tragus*) were the dominant vegetative cover.

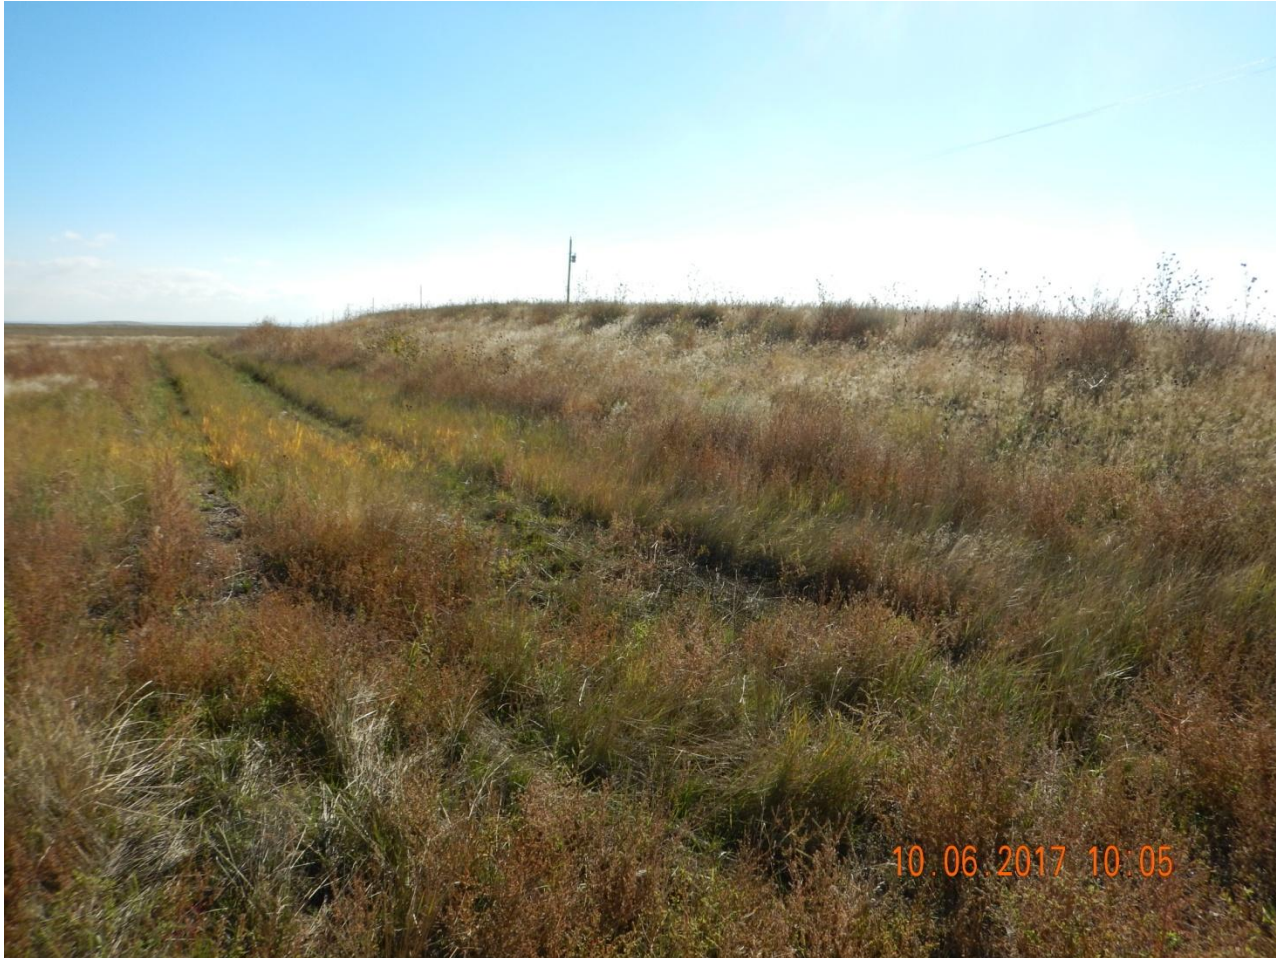
Photo 3. Photo taken from the southwestern well location, facing East. Gravel stockpile remains at location which needs to be removed and reclaimed per Rule 1004.

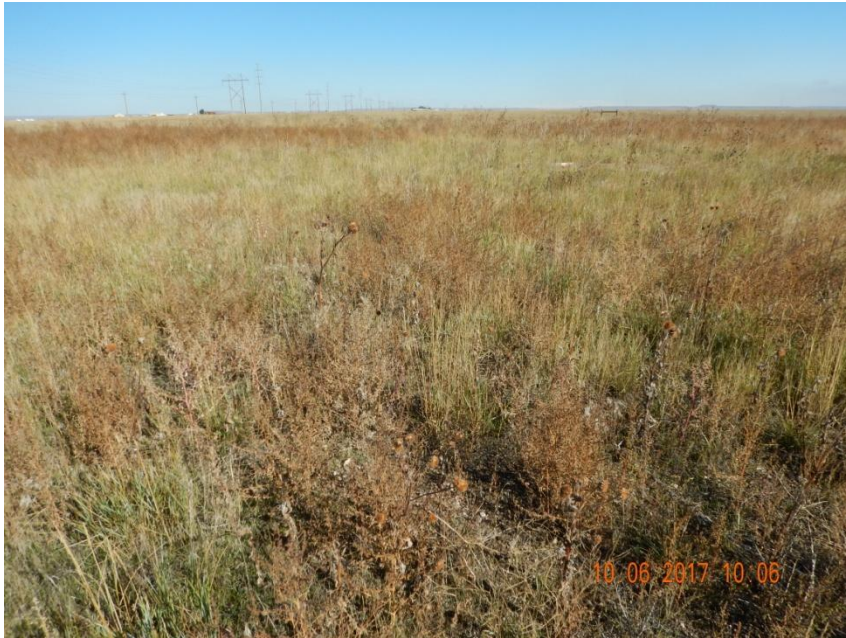
Photo 4. Photo taken from the approximate center of the well location, facing North. See comments under Photo 2.

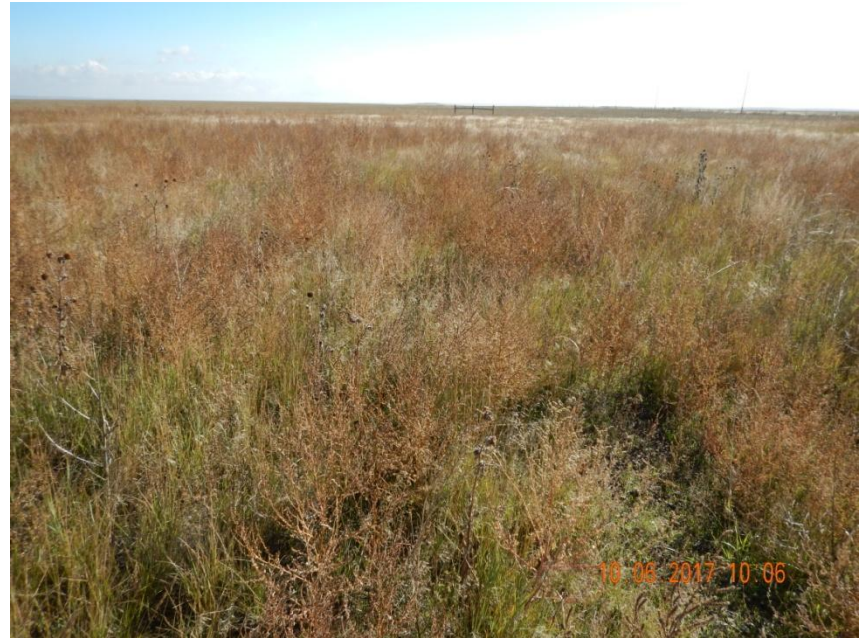
Photo 5. Photo taken from the approximate center of the well location, facing East. See comments under Photo 2.

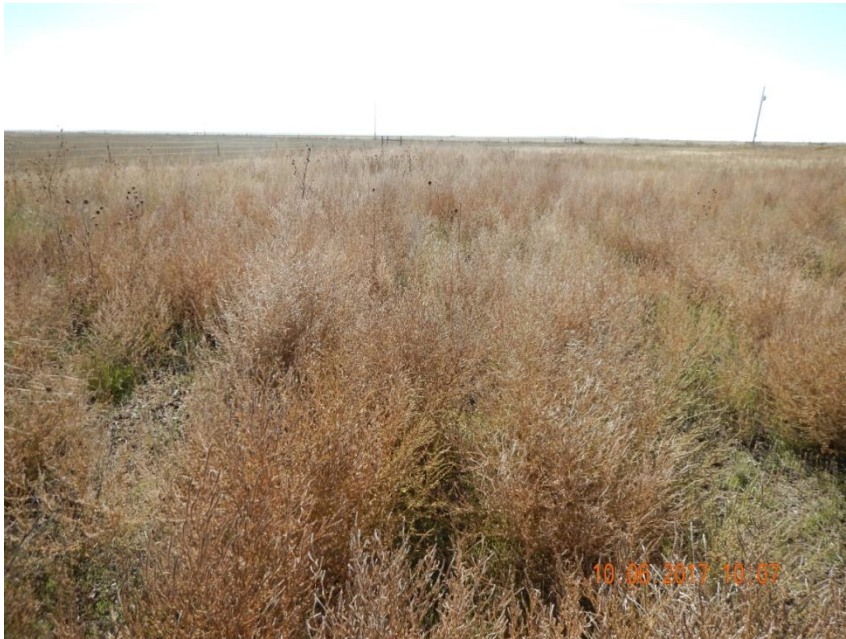
Photo 6. Photo taken from the northern well location, facing Southeast. Russian thistle is the dominant vegetative cover along this area.

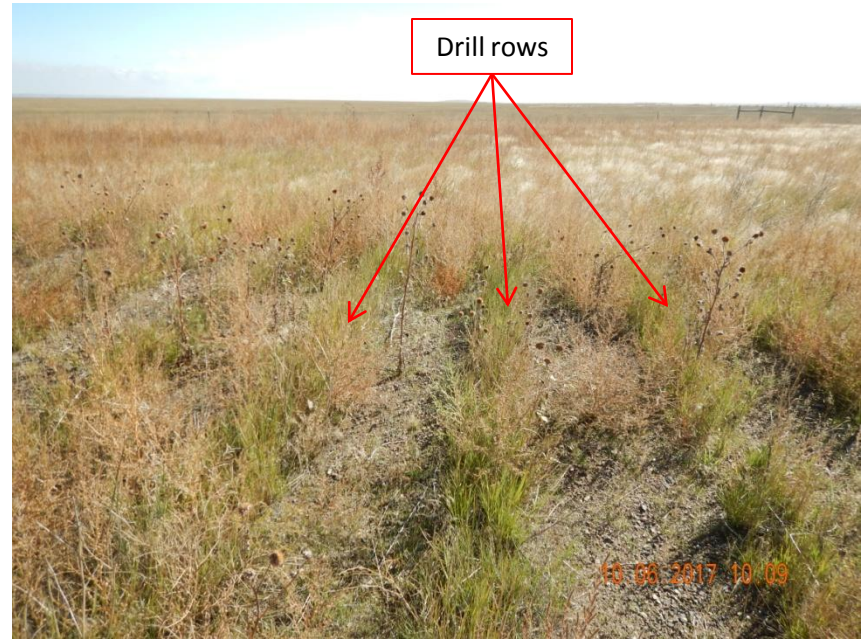
Photo 7. Photo taken from the northeastern well location, facing East. Photo illustrates what appears to be evidence of drill seeding rows. Drill row spacing appears wide leaving bare ground without any vegetative growth.

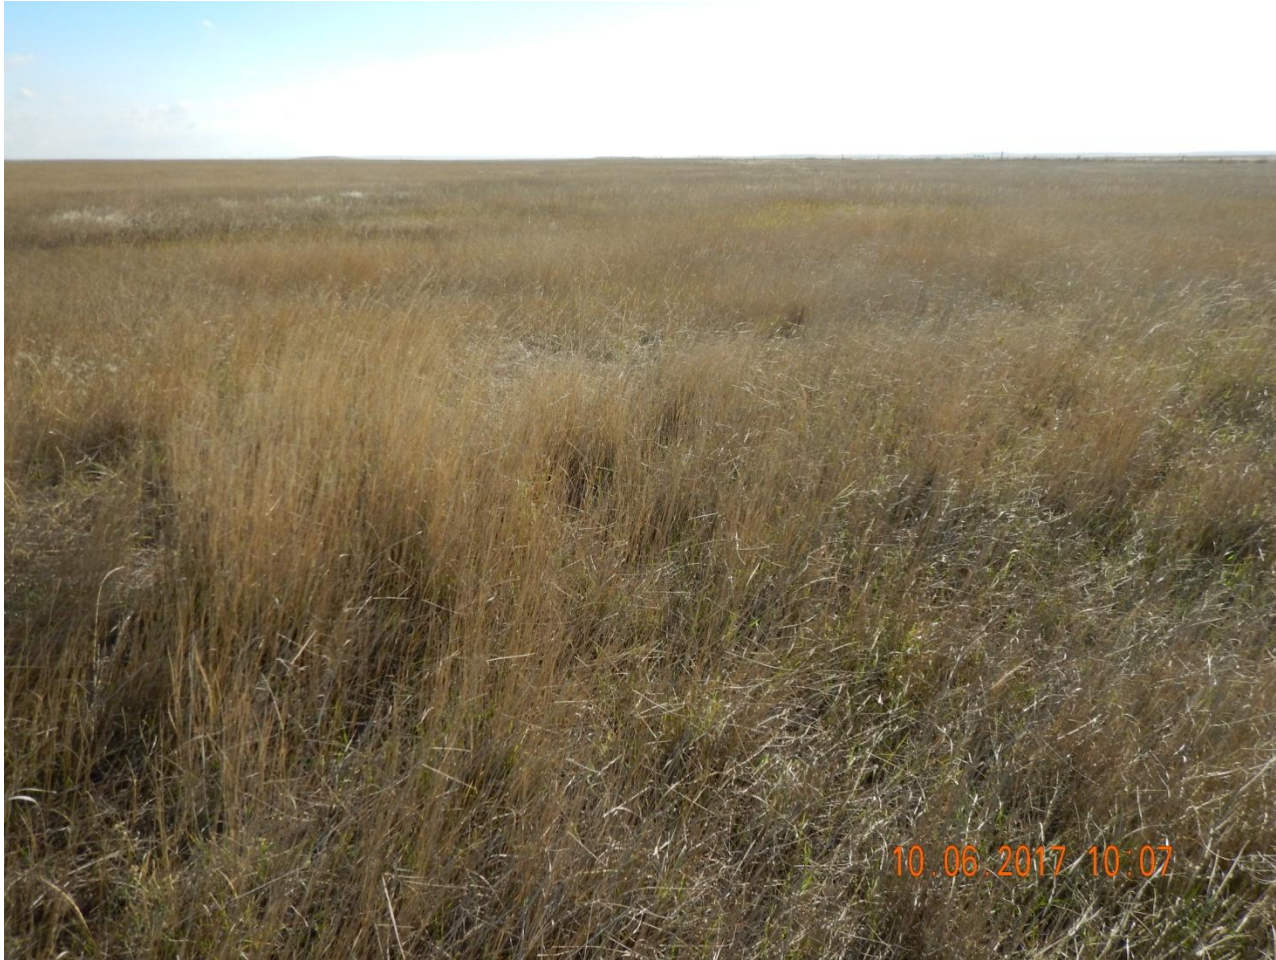
Photo 8. Reference photo taken from the eastern well location, facing East. Photo illustrates well location is not reflective of reference area levels.
