# Inspection Photos

Operator: NOBLE ENERGY INC - 100322

Location ID: 327102

Inspection Doc. Number: 682502649

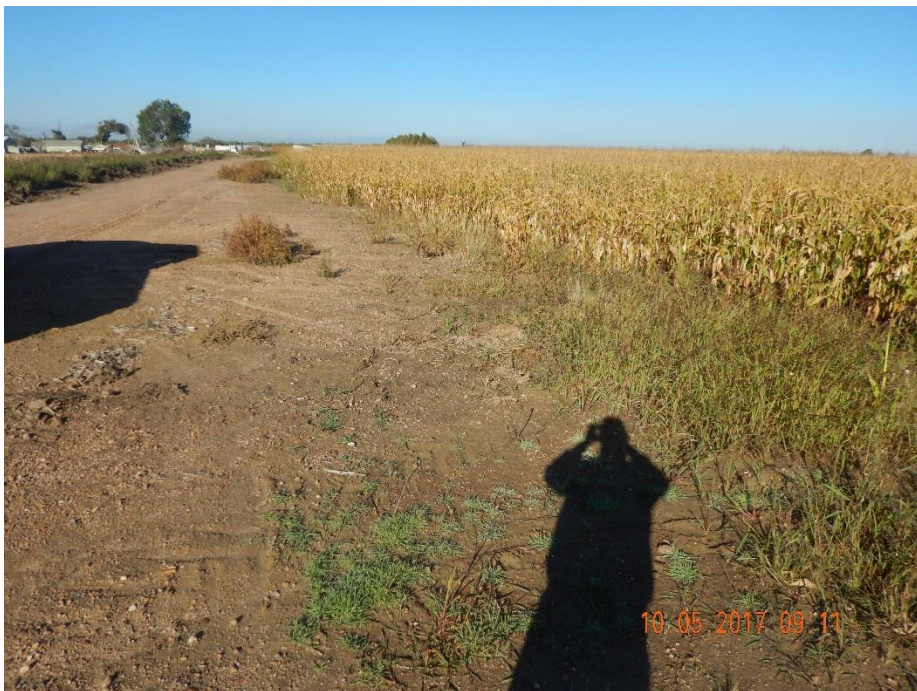
**Photo 1:** Photo taken from the southeast end of the battery facility, facing west. Photo shows overview of the former battery location.

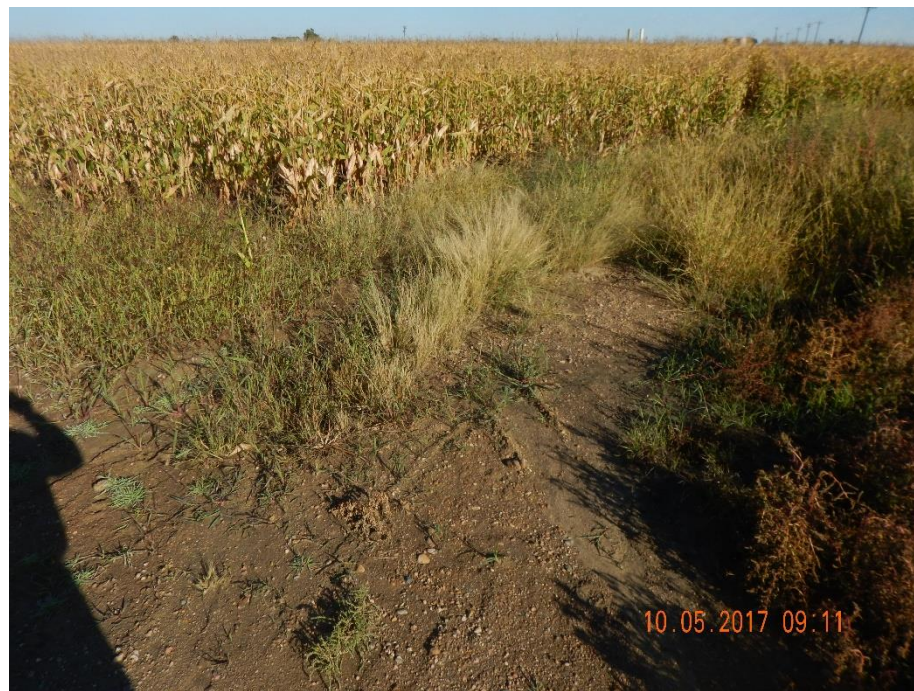
**Photo 2:** Photo taken from the southeast end of the battery facility, facing northwest. Photo shows overview of the former battery location.

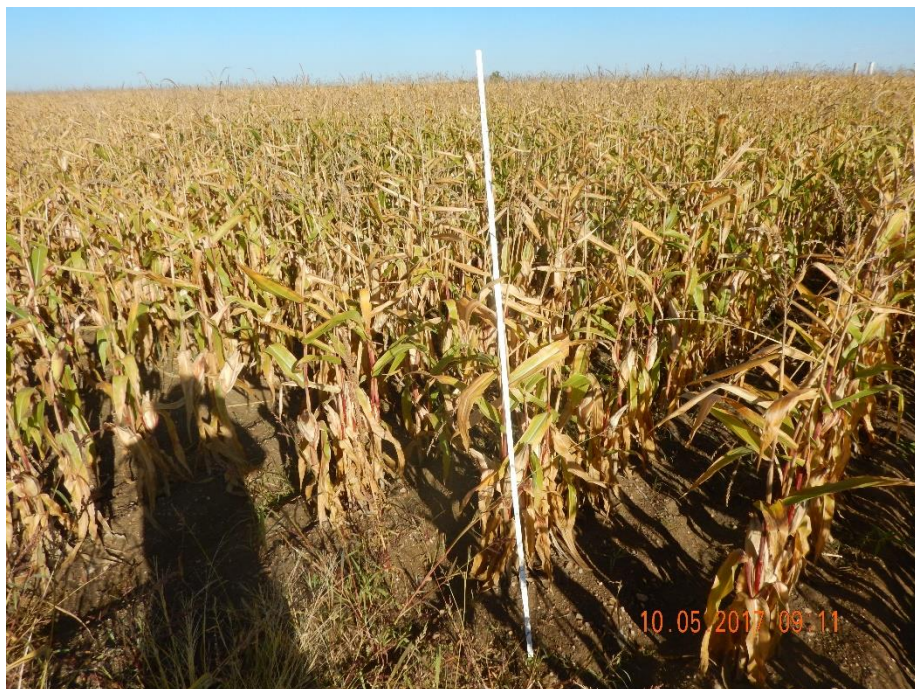
**Photo 3:** Photo taken from the former battery location. Photo shows crop (corn) vegetation growth over the well location is stunted when compared to the adjacent reference area (see photo 4). 6 foot measuring stick for reference. Crop growth within the disturbance ranges from ~3-4 feet in height. Unable to find evidence that additional reclamation activities have been performed per corrective actions.

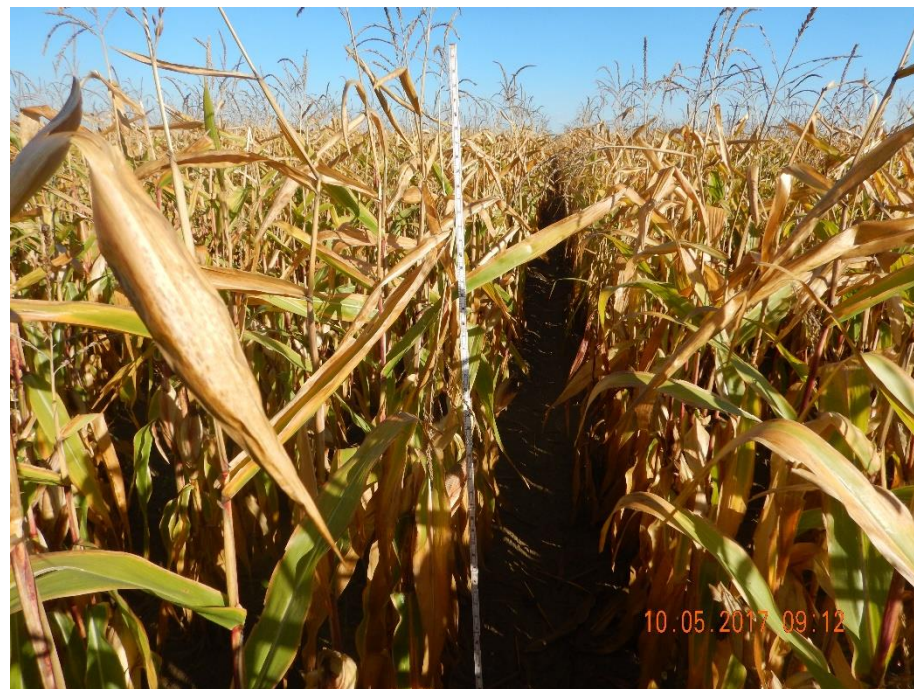
**Photo 4:** Photo taken from the adjacent reference area. Photo shows crop (corn) vegetation growth over the reference area. Crop in the disturbance areas are visibly stunted when compared to the reference. 6 foot measuring stick for reference. Crop growth within the reference ranges ~6 feet or greater.
