Inspection Photos

Operator: NOBLE ENERGY INC - 100322

Location ID: 323695

Inspection Doc. Number: 682502651

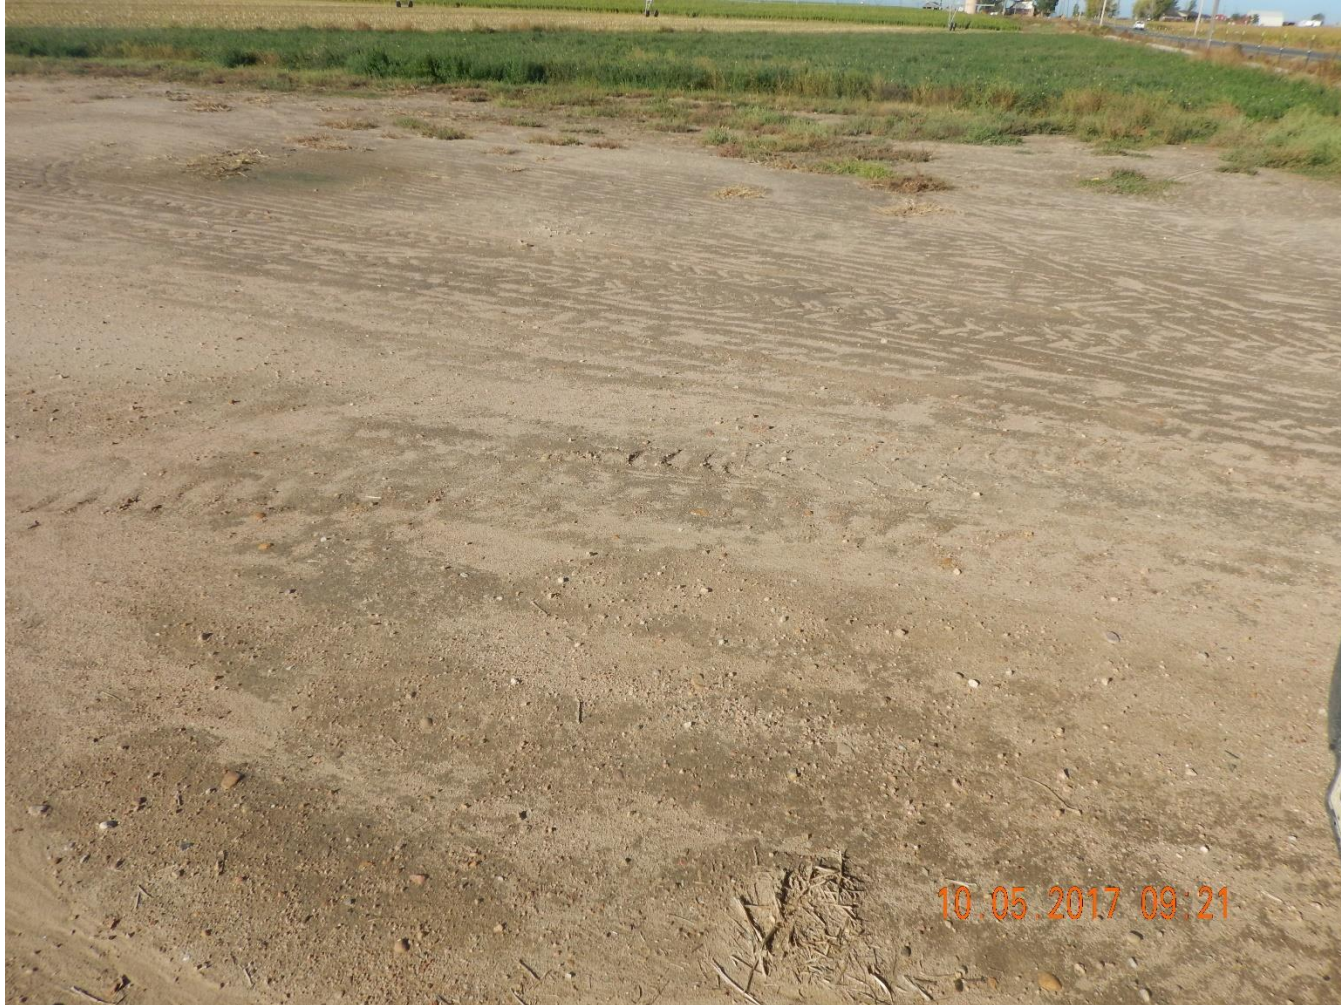
Photo 1: Photo taken from the northeast end of the former battery location. Previous inspections required operator to perform reclamation and return the disturbance area to its designated final land use. Adjacent reference area is Alfalfa crop. Photo shows no additional reclamation activities appear to have been conducted.

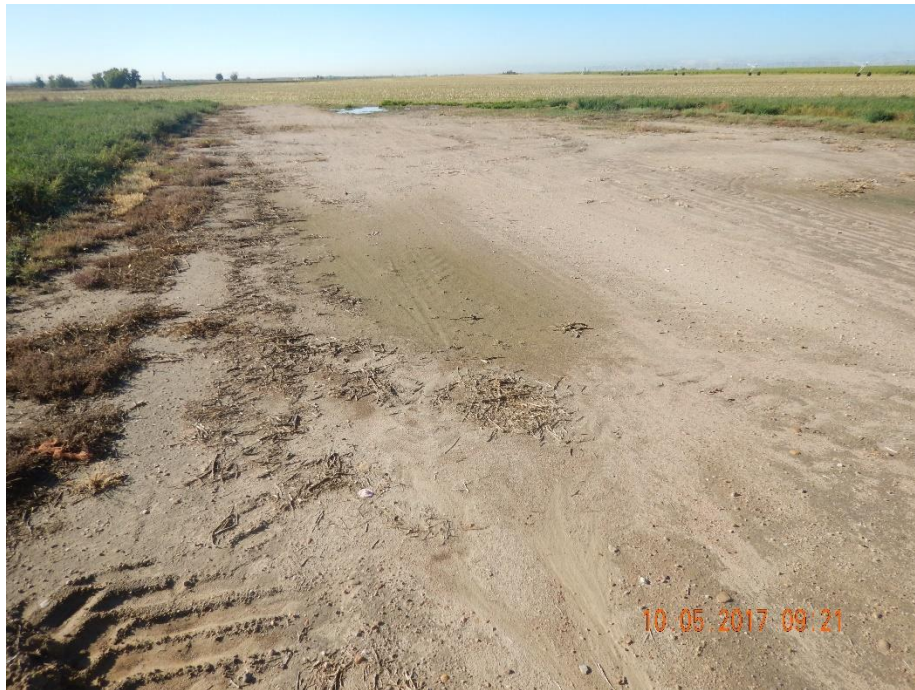
Photo 2: Photo taken from the northeast end of the former battery location, facing south. Photo shows overview of the battery location.

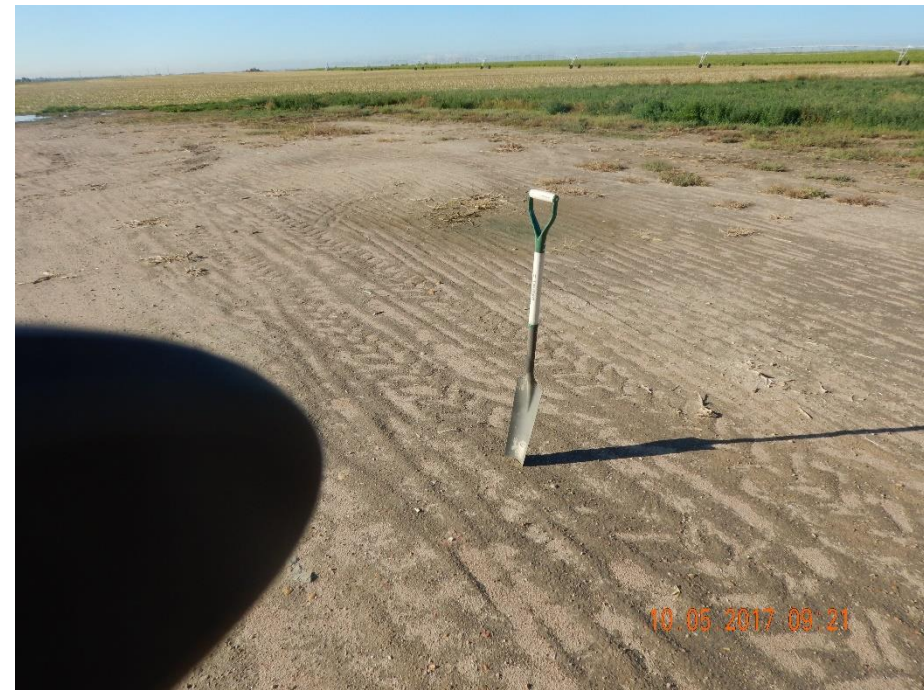
Photo 3: Photo taken from the former battery location. Photo shows inspector had tested the location to see if compaction concerns remains. Photo shows that the shovel was only able to penetrate the first couple of inches with ease. Compaction concerns remain.

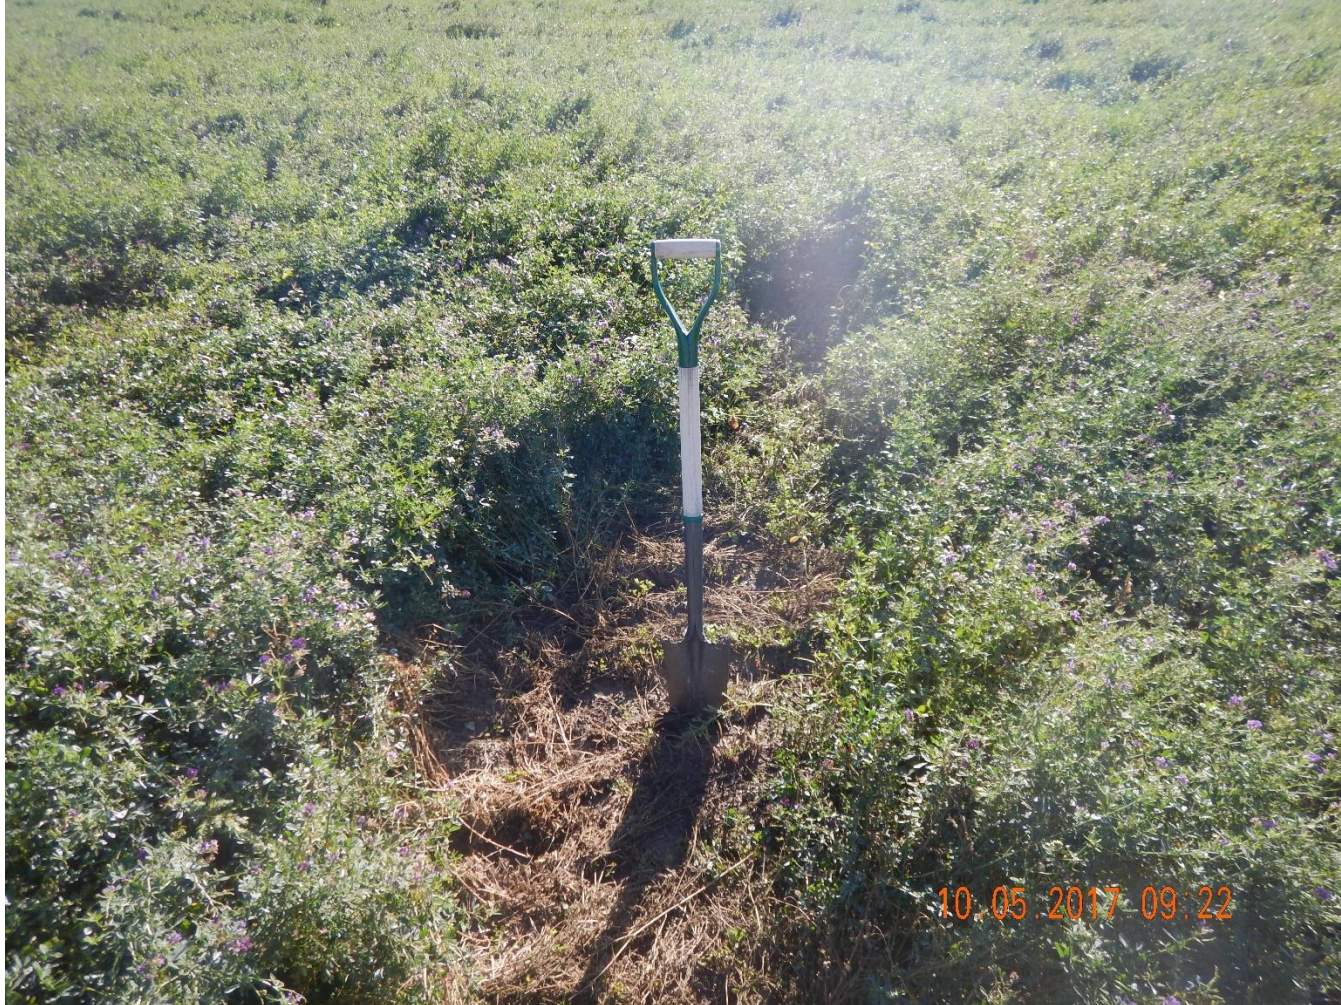
Photo 4: Photo taken from the adjacent reference area. Inspector had tested the soil in the reference area to compare to the disturbance area. Inspector was able to penetrate ~10 inches of topsoil without difficulty.
