Inspection Photos

Operator: STELBAR OIL CORP INC - 82470

Location ID: 317155

Inspection Doc. Number: 682502708

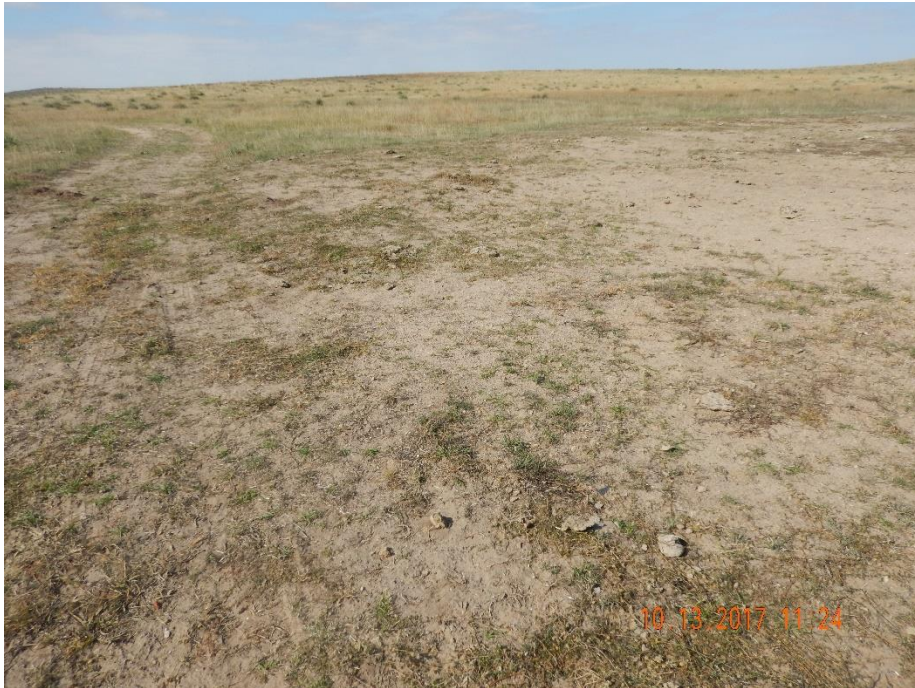
Photo 1: Photo taken from the south end of the location, facing west. Photo shows the reclamation area. Reclamation area is predominantly exposed soil, and does not appear to be progressing towards COGCC 1000 series reclamation standards and requirements.

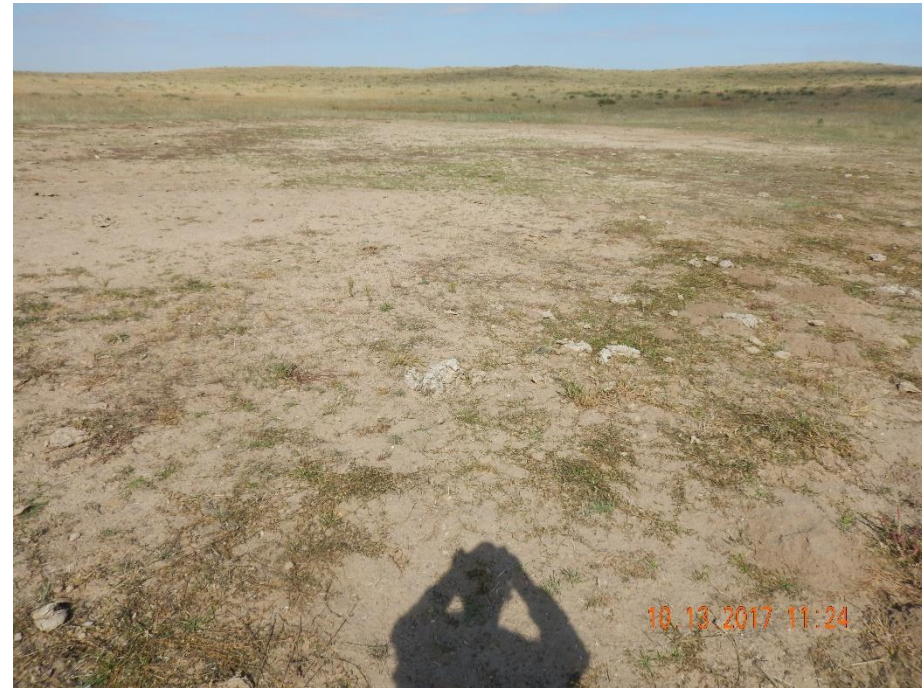
Photo 2: Photo taken from the south end of the location, facing northwest. See comments under photo 1.

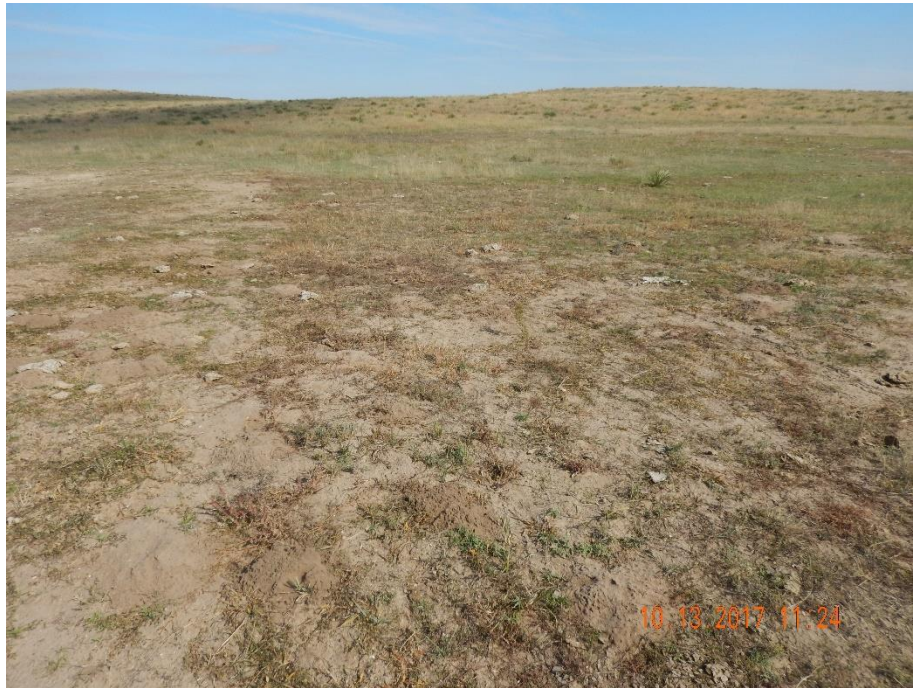
Photo 3: Photo taken from the south end of the location, facing northeast. See comments under photo 1.

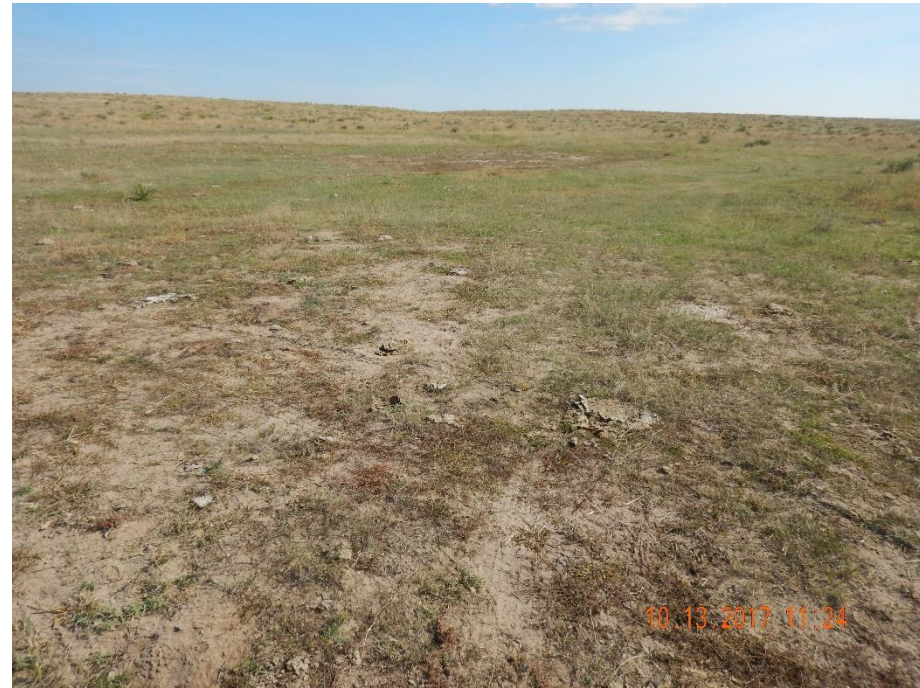
Photo 4: Photo taken from the south end of the location, facing east. See comments under photo 1.

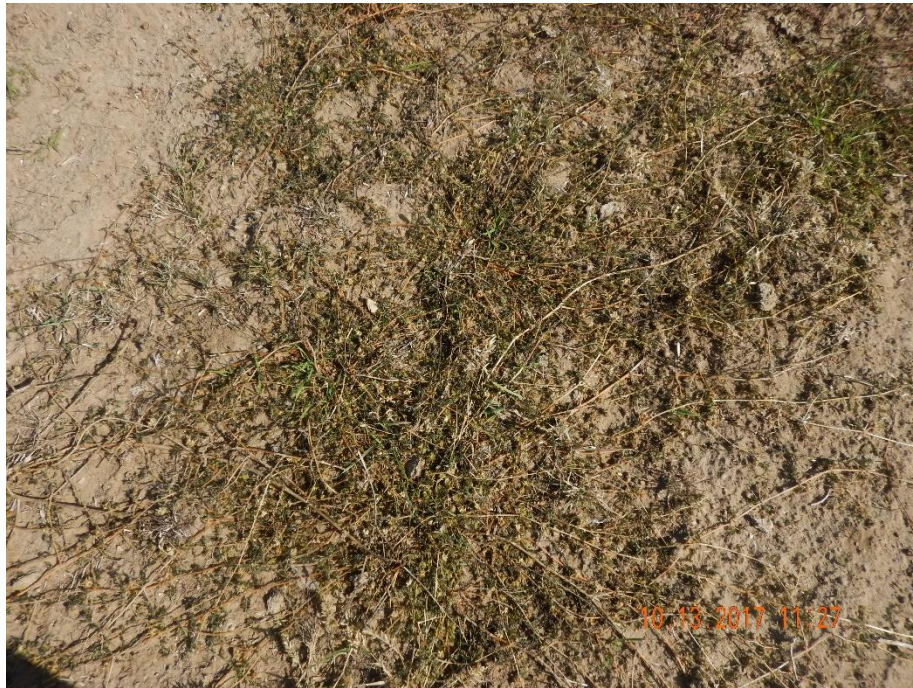
Photo 5: Photo taken from the location. Photo shows vegetation over the reclamation area predominantly undesirable weedy plant species such as *Tribulus terrestris*.

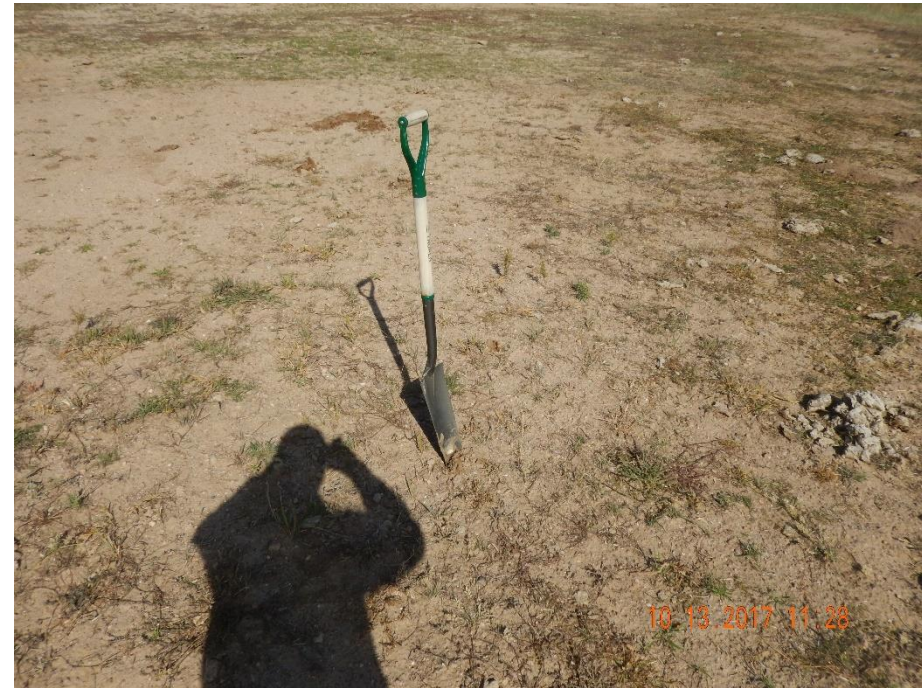
Photo 6: Photo taken from the location. Inspector had tested the site for compaction concerns. Photo shows inspector was only able to penetrate the first couple of inches of topsoil with relative ease.

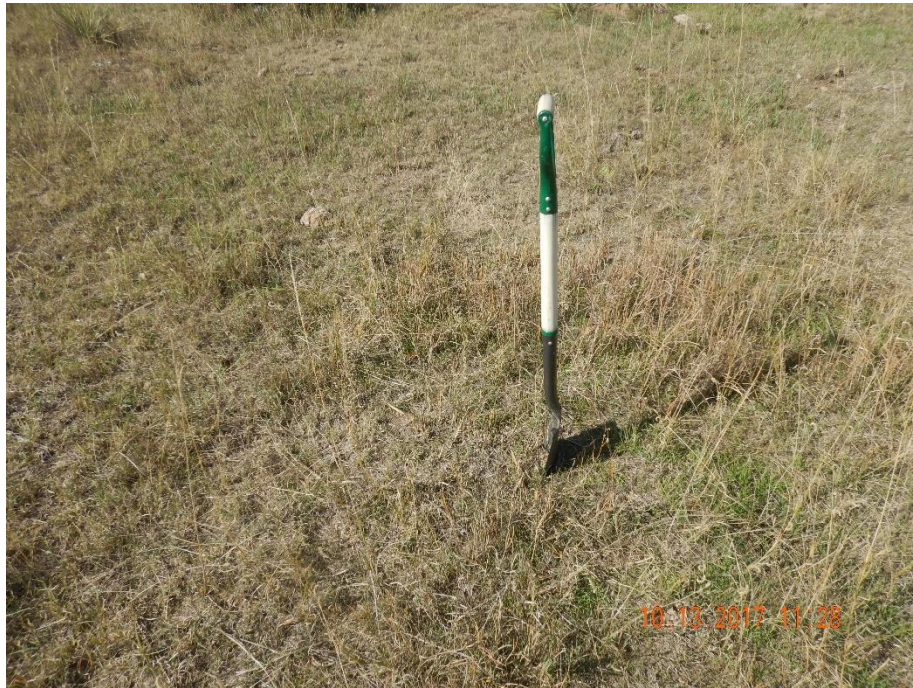
Photo 7: Photo taken from the reference area. Inspector had tested the soil in the reference area for comparison to that of the disturbance area. Photo shows inspector was able to easily penetrate the topsoil.

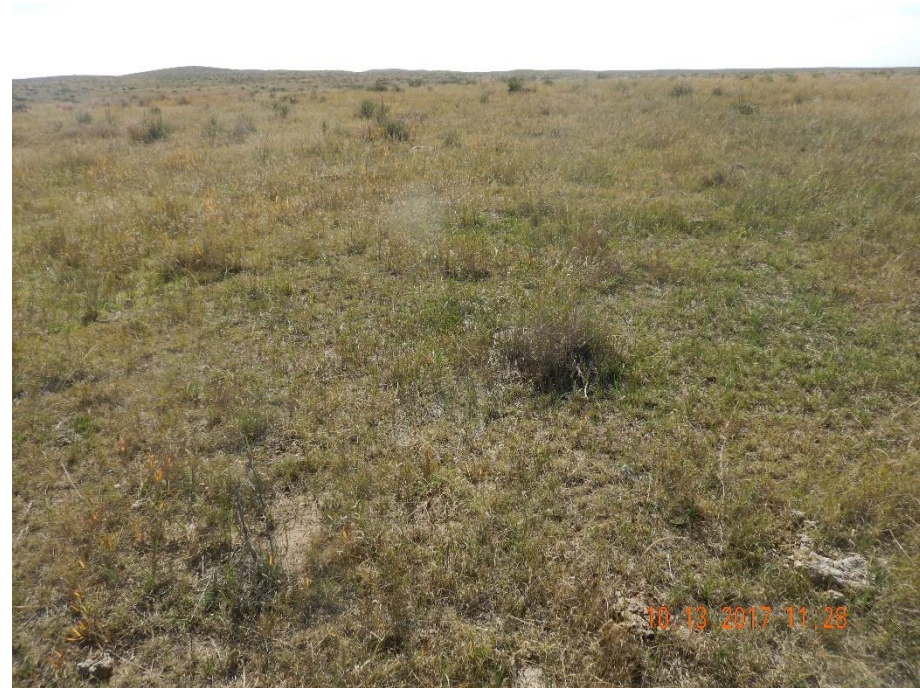
Photo 8: Photo shows vegetation over the adjacent reference area.
