Inspection Photos
Well Name: Federal 29-5
Location ID: 322398

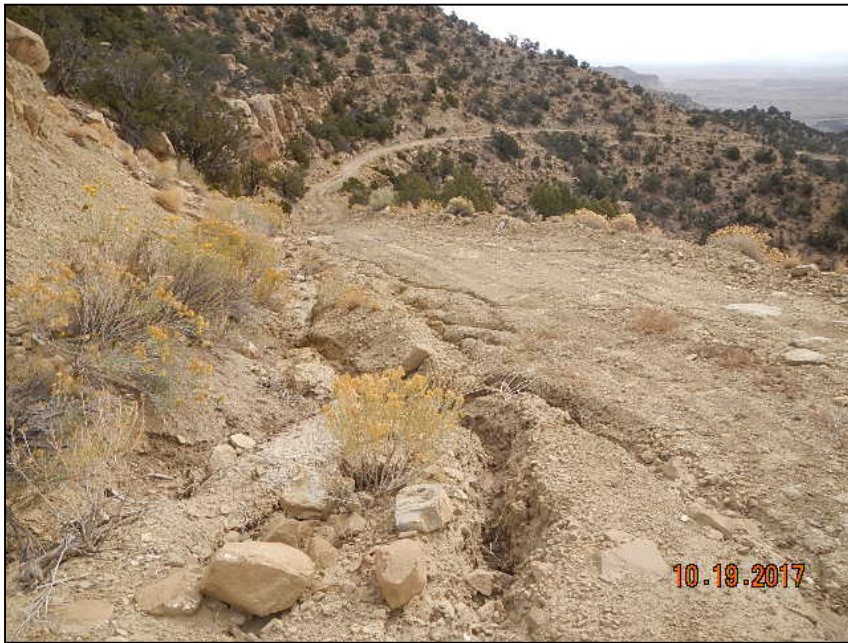
Photo 1. Main road to location has multiple areas of erosion across roadway and sediment migration down gradient of road surface.

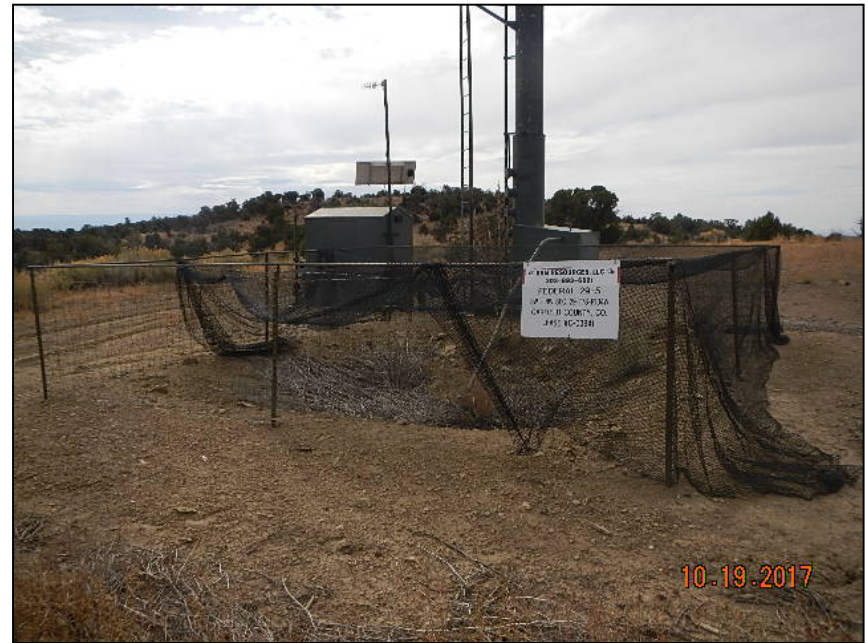
Photo 2. Netting on pit has not been maintained.
