Construction and Stormwater Inspection

Operator: BONANZA CREEK ENERGY OPERATING COMPANY LLC -#8960

Location ID: 452585 (COMPLIANCE POINT #2)

Inspection Photos
Location ID: 452585
COMPLIANCE POINT #2

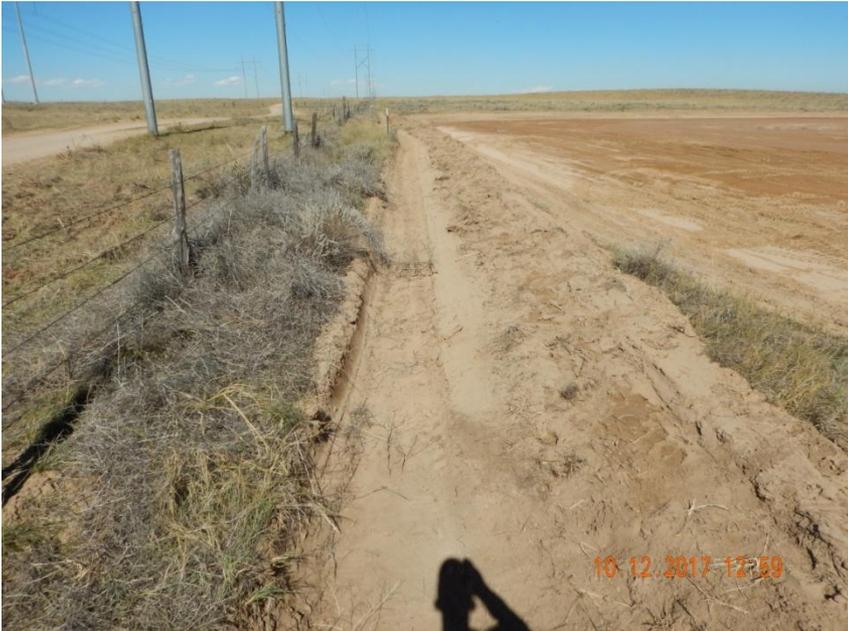
Photo 3. Photo taken from the western location, facing North. Operator has installed a ditch and berm around the entire location perimeter. The berm BMP has been left unconsolidated which would not be considered in proper functioning condition.

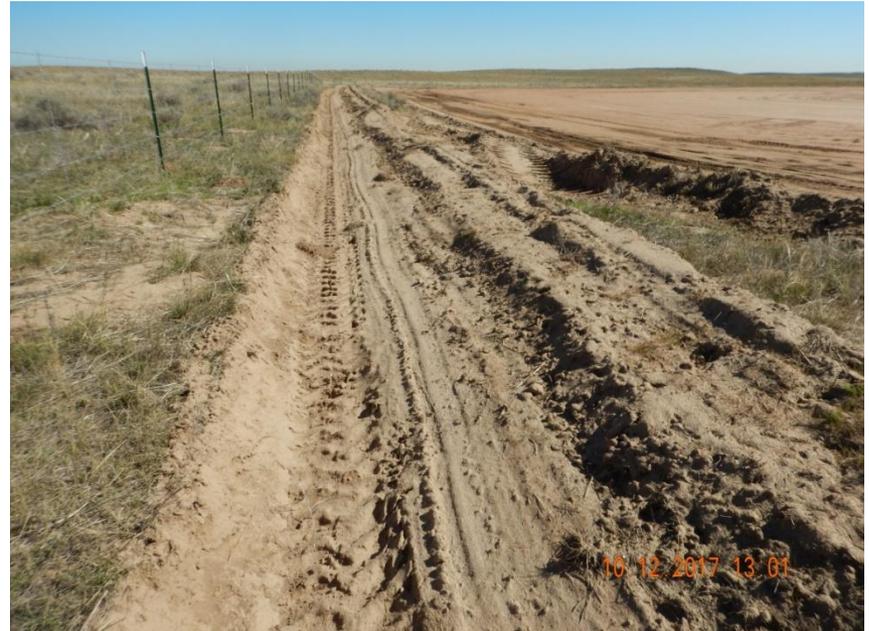
Photo 4. Photo taken from the northwestern location, facing East. See comments under Photo 3.

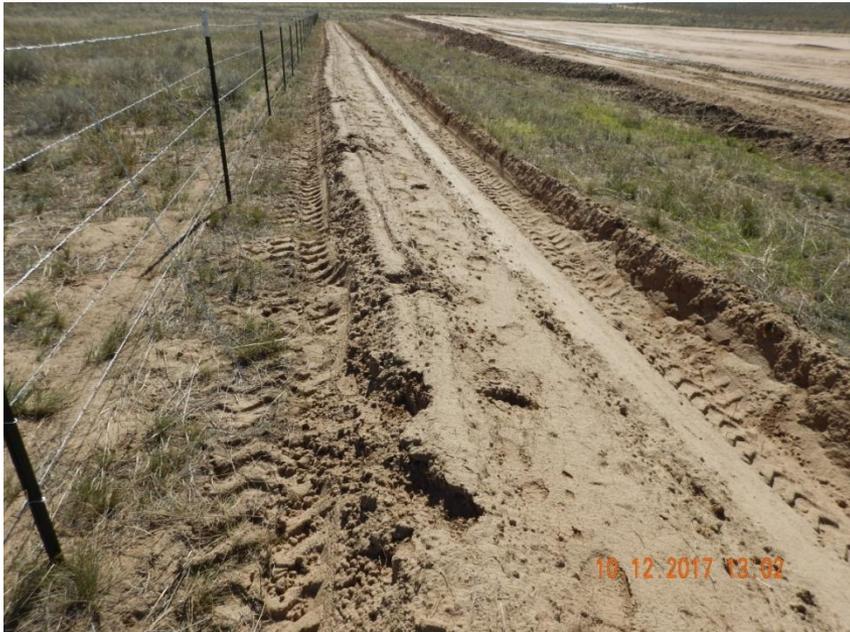
Photo 5. Photo taken from the northeastern location, facing South. See comments under Photo 3.

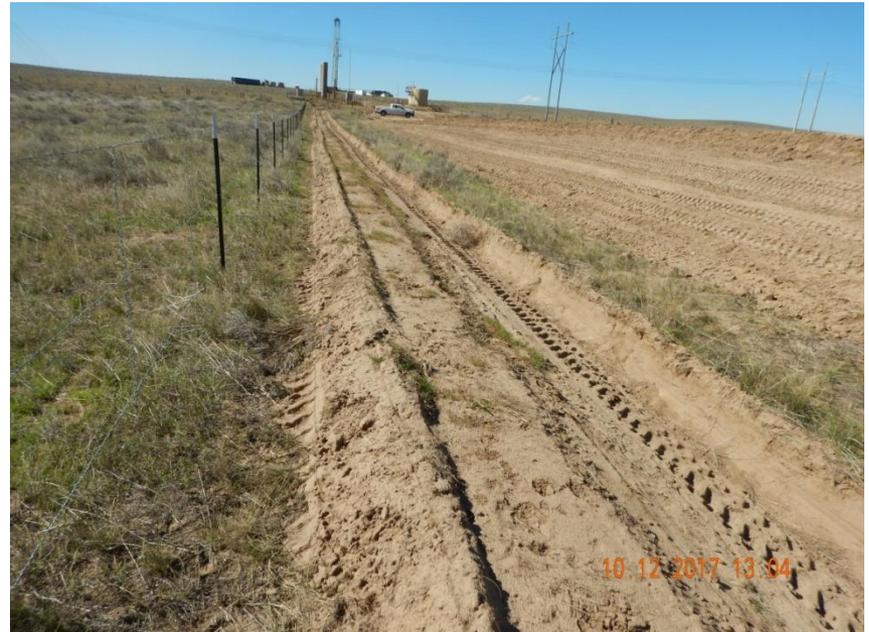
Photo 6. Photo taken from the southeastern location, facing West. See comments under Photo 3.

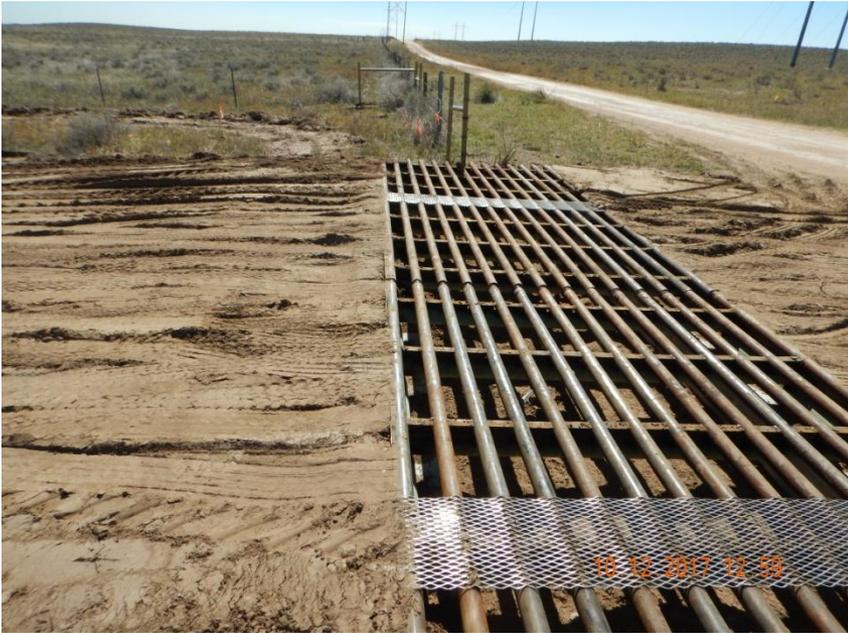
Photo 7. Photo taken from the entrance of the location, facing South. Operator has installed a cattle guard tracking device.
