Construction and Stormwater Inspection

October 12, 2017

Operator: BONANZA CREEK ENERGY OPERATING COMPANY LLC -#8960

Location ID: 452586 (COMPLIANCE POINT #3)

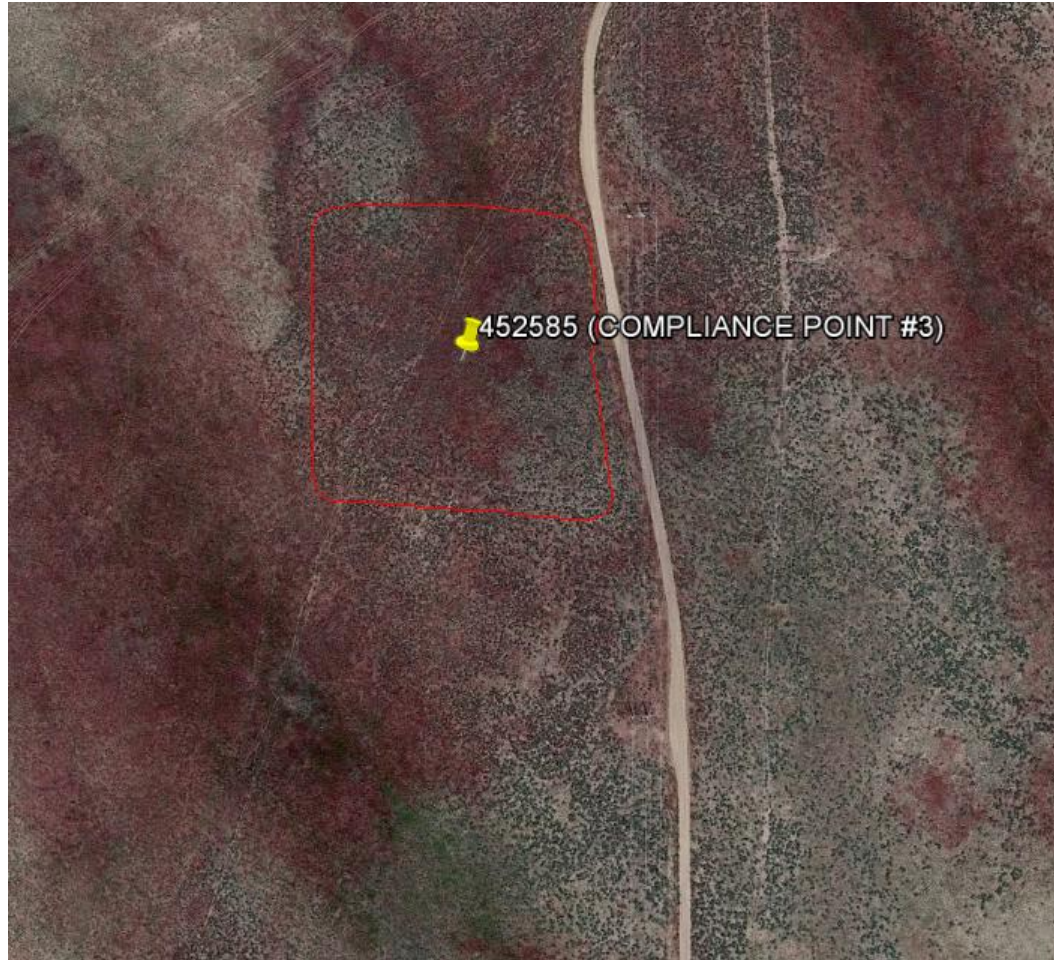
Photo 1. Google Earth aerial imagery taken on June 14, 2016. Operator has constructed a pad in the northeast of Section 34, Township 4N, Range 63W without an approved 2A- see Photo 2. The approximate center of the pad is at the following Latitude/Longitude: 40.271549/-104.416259. A disturbance area of 4.47 acres was mapped on 10/12/2017 using a Trimble Juno 3B handheld device (red line).

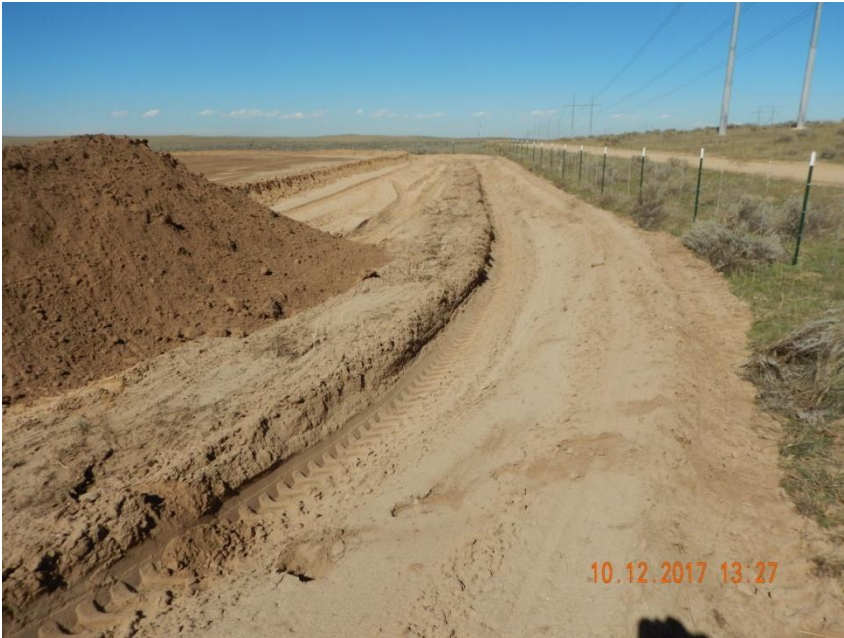
Photo 3. Photo taken from the eastern location, facing North. Operator has installed a ditch and berm around the entire location perimeter. The berm BMP has been left unconsolidated which would not be considered in proper functioning condition.

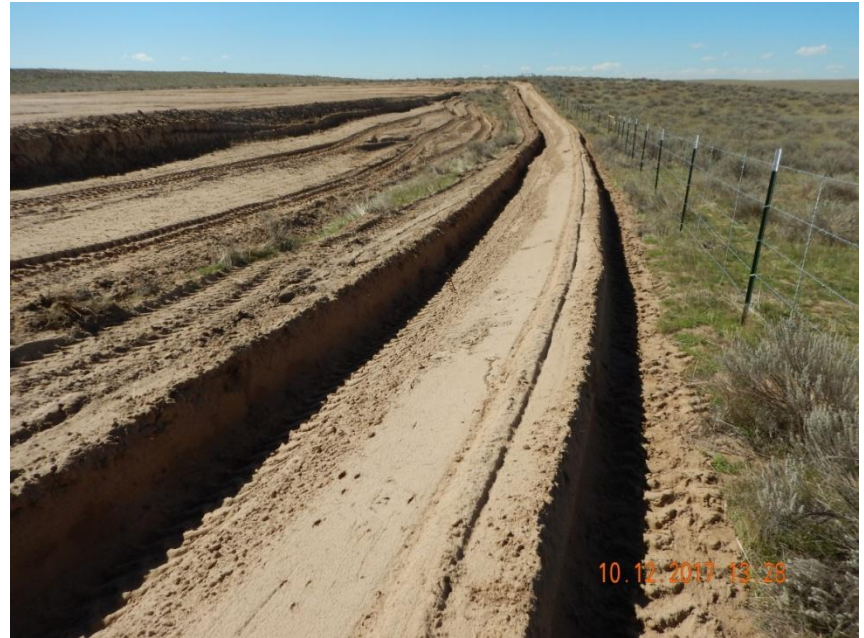
Photo 4. Photo taken from the northeastern location, facing West. See comments under Photo 3.

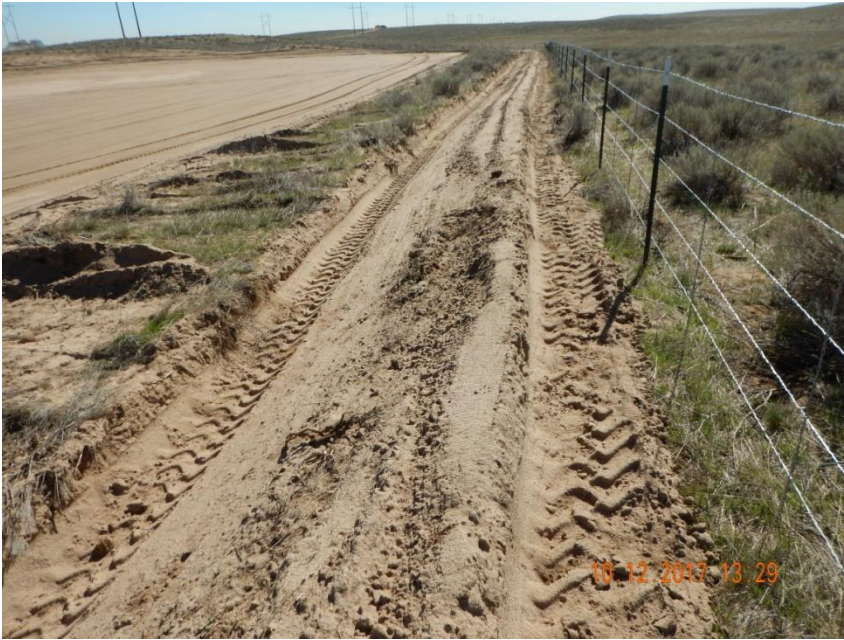
Photo 5. Photo taken from the northwestern location, facing South. See comments under Photo 3.

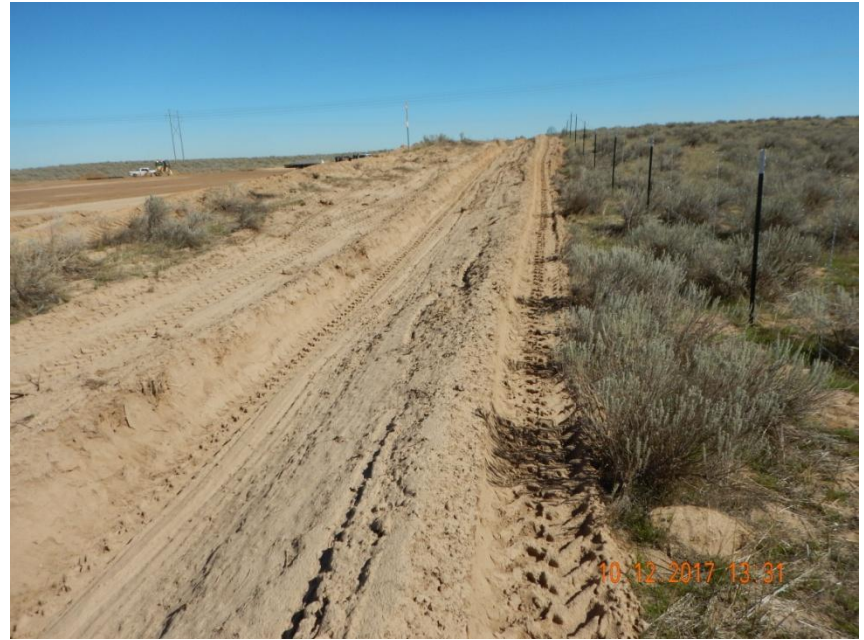
Photo 6. Photo taken from the southwestern location, facing East. See comments under Photo 3.

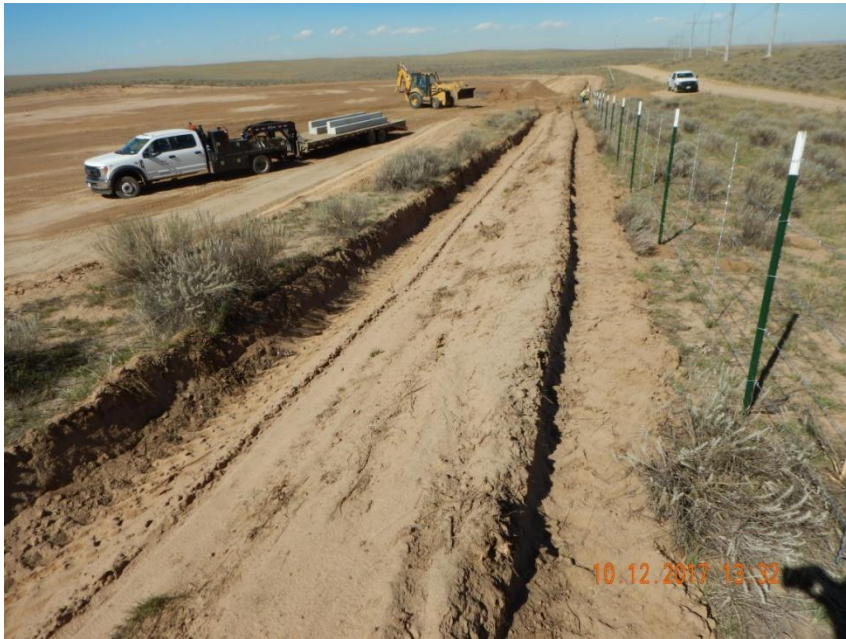
Photo 7. Photo taken from the southeastern location, facing North. See comments under Photo 3.

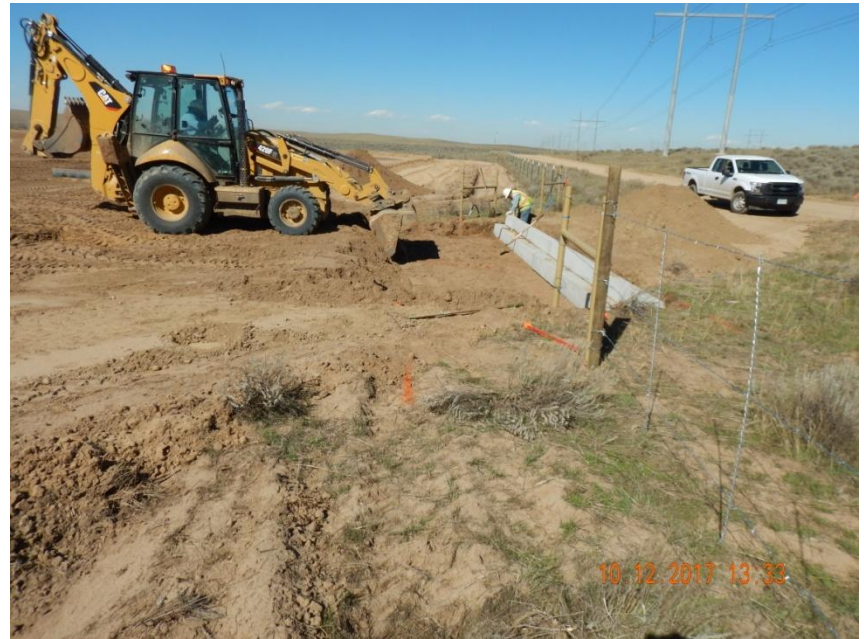
Photo 8. Photo taken from the entrance of the location, facing South. Operator in-process of installing a cattle guard tracking device.
