Inspection Photos

Operator: Noble Energy

Location ID: 327317

Inspection Doc. Number: 682502799

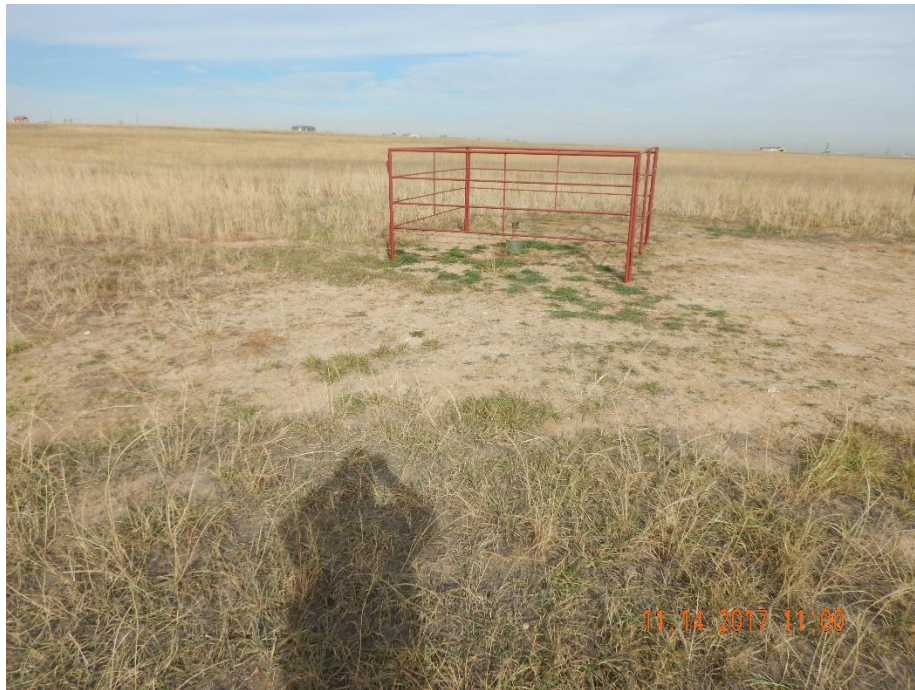
Photo 1: Photo taken from the south end of the well, facing north. Photo shows riser and disturbance due to re-plugging efforts from Noble. Upon formal abandonment of the well, Noble will be required to reclaim the location in accordance to COGCC 1000 series reclamation rules and requirements.

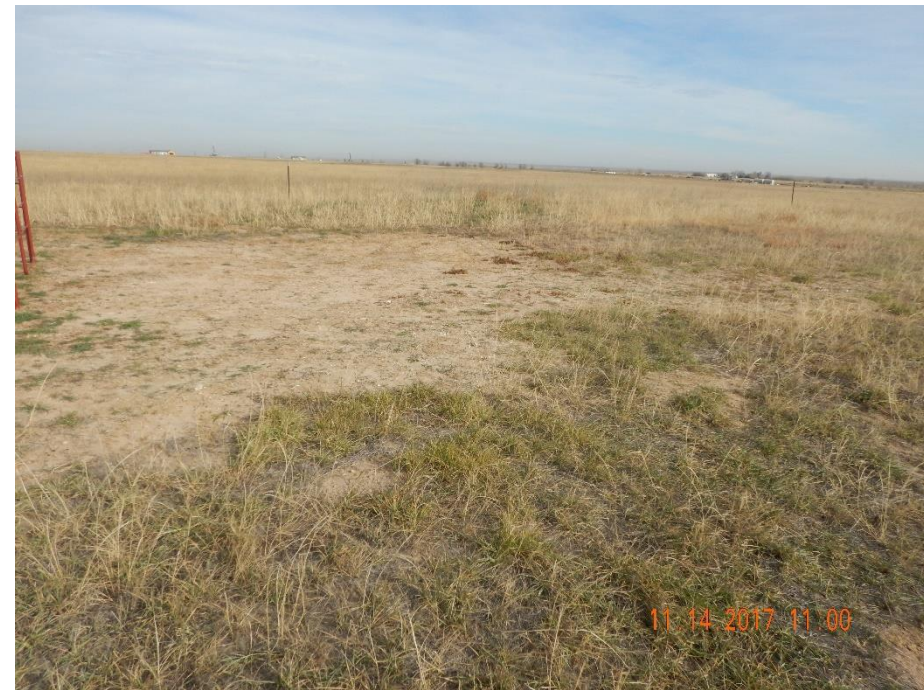
Photo 2: Photo taken from the south end of the well, facing northeast. Photo shows riser and disturbance due to re-plugging efforts from Noble. Upon formal abandonment of the well, Noble will be required to reclaim the location in accordance to COGCC 1000 series reclamation rules and requirements.

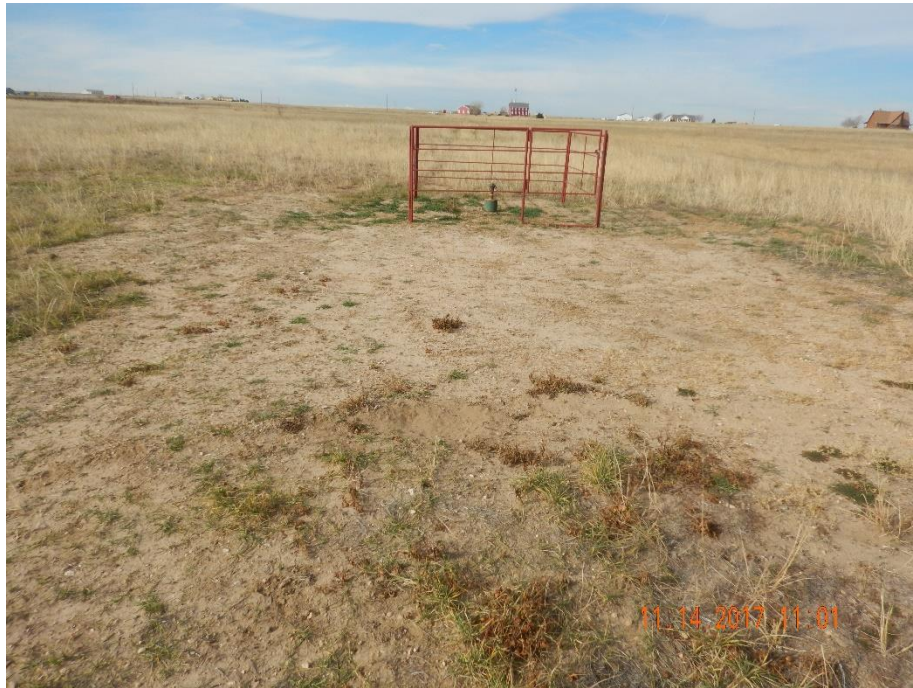
Photo 3: Photo taken from the east end of the well, facing west. Photo shows riser and disturbance due to re-plugging efforts from Noble. Upon formal abandonment of the well, Noble will be required to reclaim the location in accordance to COGCC 1000 series reclamation rules and requirements.

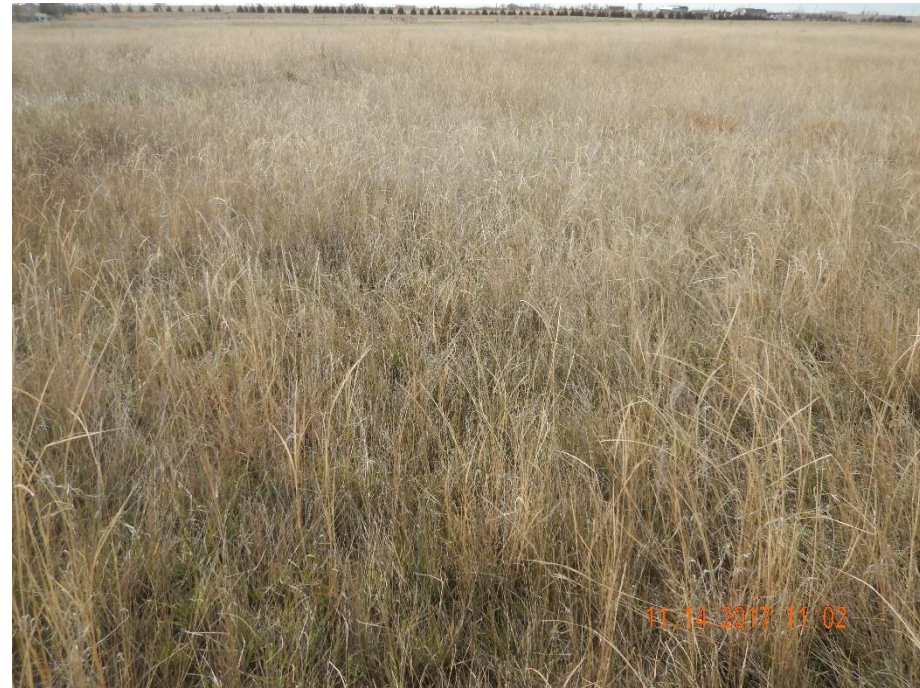
Photo 4: Photo taken from adjacent reference area. Photo shows vegetation over the reference area. Vegetation seen here predominantly Sand Dropseed, Western Wheatgrass, etc..

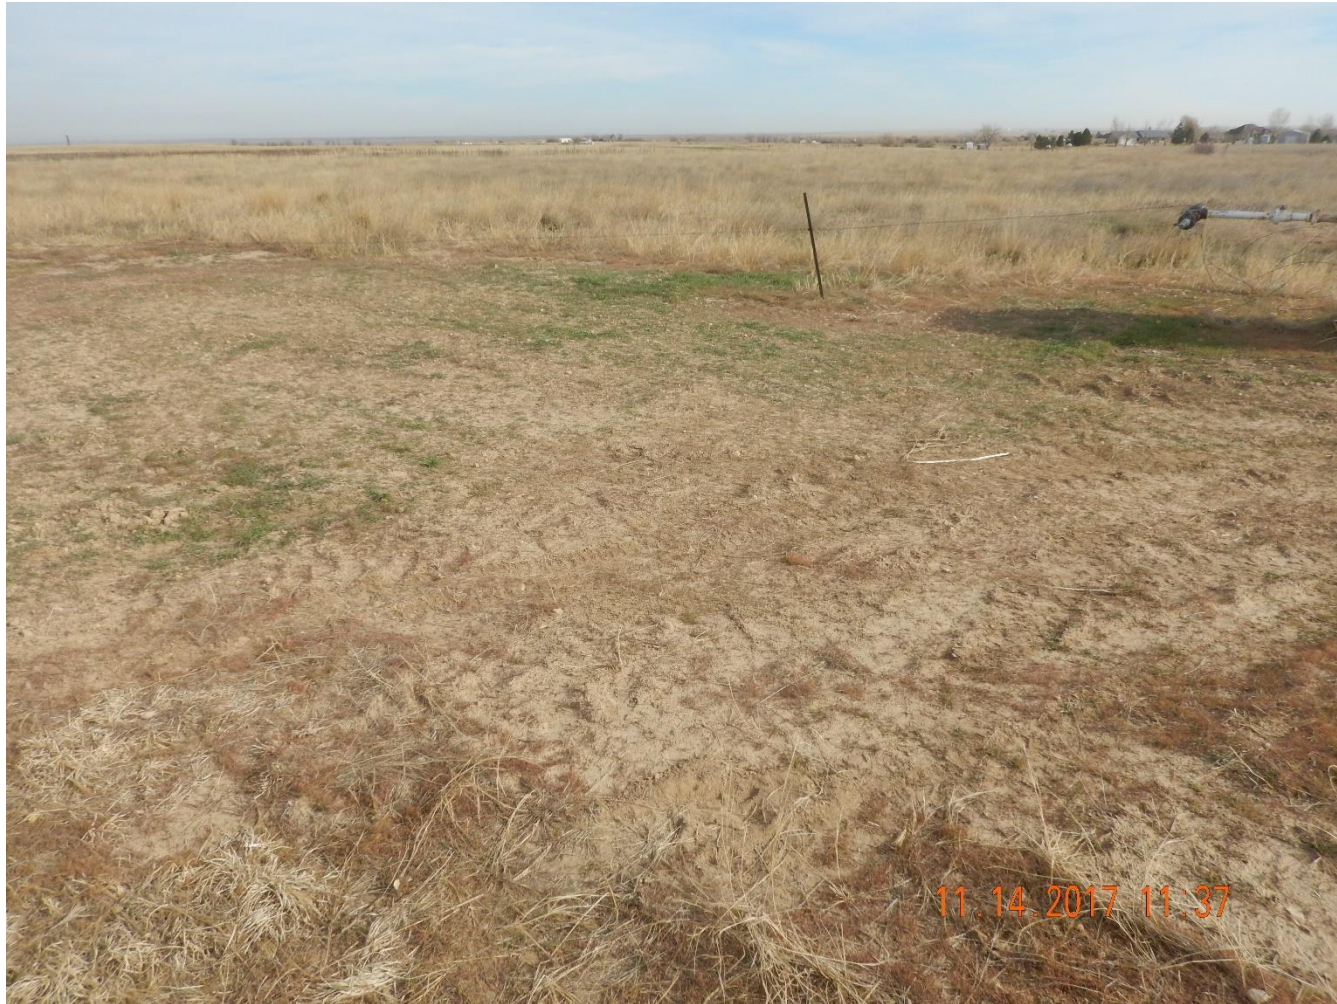
Photo 1: Photo taken from the former battery location. Photo shows pipe riser equipment has been removed per the CA.
