# Final Reclamation Inspection

November 22, 2017

Operator: ENERGY SEARCH CO ADBA ENERGY  
SEARCH CO INC - 27635

API: 05-001-07298

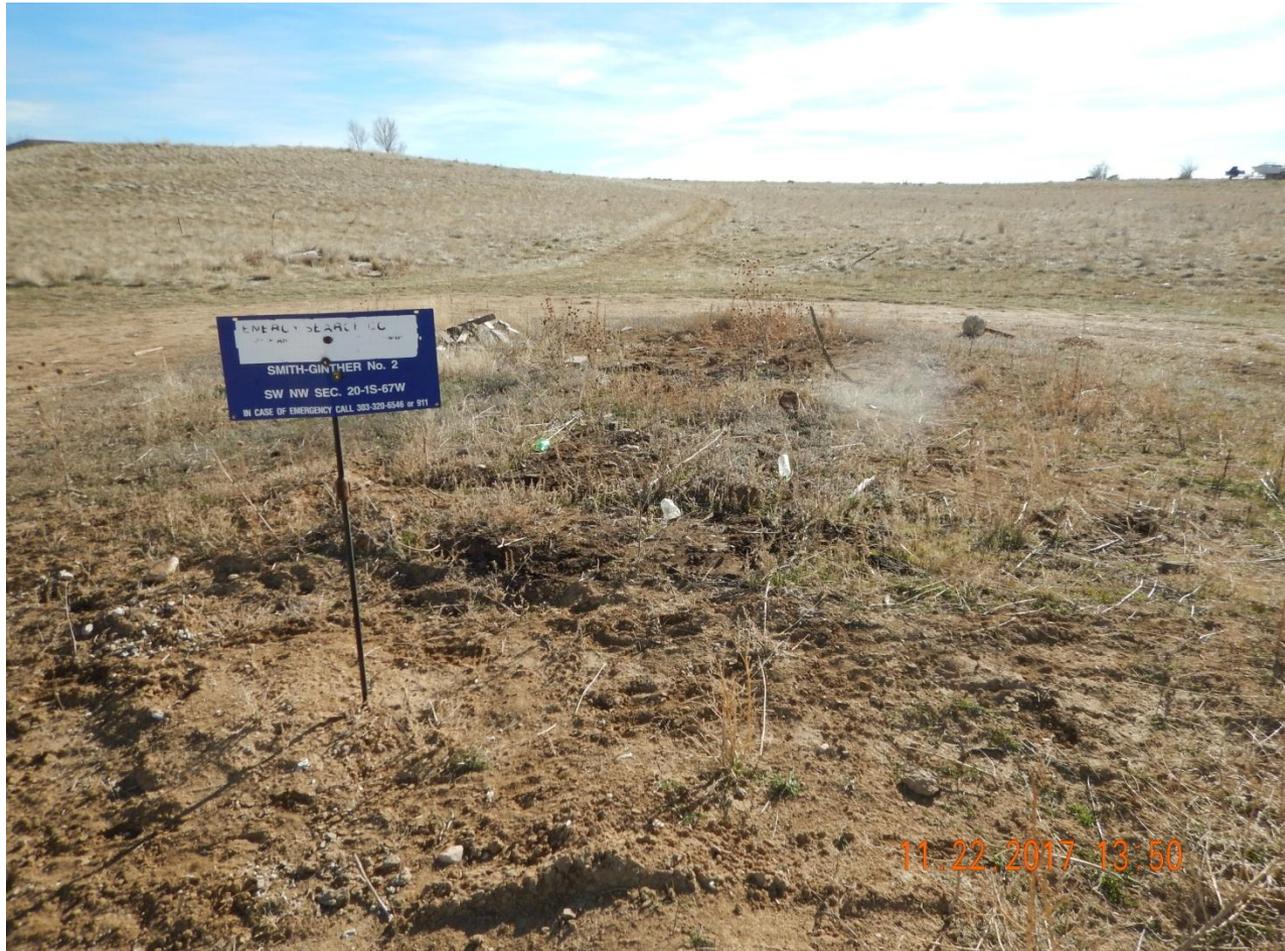
**Photo 1.** Photo taken from the approximate PA well location, facing South. Final land use might be housing development as housing development construction activities are in-process nearby. The access road and location have not been reclaimed. There is various debris which remains at location. Berms remain from the former battery. See Photo 4 for an aerial photo for more information.

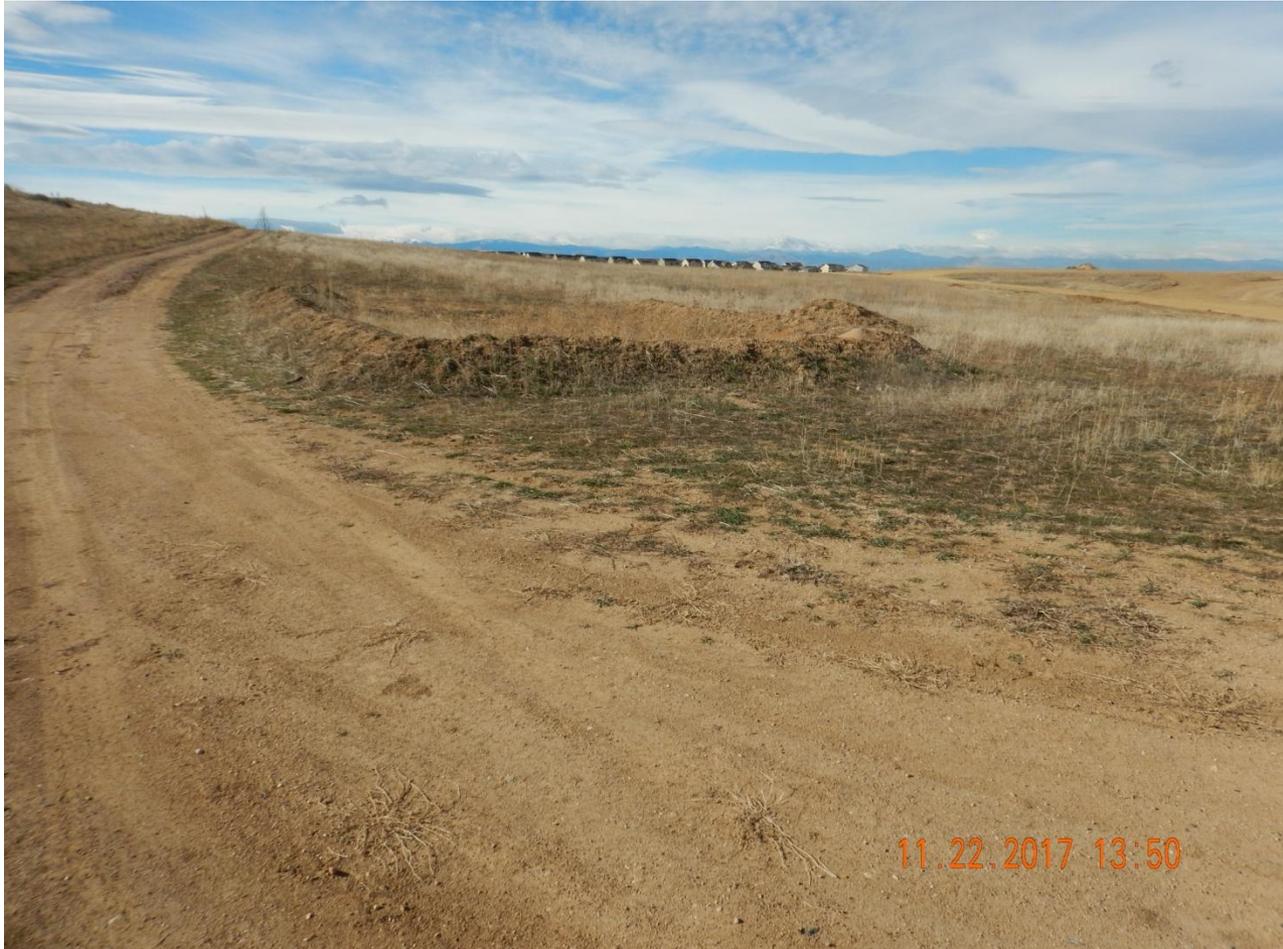
**Photo 2.** Photo taken from the approximate PA well location, facing West. See comments under Photo 1.

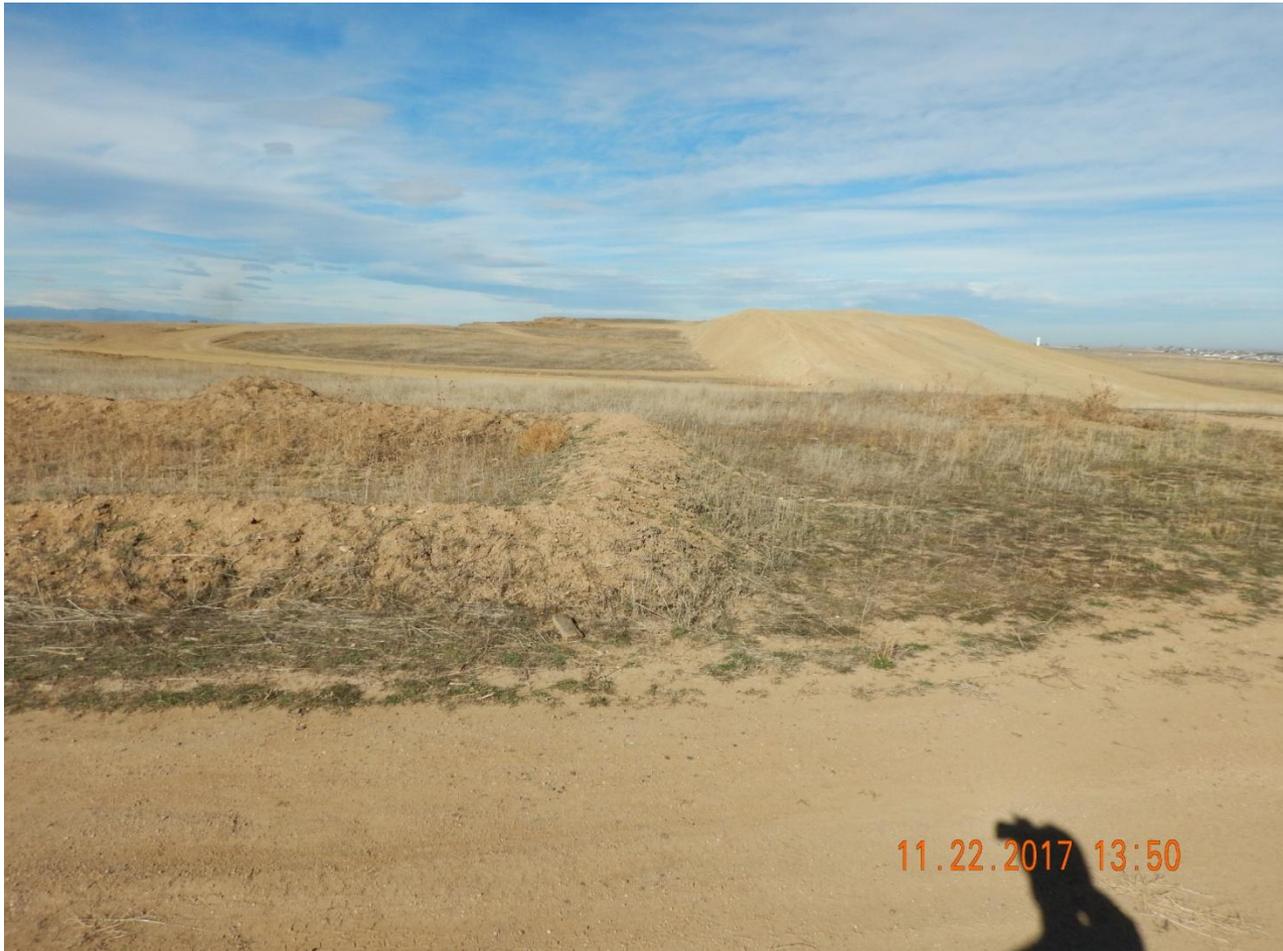
**Photo 3.** Photo taken from the approximate PA well location, facing East. See comments under Photo 1.

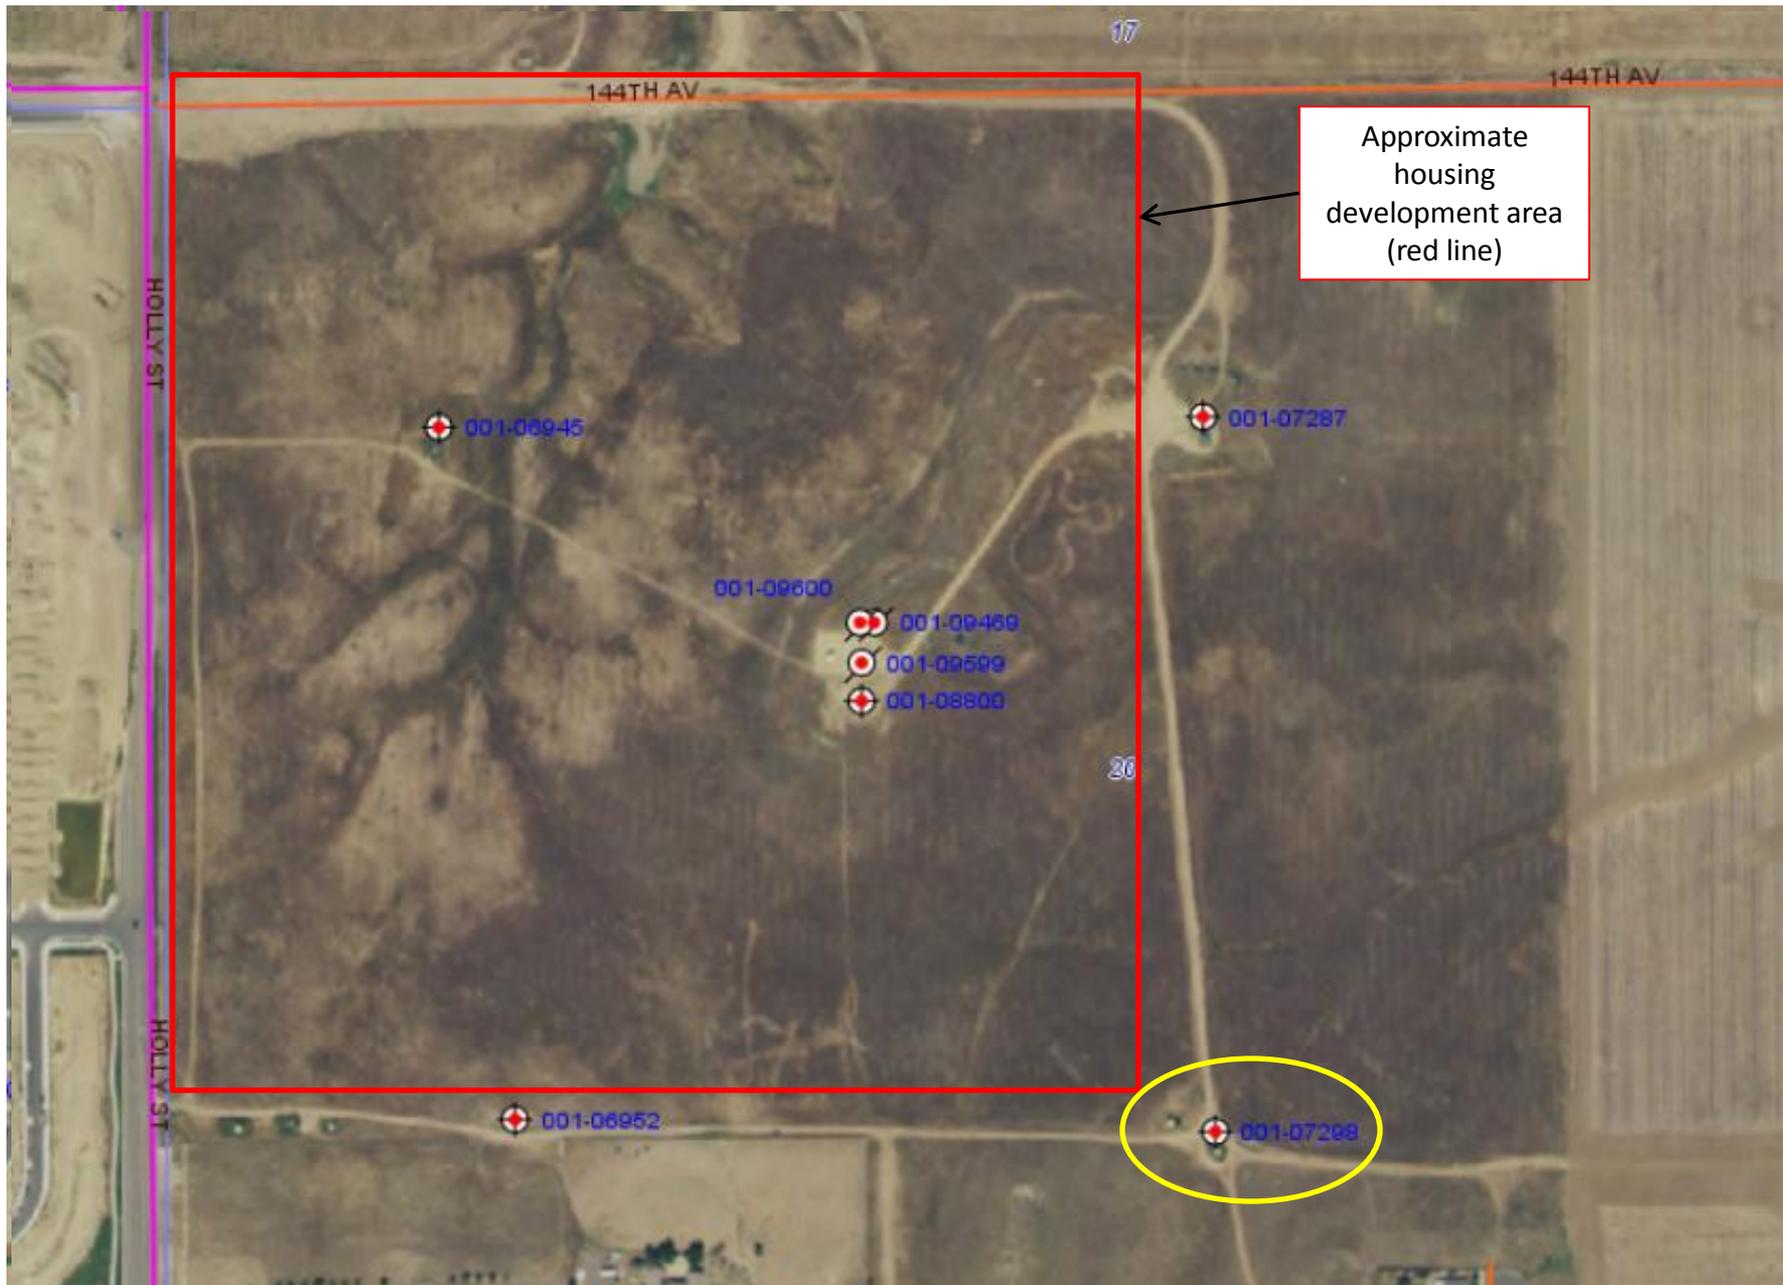
**Photo 4.** Aerial photo taken using COGCC GISOnline database illustrating well location in relation to new housing development.
