November 30, 2017

**COLORADO**  
Oil & Gas Conservation  
Commission  
Department of Natural Resources

Inspection Photos: Black Hills Federal API#077-08554

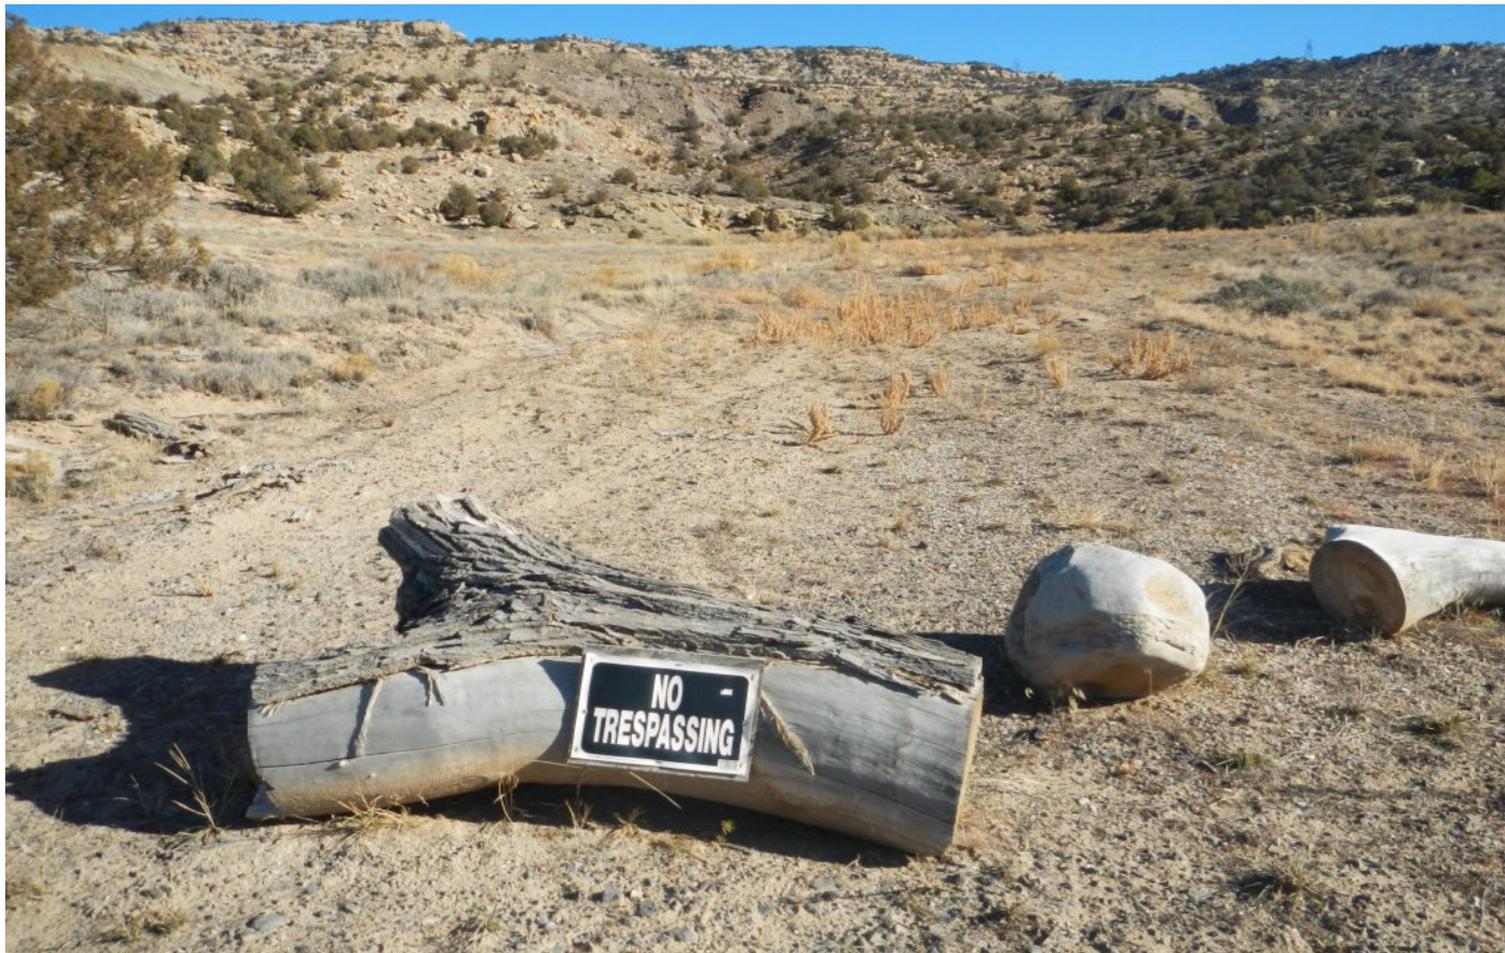
Photo#1:

View of Location from Access Road entry to East.

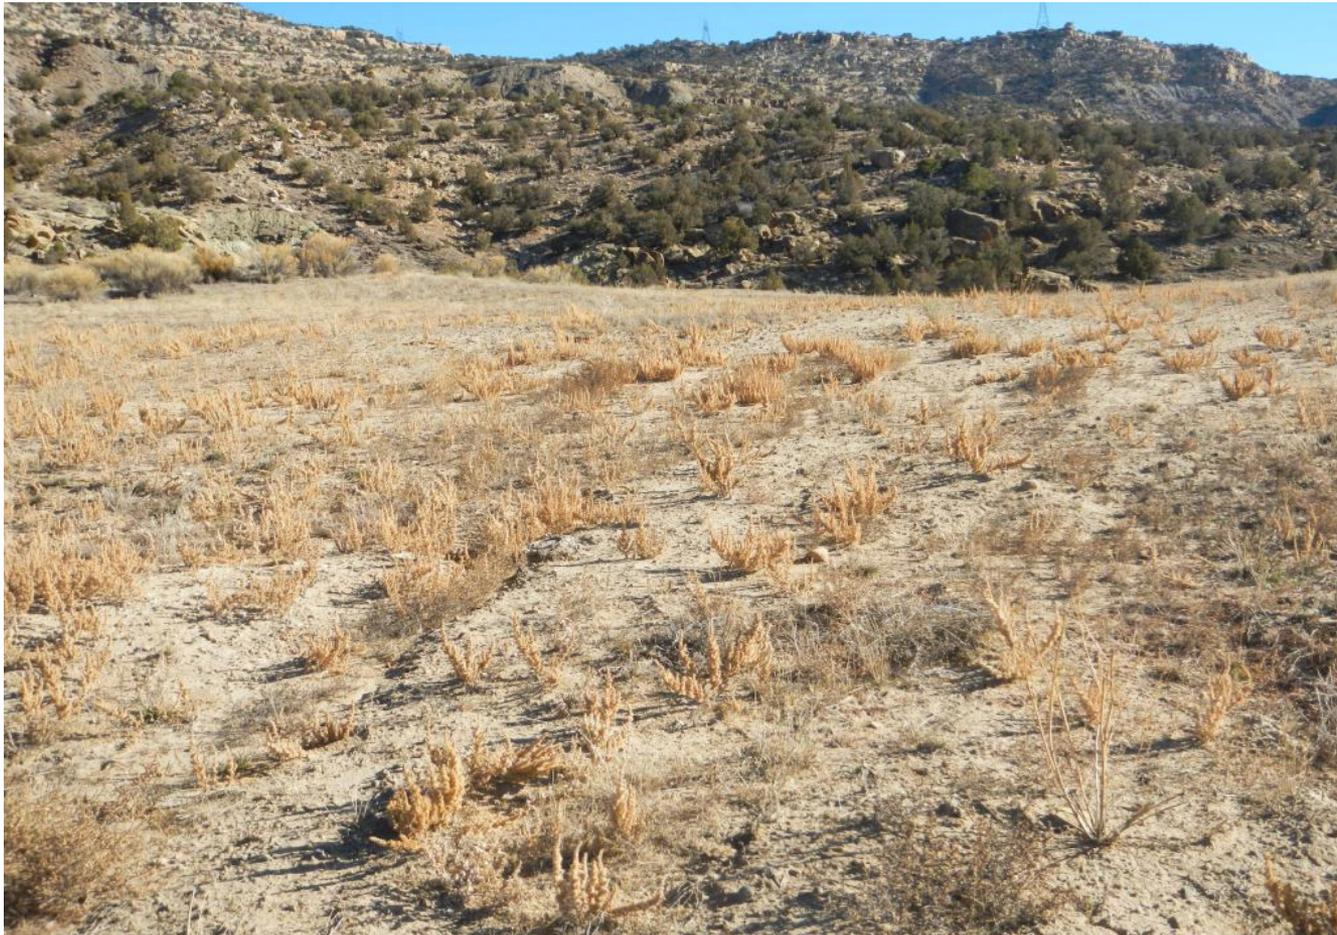
Photo#2:

Overview of Location to Southeast. Vegetation has not emerged / been washed out / buried in large areas because of SW flow & Sediment migration. C list Noxious Weed, Halogeton is established in these areas

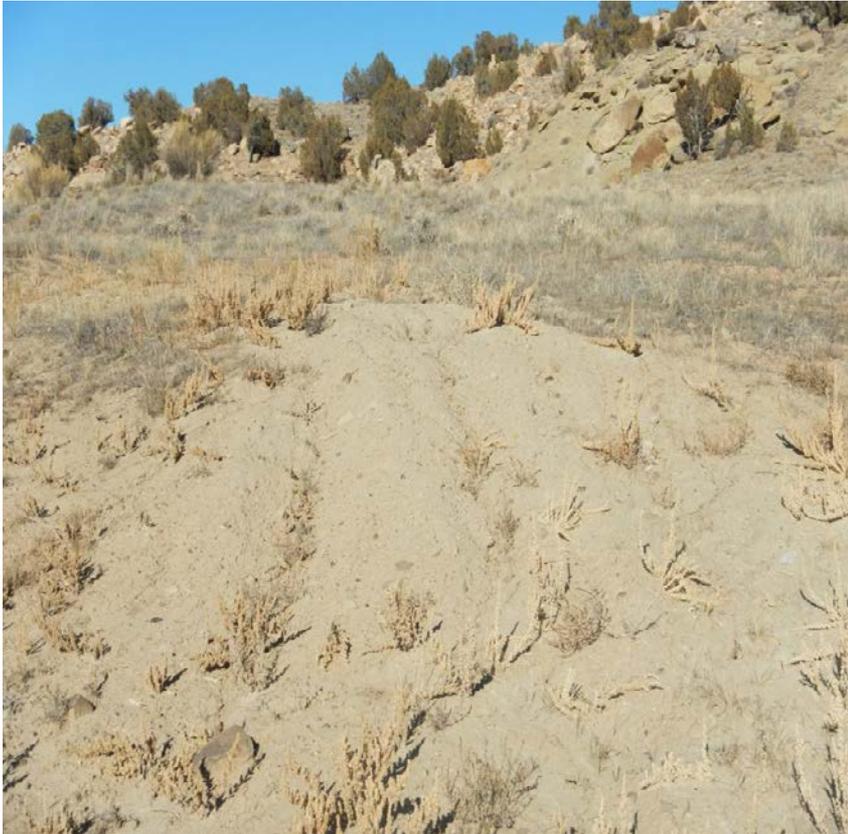
Photo#3:

Vegetation has not emerged / been washed out / buried in large areas because of SW flow & Sediment migration. C list Noxious Weed, Halogeton is established in these areas

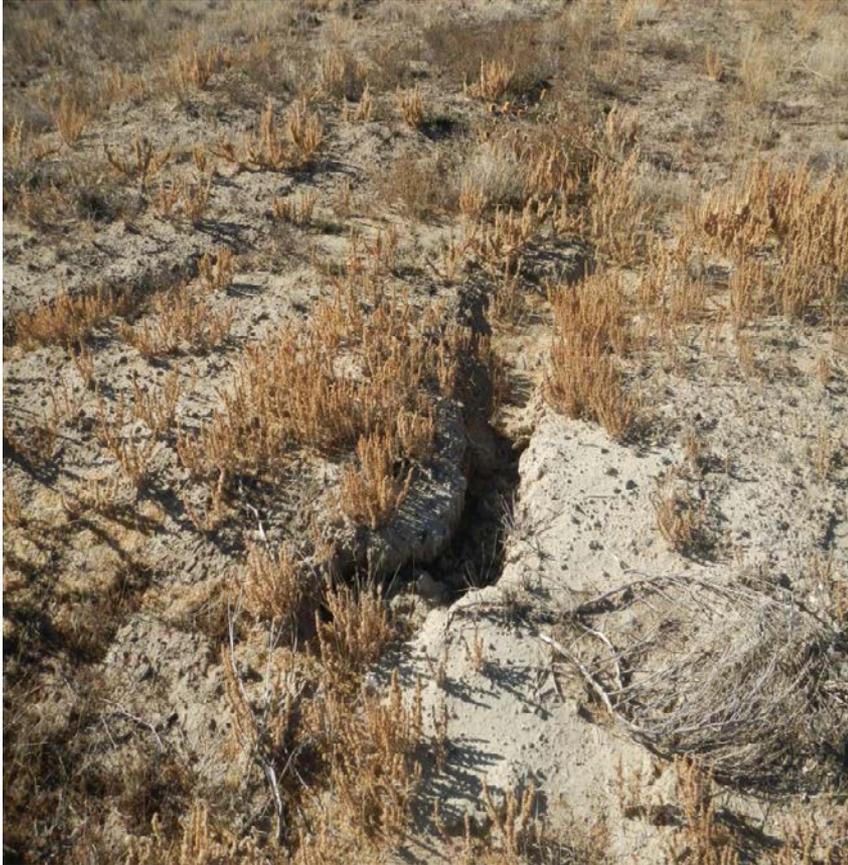
Photo#5:

Vegetation has not emerged / been washed out / buried in large areas because of SW flow & Sediment migration. C list Noxious Weed, Halogeton is established in these areas

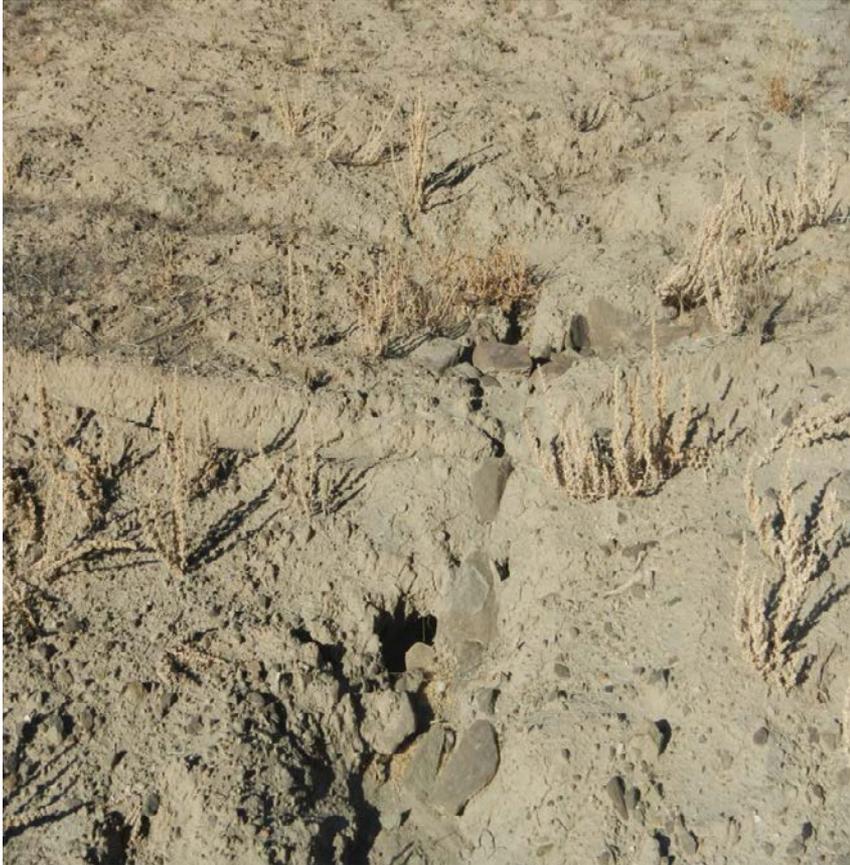
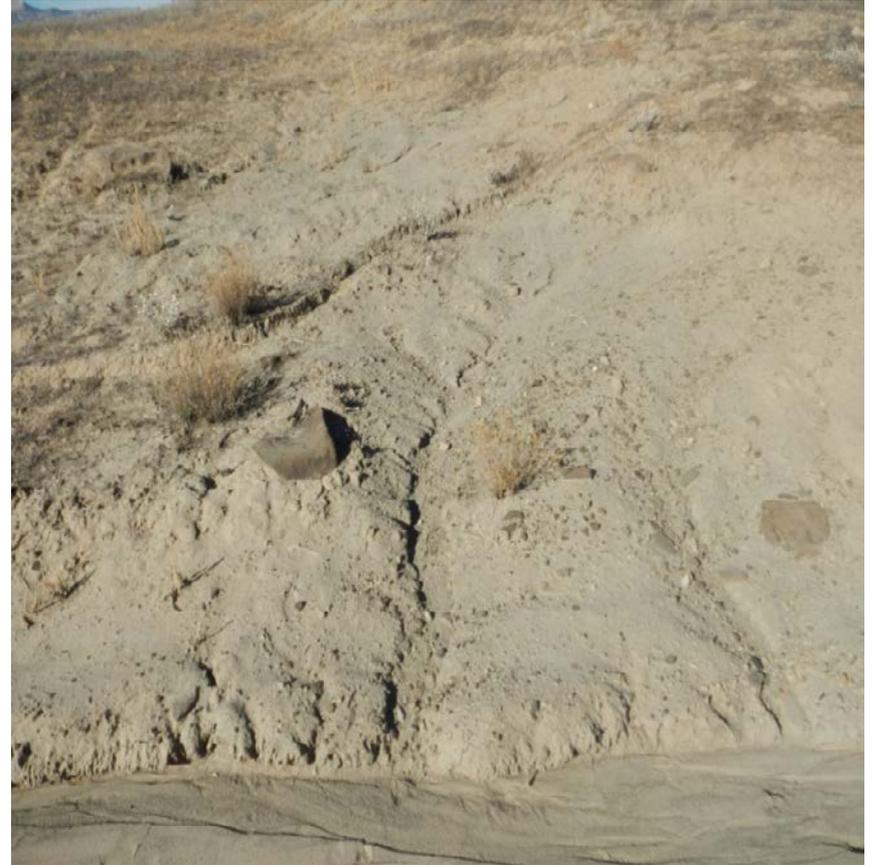
Wattles have been removed at South end of Location Sediment migration is occurring.
