# Inspection Photos

Operator: PCR OPERATING LLC - 10657

Location ID: 313784

Inspection Doc. Number: 682502917

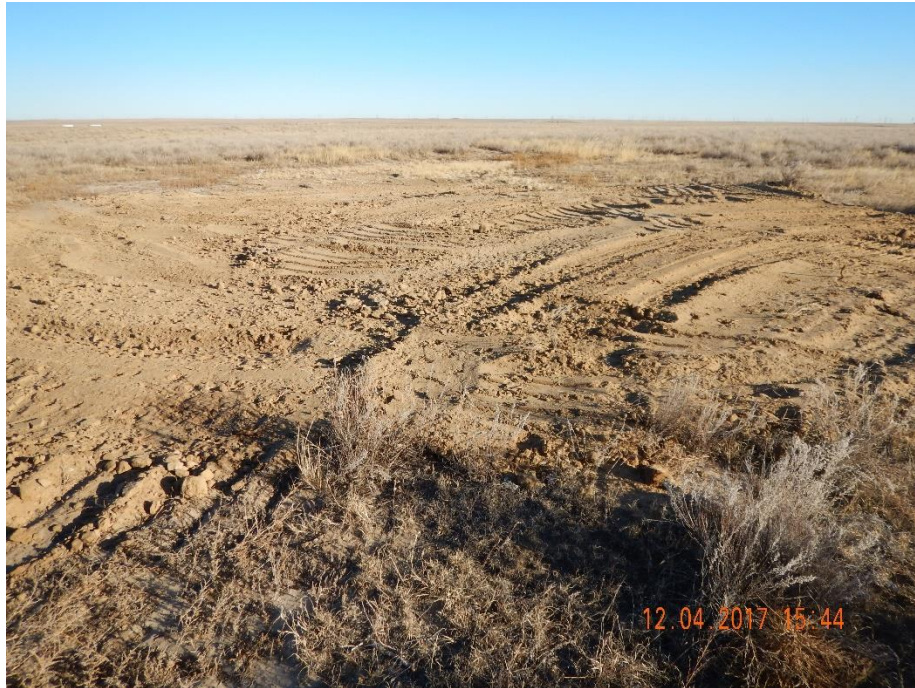
**Photo 1:** Photo taken from the well location, facing northeast. Photo shows concrete pump base has been removed per the corrective actions. Previous inspection also required operator to perform revegetation activities and ensure seeded soil is stabilized. Unable to find evidence that reseeding or additional reclamation activities have been conducted.

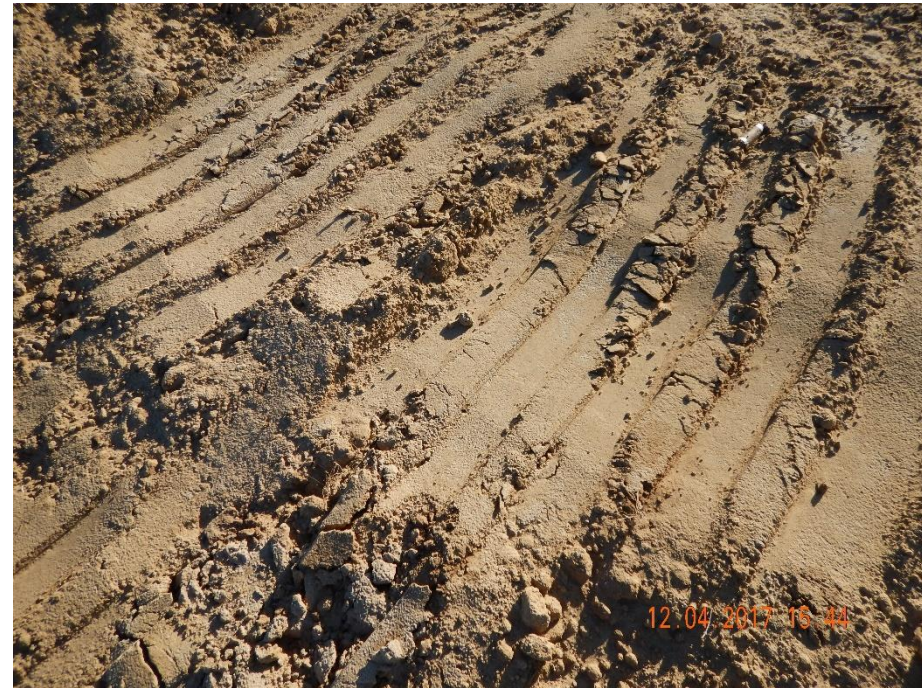
**Photo 2:** Photo taken from the well location. Photo shows soil surface; unable to find evidence that reseeding or additional reclamation activities have been conducted.

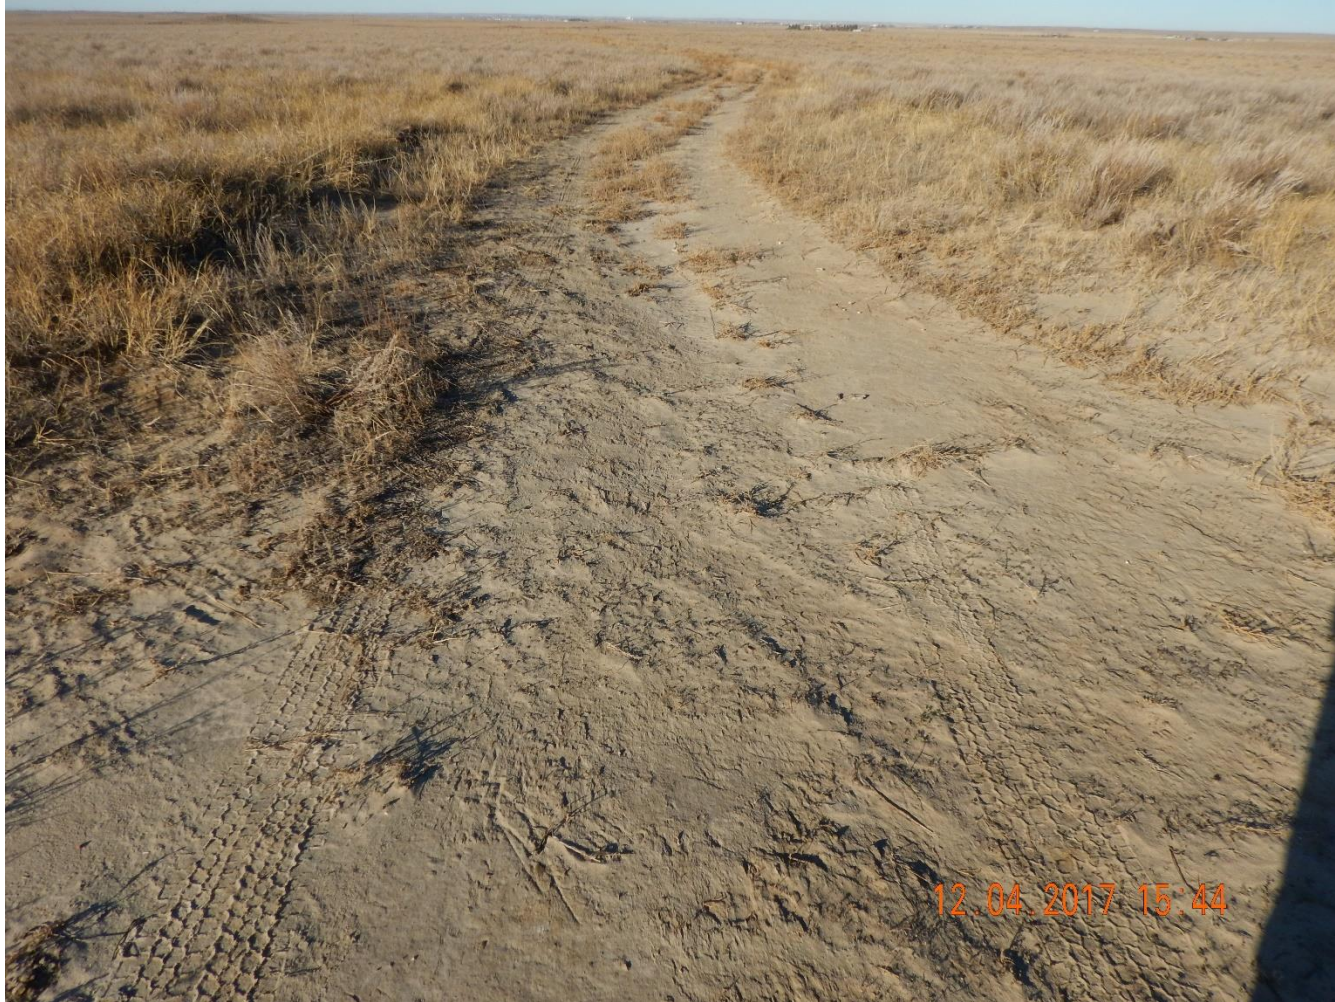
**Photo 3:** Photo taken from the well location facing north. Previous inspection required operator to perform reclamation on the access road. Photo shows no reclamation activities have been conducted on access road.
