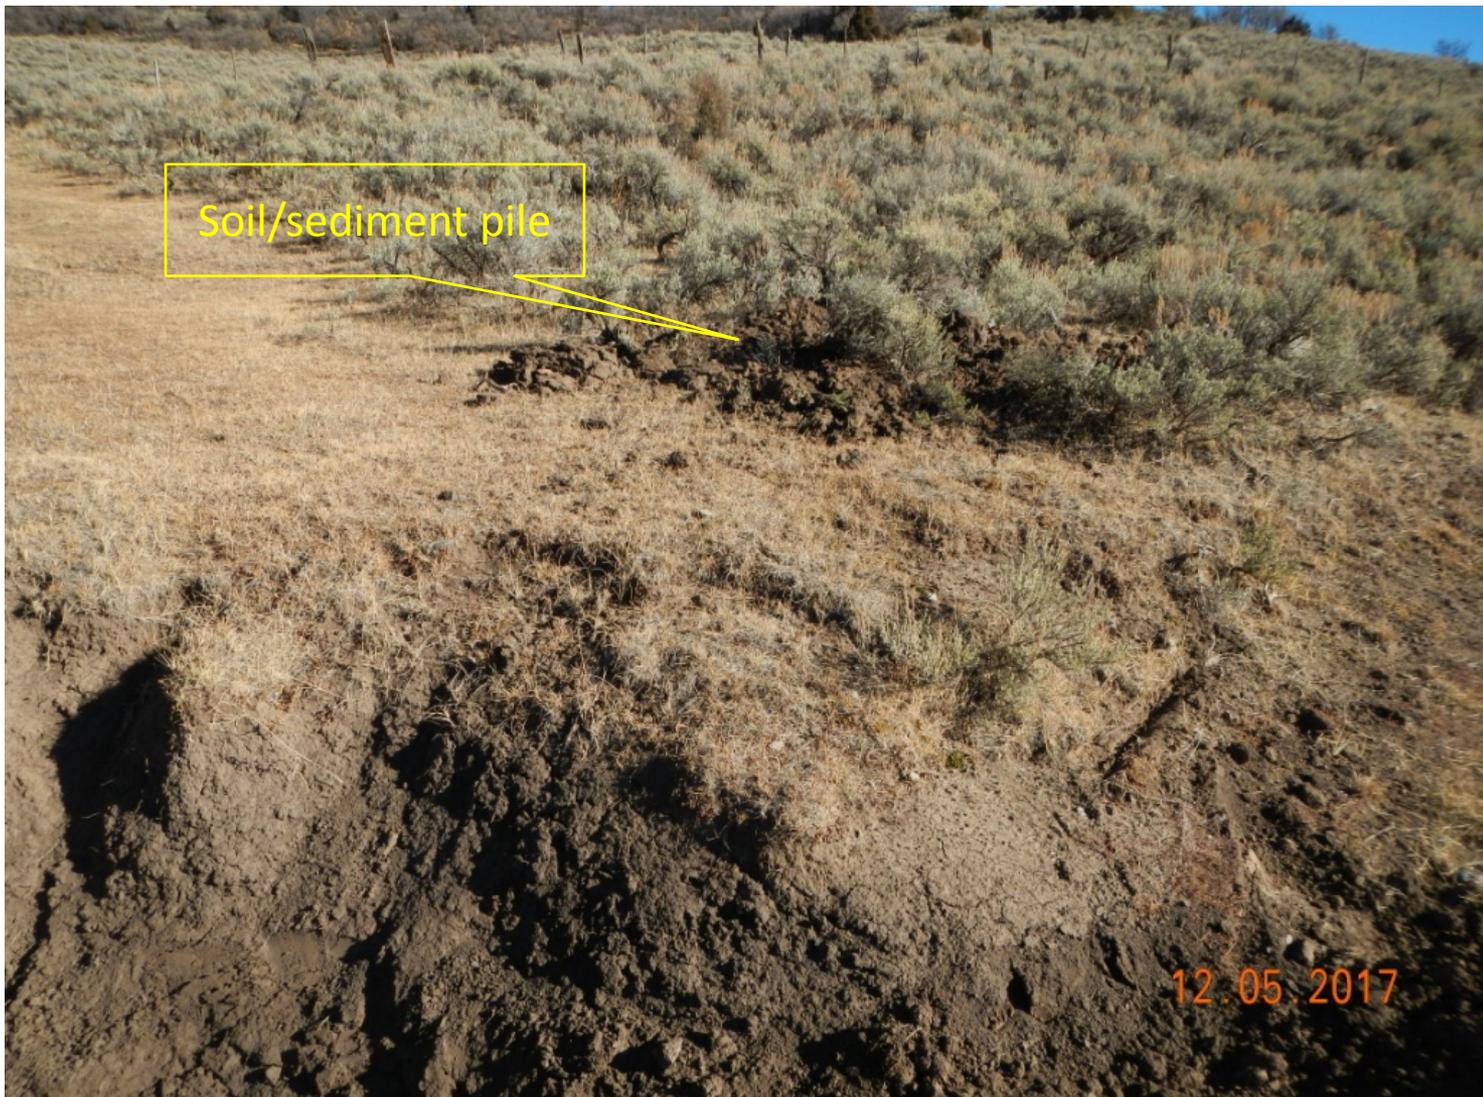
Photo 1. View of area along the access road where silt trap was recently cleaned and sediment placed offsite into adjacent sagebrush habitat.

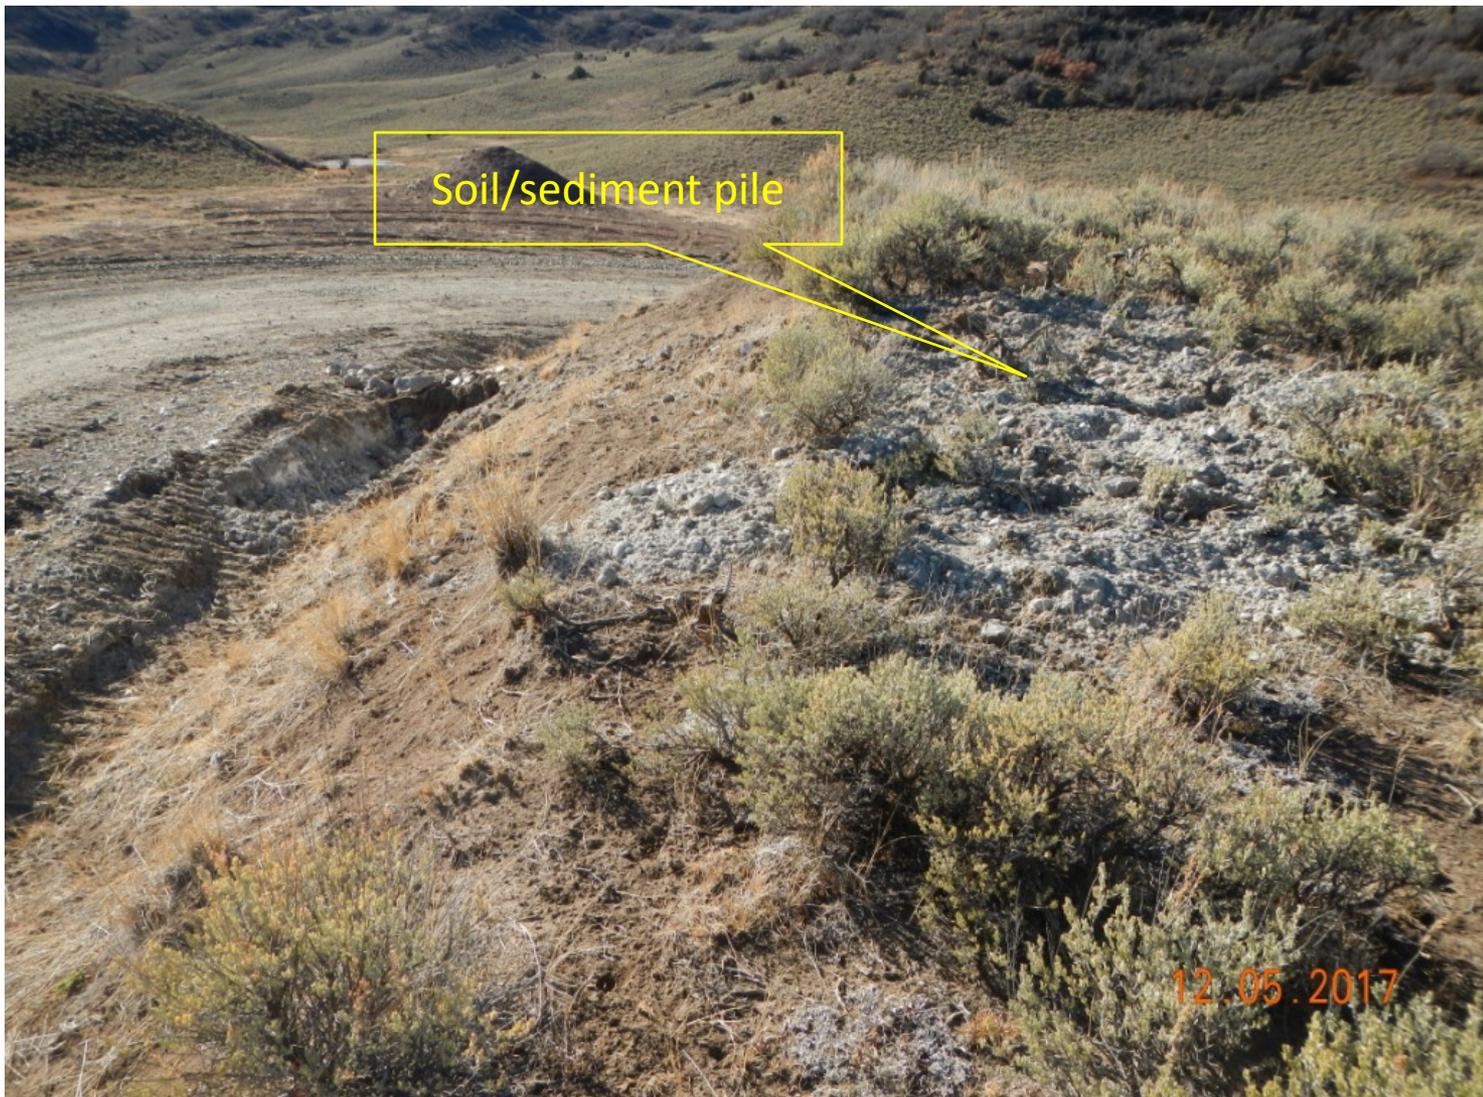
Photo 2. View of area along access road where sediment from roadside ditch was placed into adjacent sagebrush habitat.

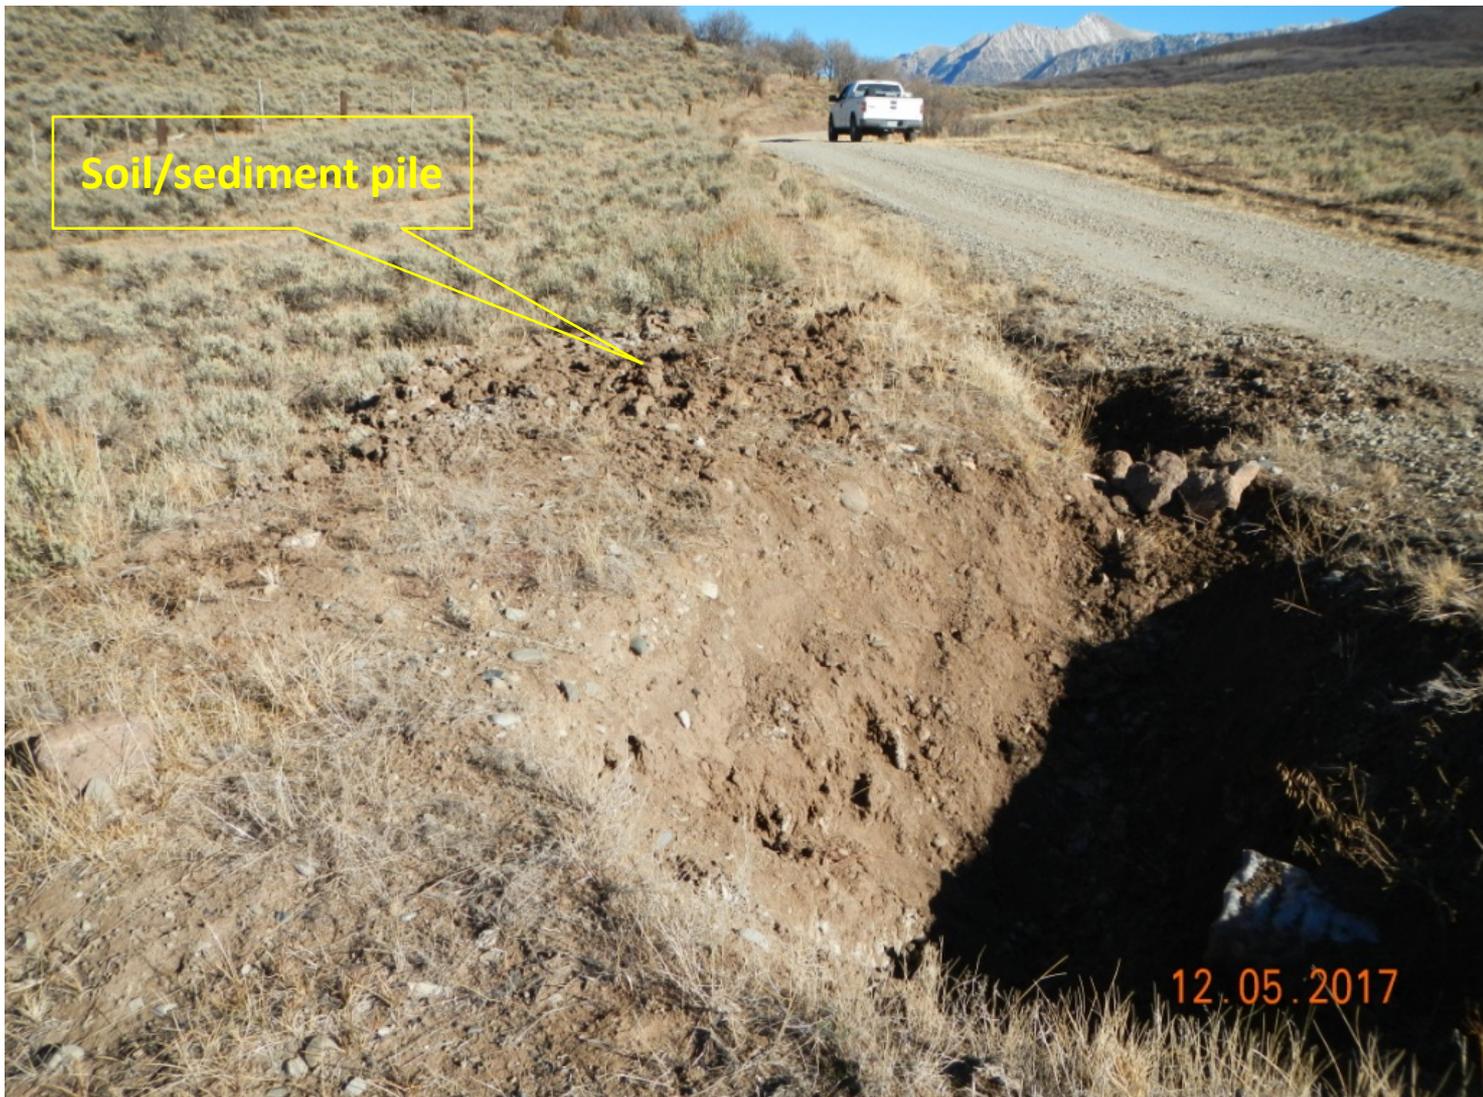
Photo 3. View of another area along the access road where silt trap was maintained and sediment placed in adjacent habitat.

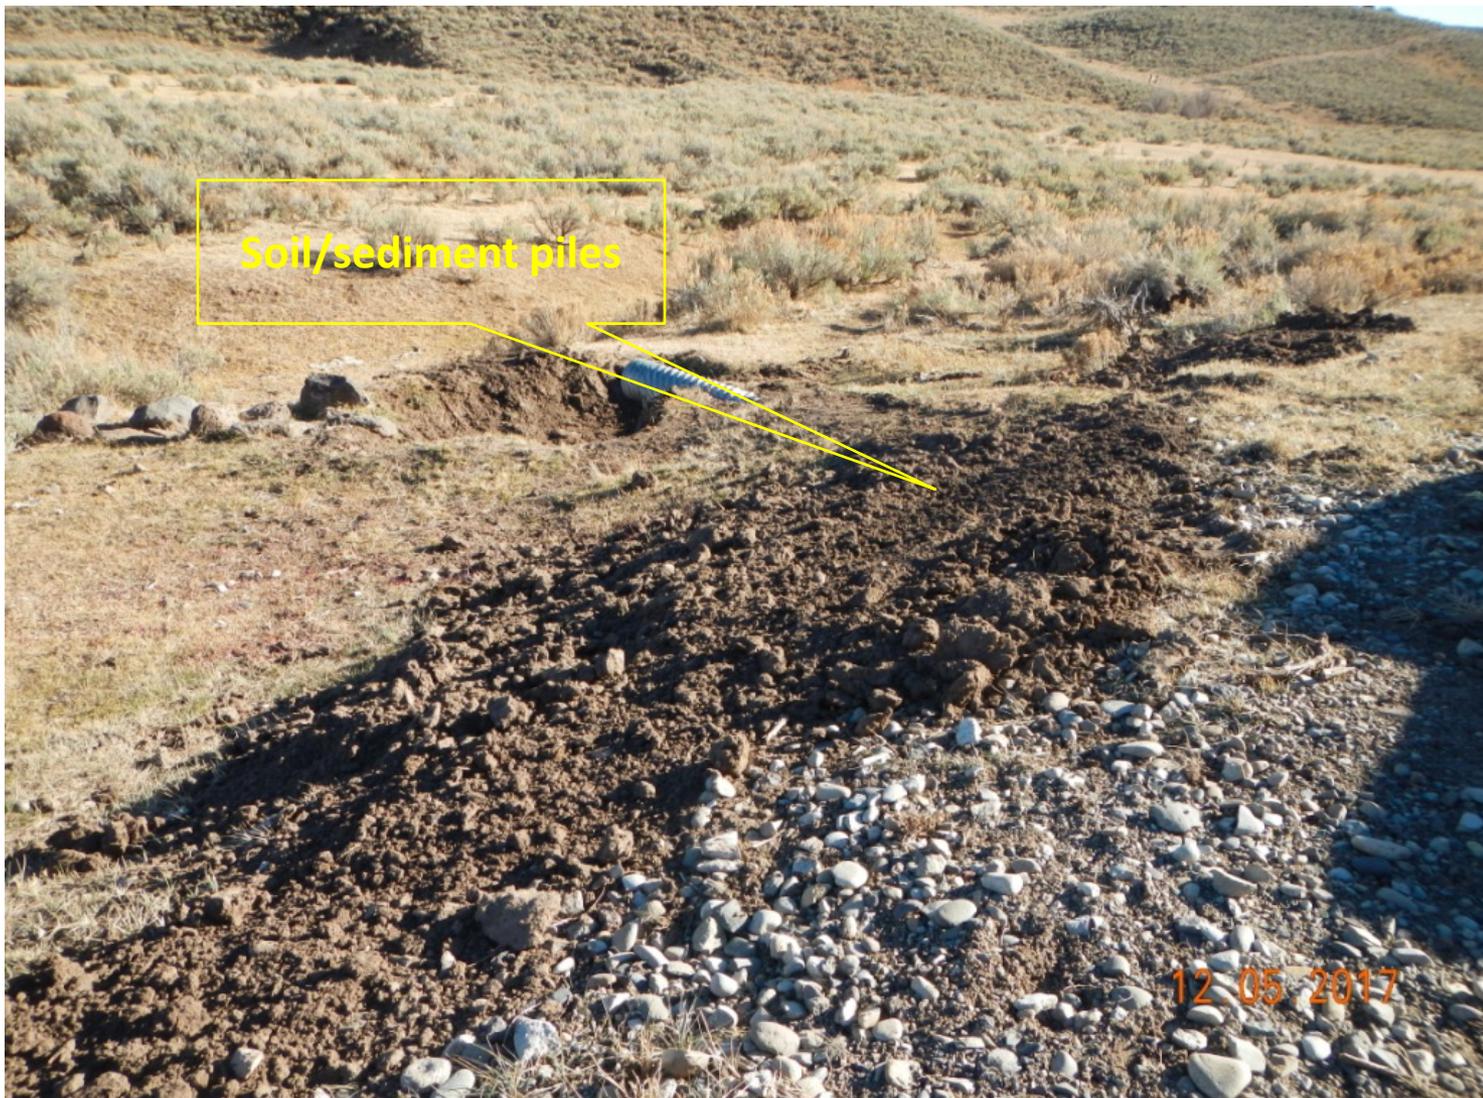
Photo 4. View of area along the access road where sediment and soil has been scraped and placed in piles along roadside and in adjacent grass/sagebrush habitats.
