# Final Reclamation Inspection

Operator: MAGPIE OPERATING, INC- # 52530

API: 05-069-06112

Inspection Photos  
Location Name: SAULCY #3  
API: 05-069-06112

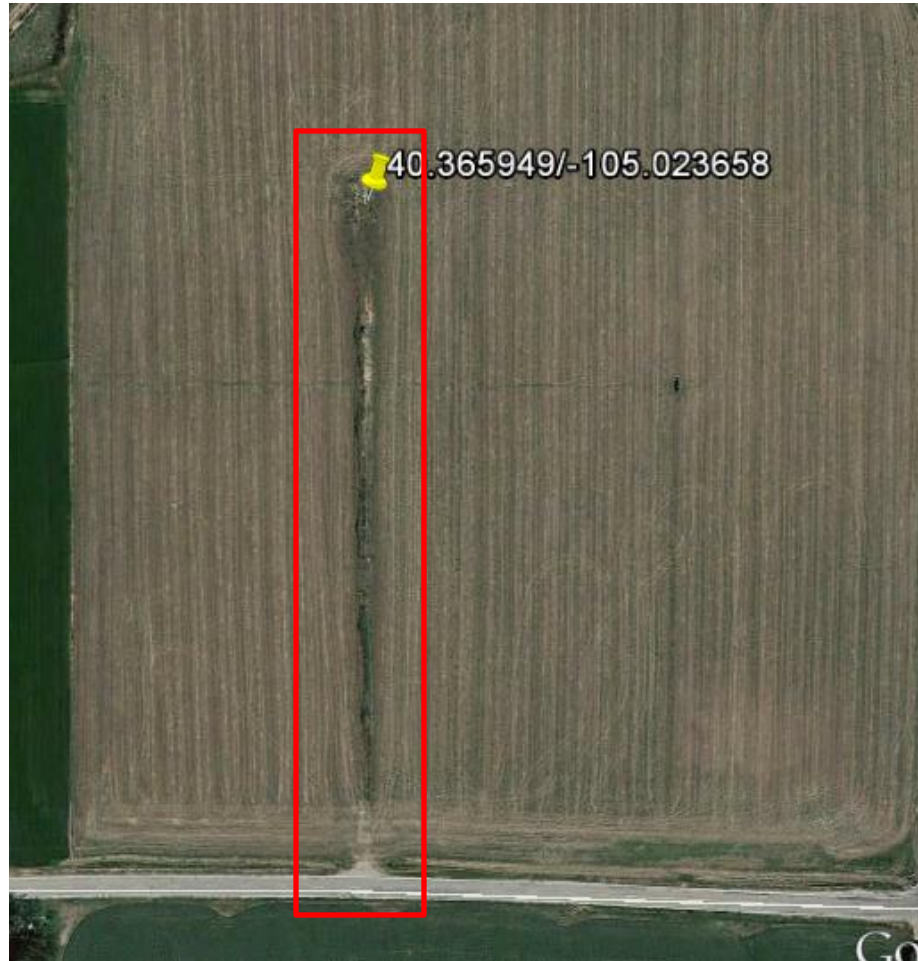
Google Earth aerial imagery taken June 19, 2014 illustrating an approximate 770' access road AND well location that has not been reclaimed per Rule 1004 standards.

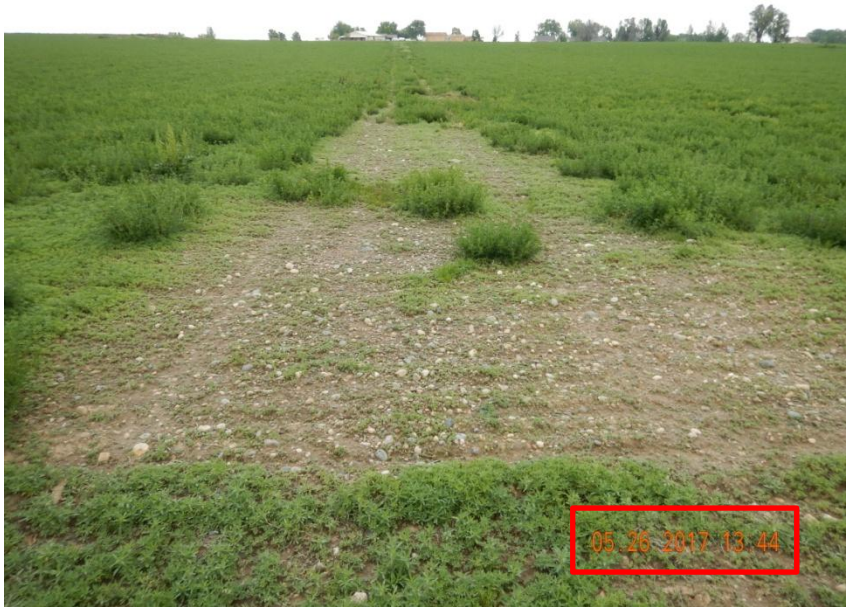
**Photo 1.** Photo taken on May 26, 2017 from the access point off CO Rd. 16, facing North along the access road. Gravel has not been removed and access road has not been contoured.

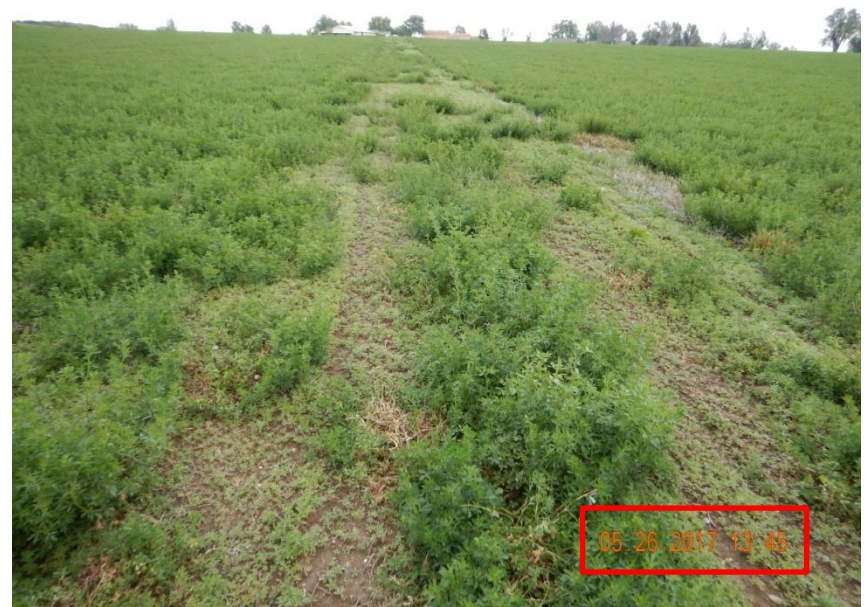
**Photo 2.** Photo taken on May 26, 2017 north of the previous photo location, facing North along the access road. See comments under Photo 1.

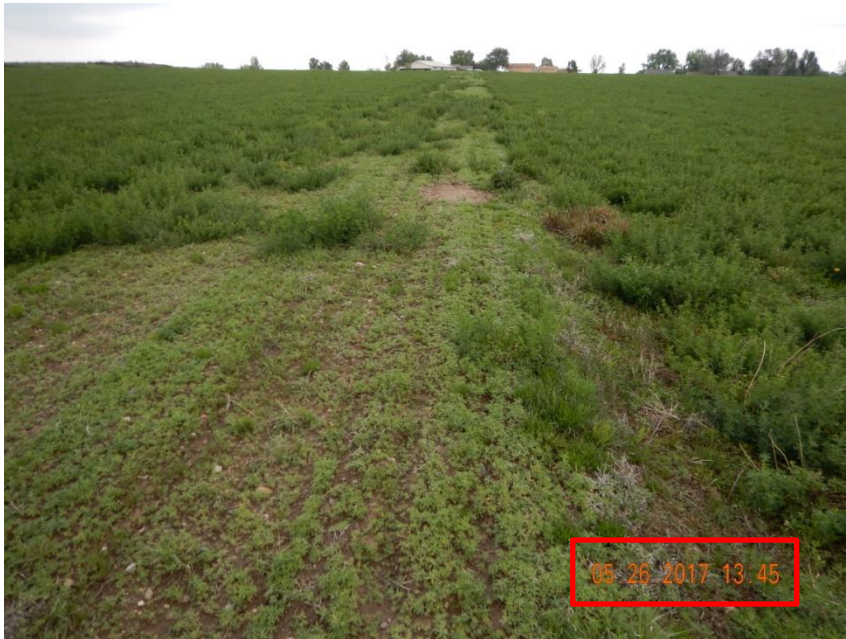
**Photo 3.** Photo taken on May 26, 2017 north of the previous photo location, facing North along the access road. See comments under Photo 1.

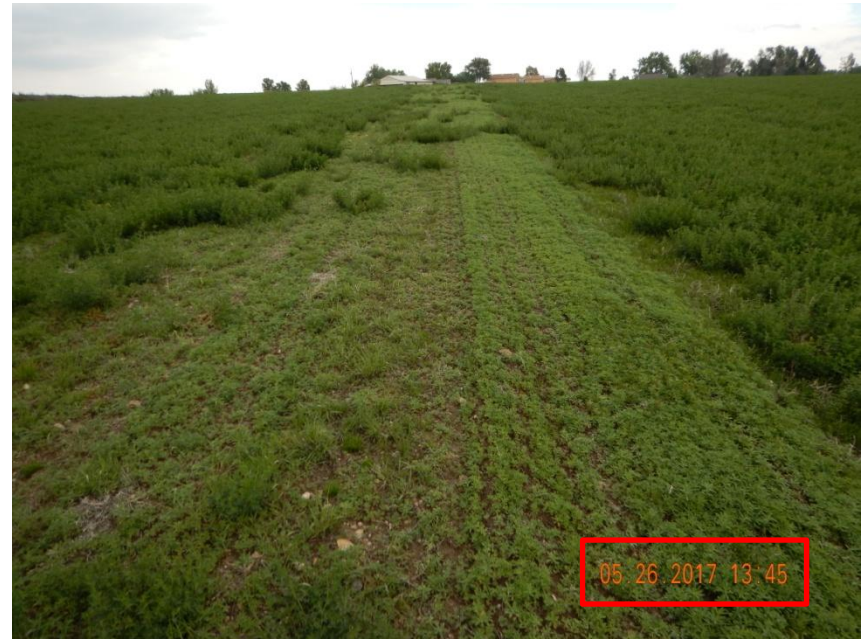
**Photo 4.** Photo taken on May 26, 2017 north of the previous photo location, facing North along the access road. See comments under Photo 1.

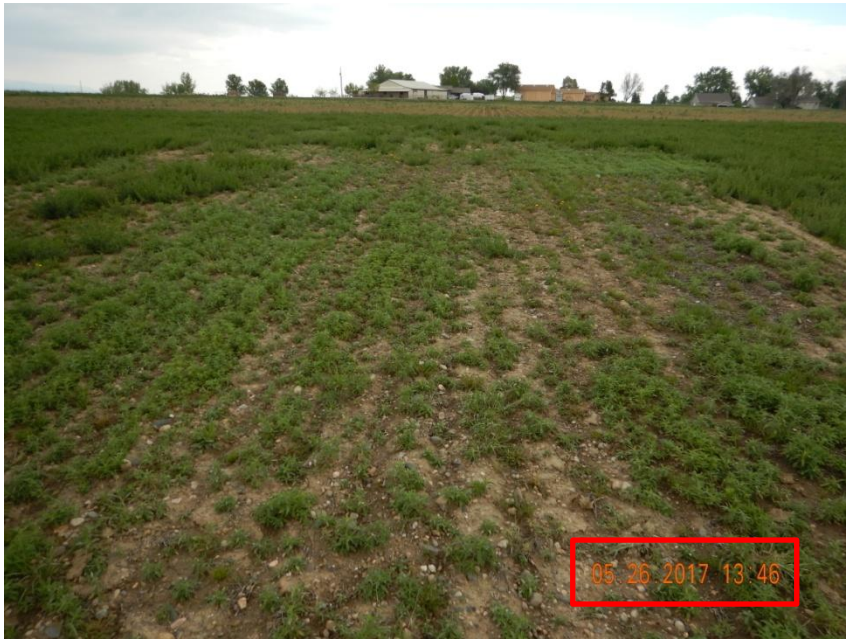
**Photo 5.** Photo taken on May 26, 2017 from the well location, facing North. Gravel has not been removed and has not been contoured.

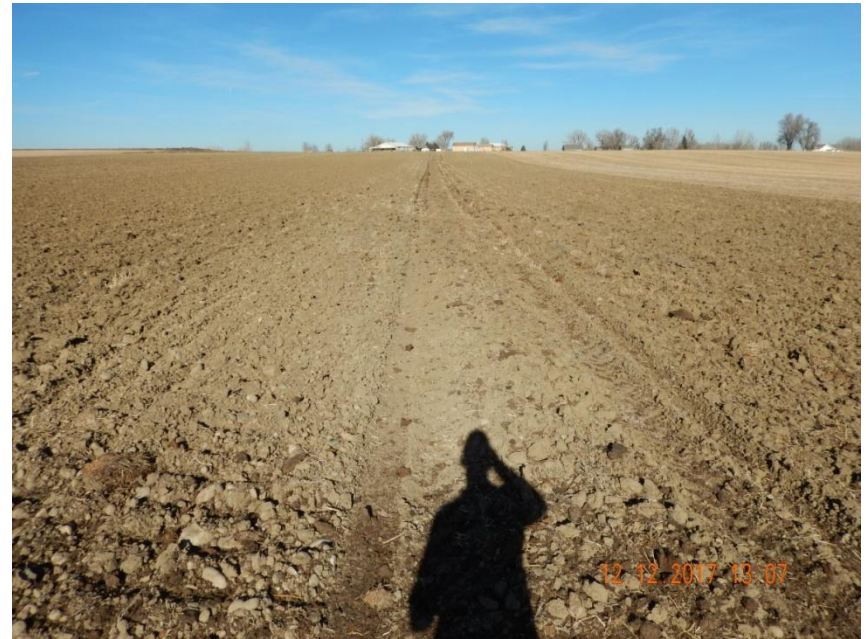
**Photo 6.** Photo taken on December 12, 2017 from the access point off CO Rd. 16, facing North. Land has been recently tilled. It appears the access road may not have been recontoured as soil material appeared to be elevated along the access road in relation to the adjacent land.
