Final Reclamation Inspection

Operator: CHESAPEAKE OPERATING LLC- 16660

API: 05-123-31630

Inspection Photos
Location Name: STATE 16-9-66 #1H
API: 05-123-31630

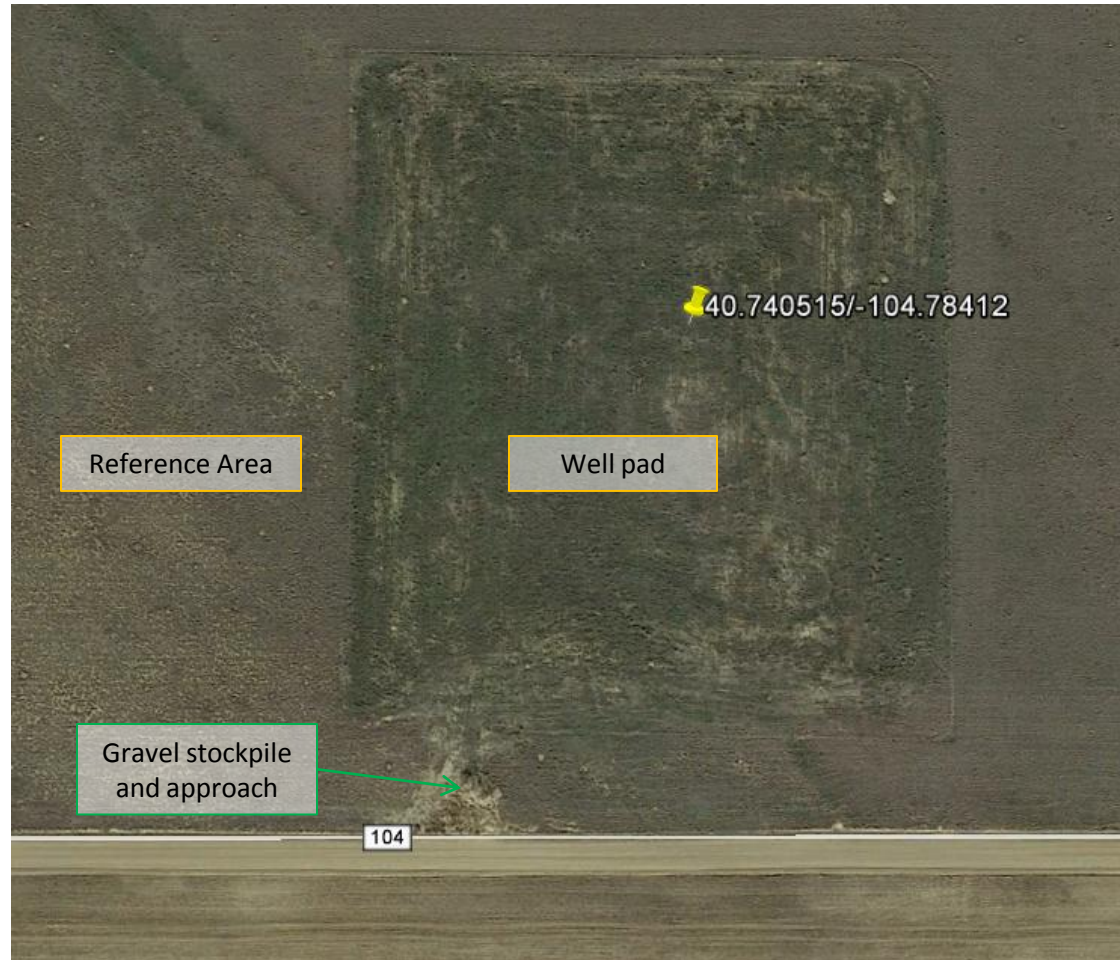
Google Earth imagery taken October 14, 2017. Photo illustrates the well pad location (~4.3 acres) in relation to adjacent reference areas.

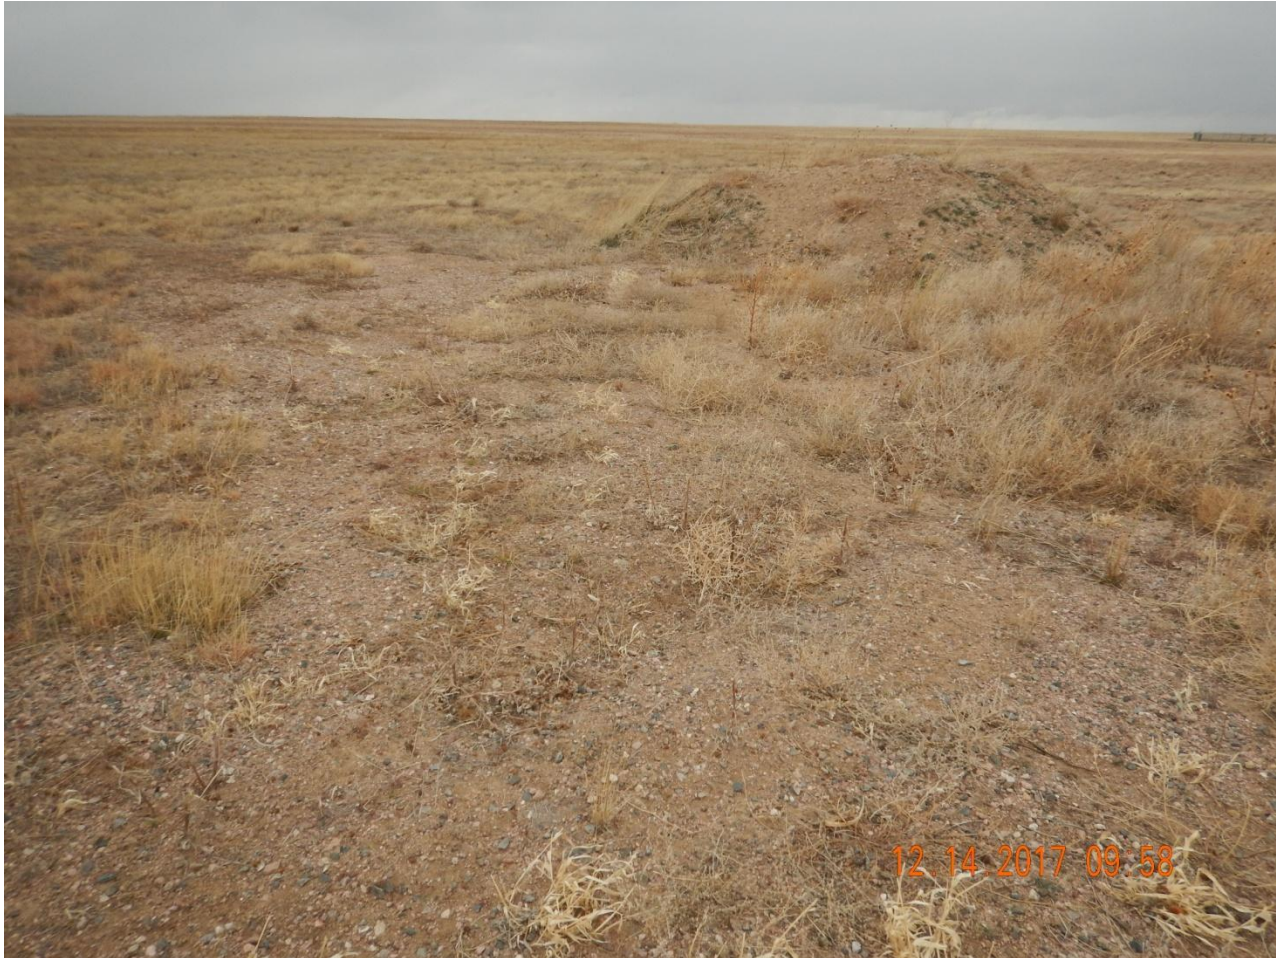
Photo 1. Photo taken from the entrance of the location, facing North. Approach and gravel pile left behind which has not been reclaimed per Rule 1004 standards.

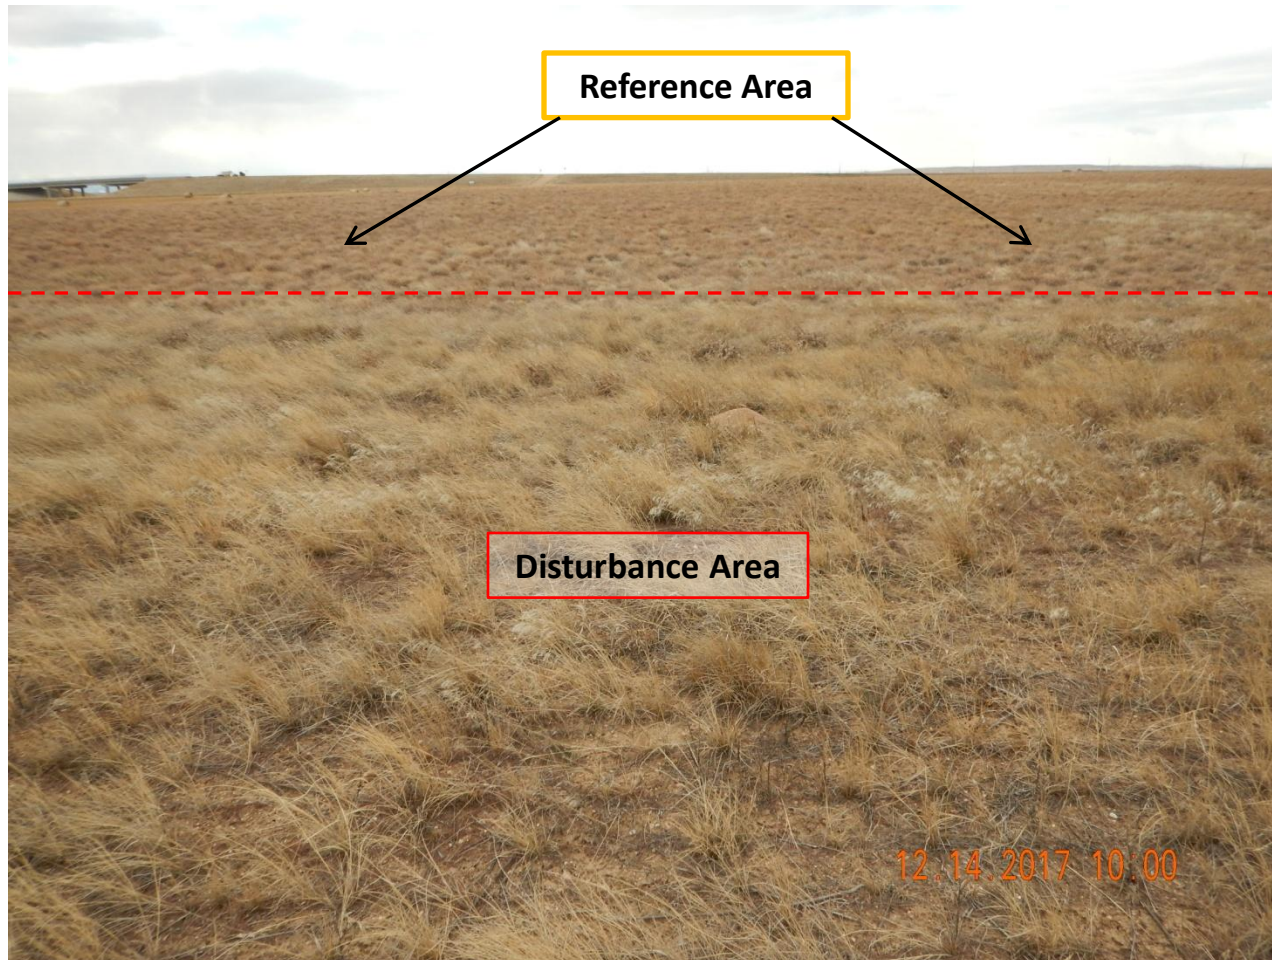
Photo 2. Photo taken from the western location, facing West. Disturbance area vegetation consists mainly of a crested wheatgrass, another wheatgrass species, wildrye species, and smooth brome- none of these species were observed in the reference area. Reference area vegetation consists mainly of Switchgrass, little bluestem, sideoats grama, and blue grama.

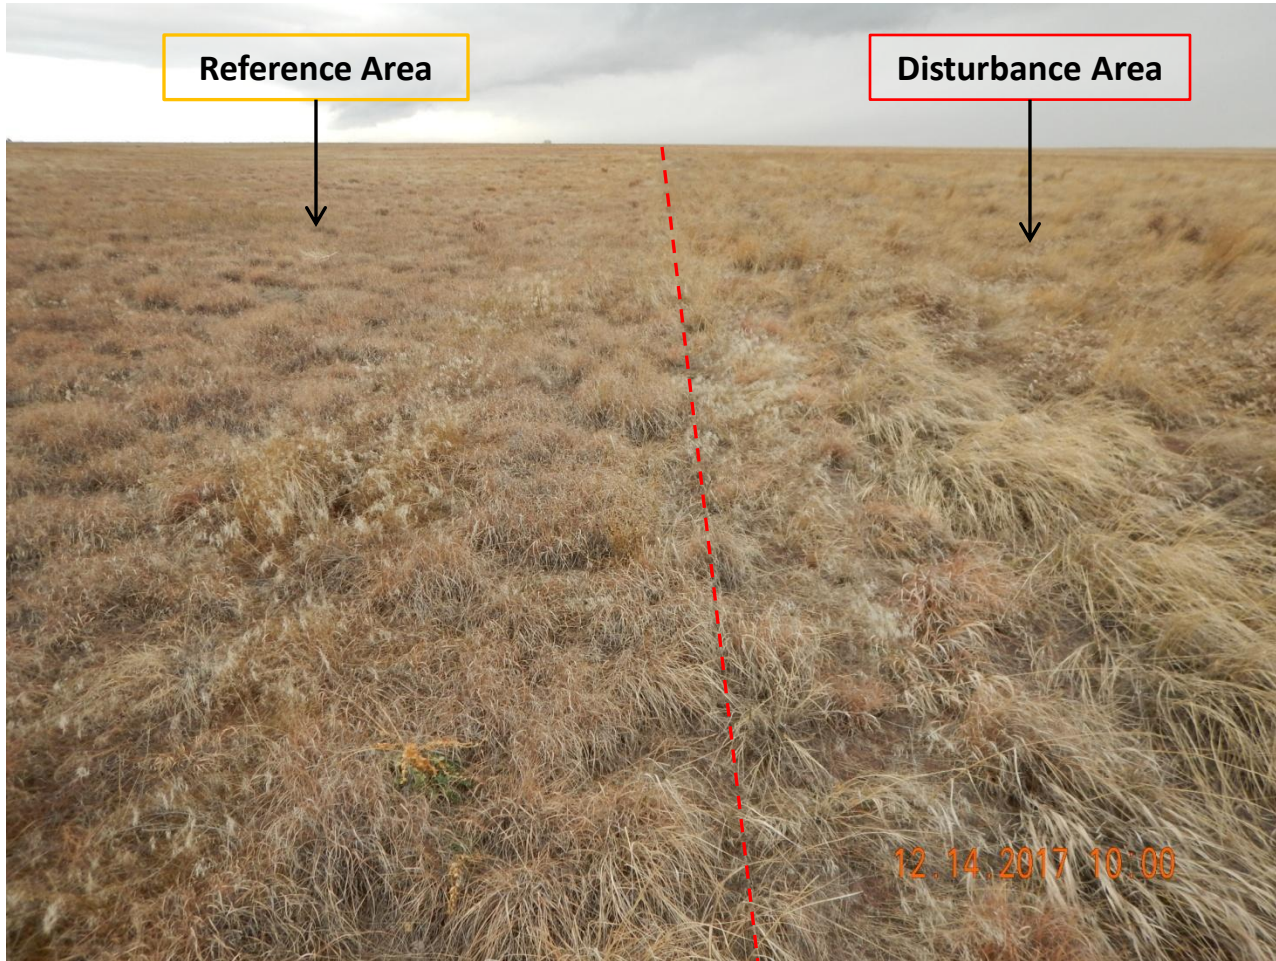
Photo 3. Photo taken from the western location, facing North. See comments under Photo 2.

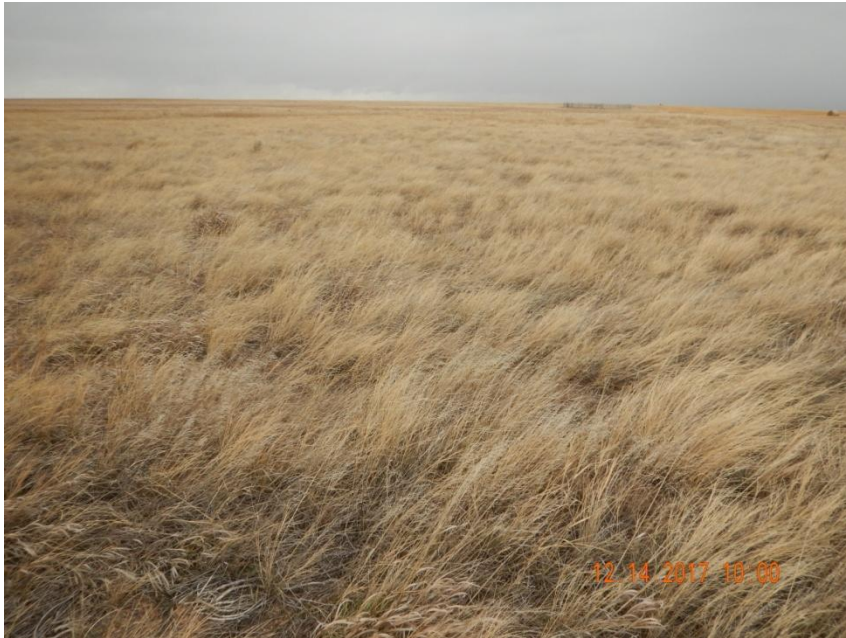
Photo 4. Photo taken from the approximate center of location, facing East. See comments under Photo 2.

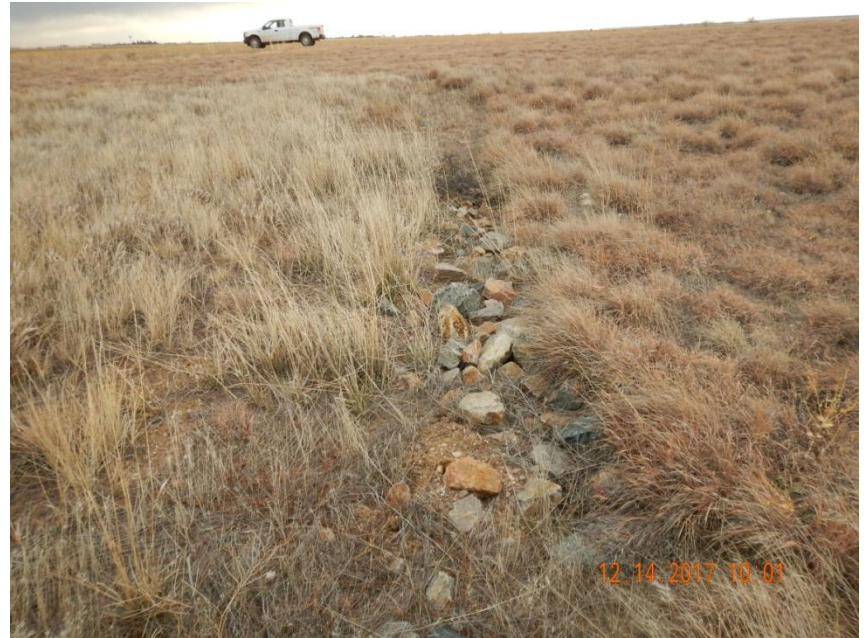
Photo 5. Photo taken from the southwest location, facing South. Operator needs to remove excessive rip-rap material that may have been used as stormwater BMPs.
