Inspection Photos

Operator: NOBLE ENERGY INC - 100322

Location ID: 327002

Inspection Doc. Number: 682503010

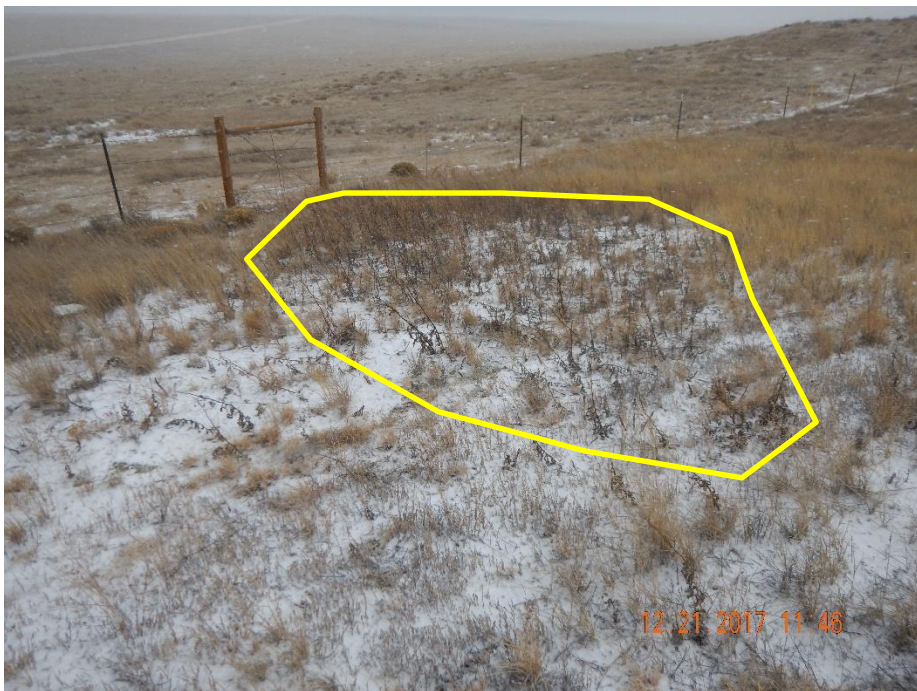
Photo 1: Photo taken from the west end of the location, facing west. Photo shows a patch of Canada thistle. Previous inspection documented thistle and had required it's management and removal. Canada thistle is a listed noxious weed and is required to be managed by the COGCC, Colorado State and Weld County. Photo shows thistle does not appear to have been managed or removed per corrective actions.

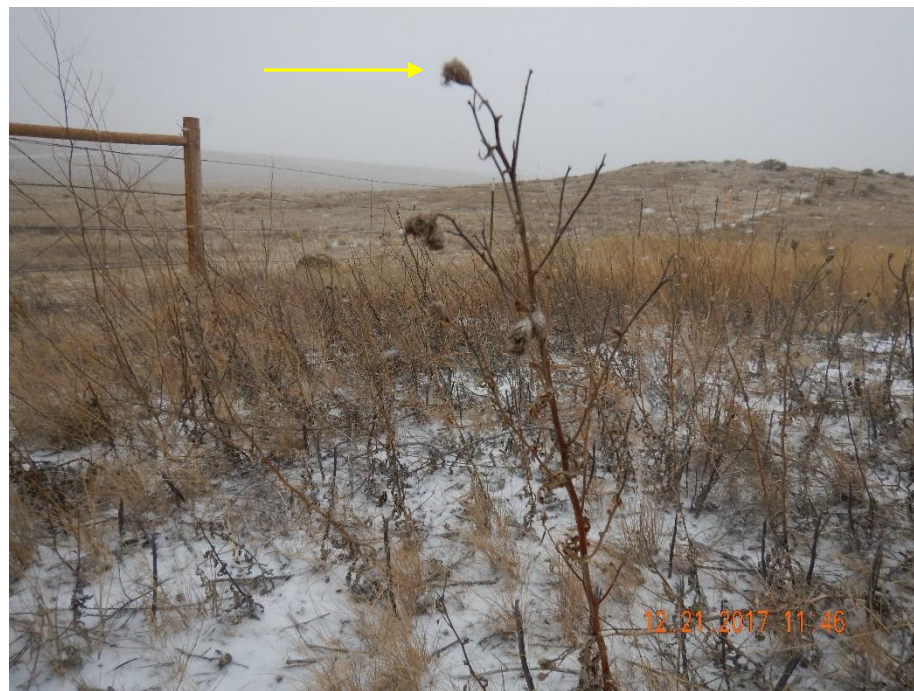
Photo 2: Photo of Canada thistle stalk remaining on location. Photo shows plants were not managed and appear to have seeded-out. Operator has failed to manage weeds in a timely manner. Canada thistle was not removed per corrective actions in 2017 and was allowed to reach maturity and seed-out. Canada thistle has possibly spread throughout location and adjacent lands.

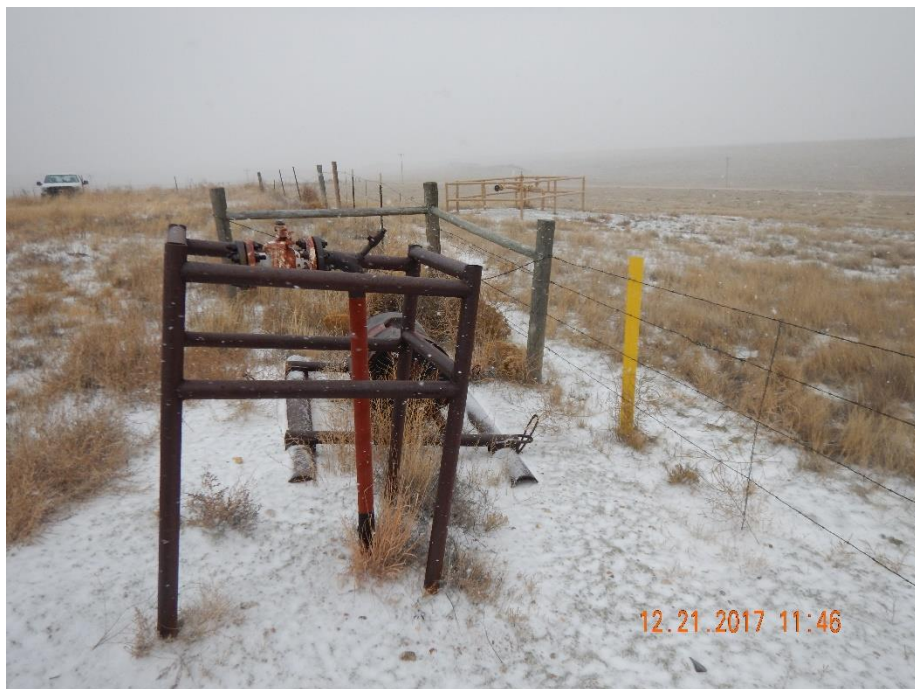
Photo 3: Photo taken from the south end of the location, facing east. Photo shows pipe riser remaining on location.

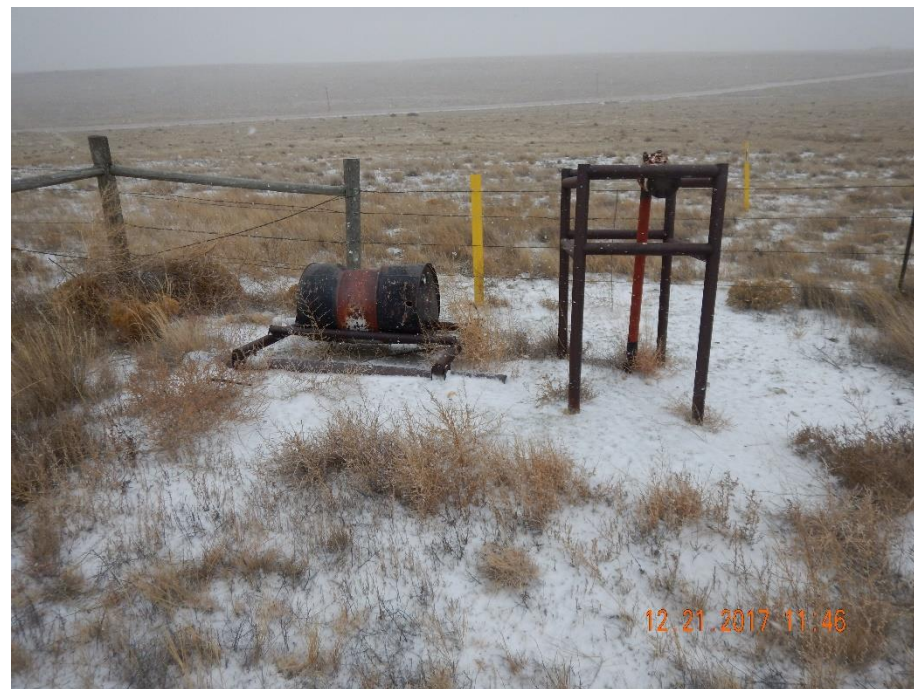
Photo 4: Photo taken from the south end of the location, facing southwest. Photo shows pipe riser and trash debris (barrel scraper, can be considered unused equipment) remaining on the location.
