# Interim Reclamation and Stormwater Inspection

Operator: GREAT WESTERN OPERATING COMPANY LLC- #10110

Location ID: 453032

Inspection Photos  
Location Name: Pierce DE /26-054  
Location ID: 453032

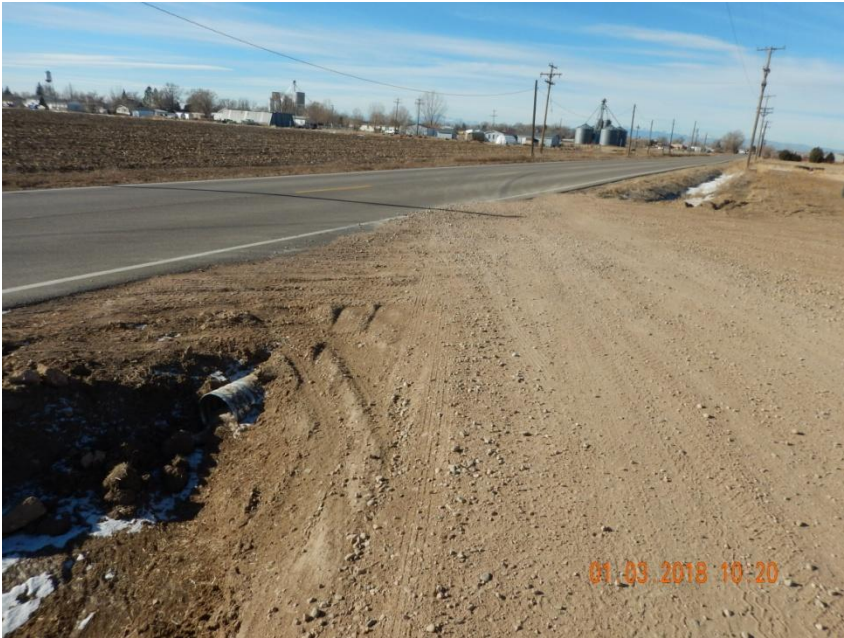
**Photo 1.** Photo taken from the entrance of location off CR90, facing West. Operator has installed a culvert along the bar ditch. Operator has installed gravel but may not be a sufficient tracking pad device by itself.

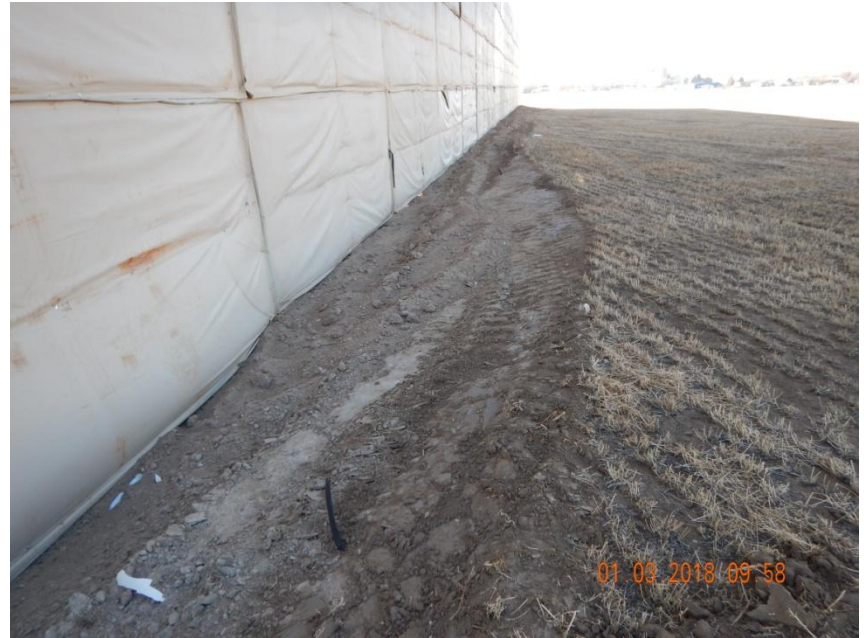
**Photo 2.** Photo taken from the cut slope of the northern location, facing West. Operator has failed to install stormwater BMPs per Rule 1002.f.(2).

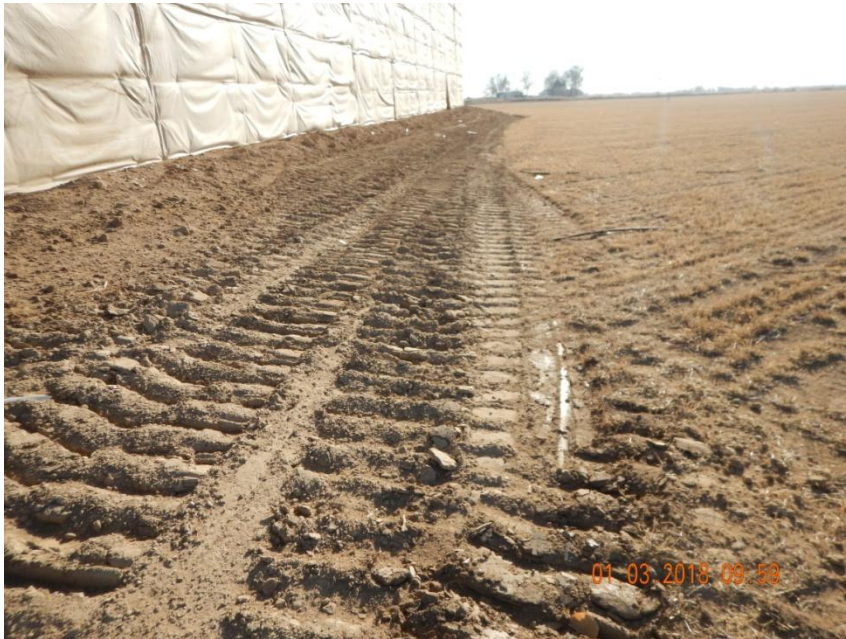
**Photo 3.** Photo taken from the western location, facing South. See comments under Photo 2.

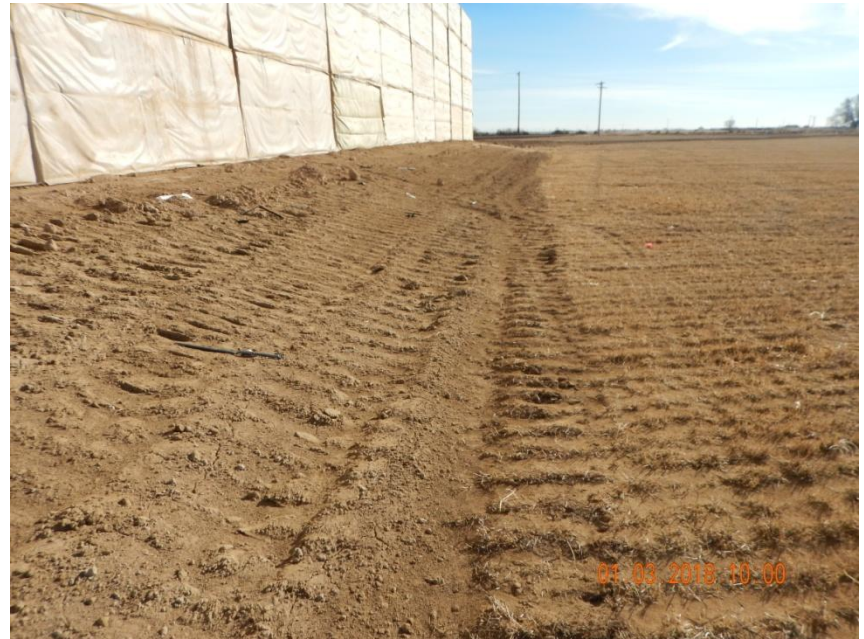
**Photo 4.** Photo taken from the southern location, facing East. See comments under Photo 2.

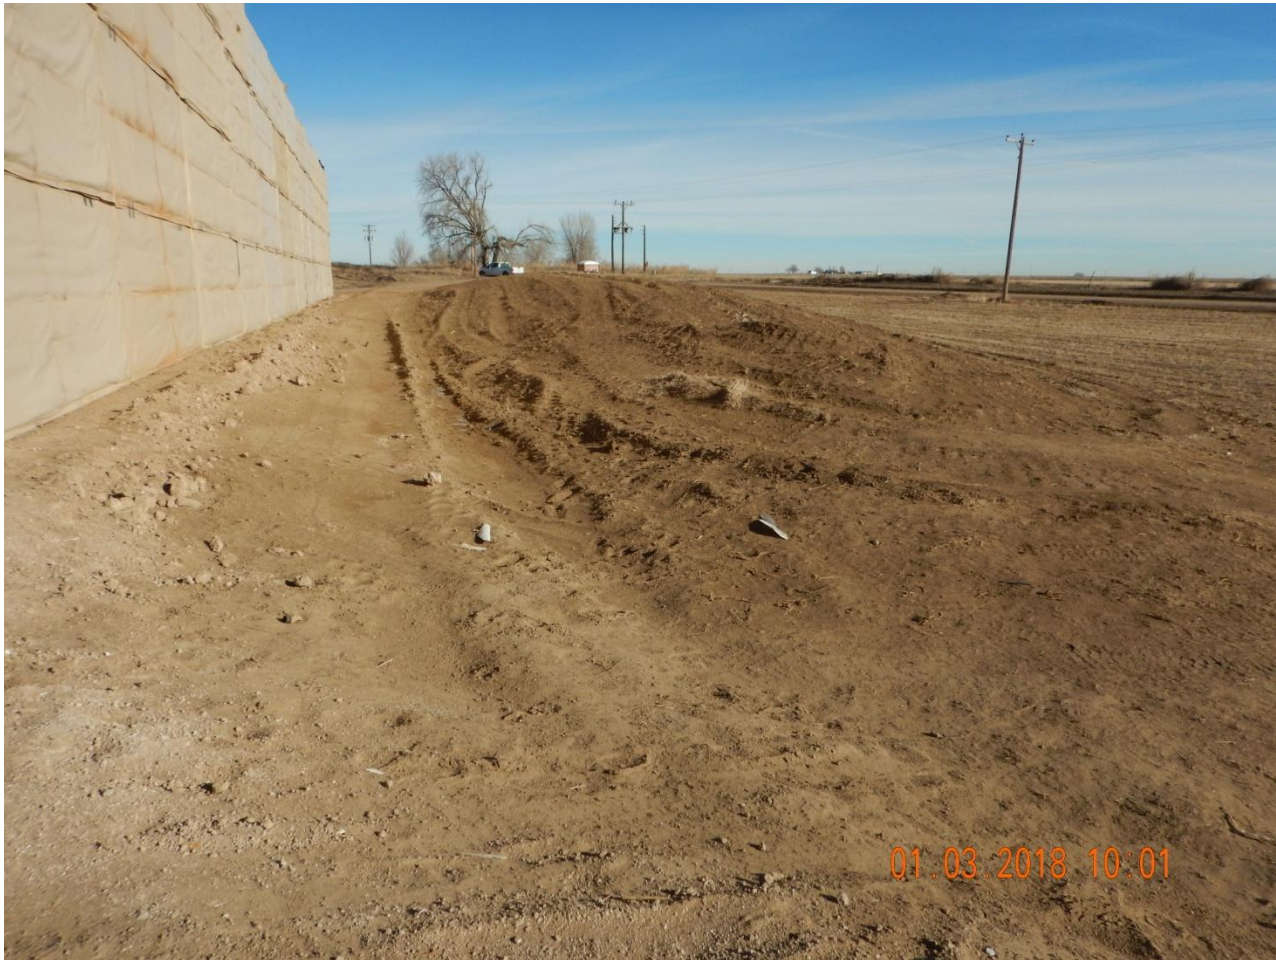
**Photo 5.** Photo taken from the eastern location, facing North. See comments under Photo 2. Topsoil stockpile stored along the eastern perimeter and appears to be temporarily stabilized with equipment tracking. Operator needs to stabilize topsoil stockpile for long-term stabilization.
