Final Reclamation Inspection

Operator: MAGPIE OPERATING, INC- # 52530

API: 05-069-06112

Inspection Photos
Location Name: SAULCY #3
API: 05-069-06112

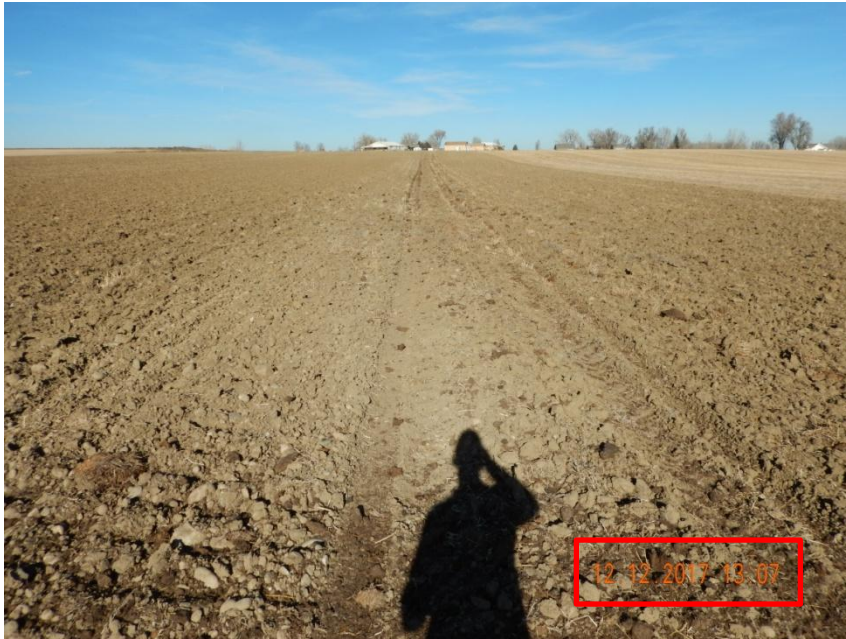
Photo 1. Photo taken on December 12, 2017 from the access point off CO Rd. 16, facing North. Land has been recently tilled. It appears the access road may not have been recontoured as soil material appeared to be elevated along the access road in relation to the adjacent land.

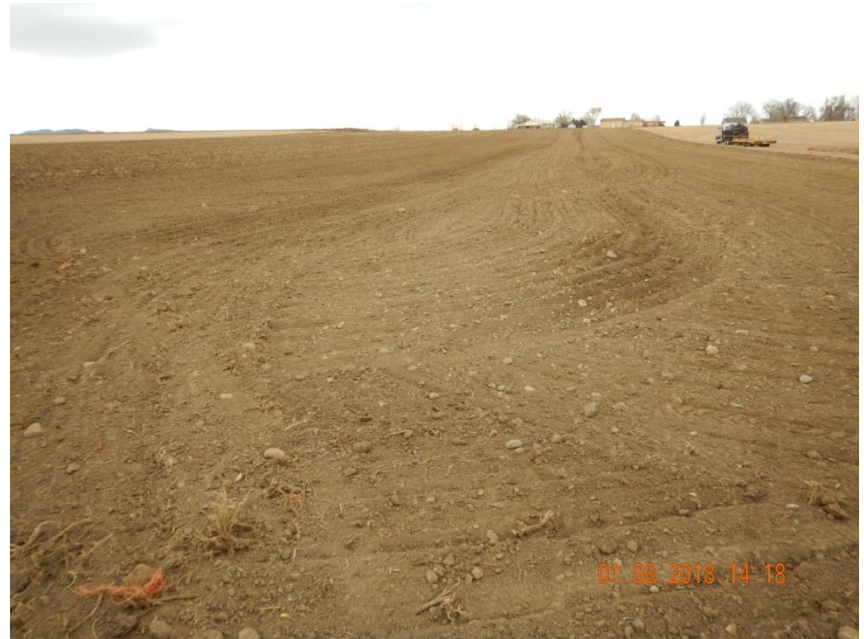
Photo 2. Photo taken on January 8, 2018 from the access point off CO Rd. 16, facing North. Land has been recently tilled and it appears the access road has been recontoured. A follow-up inspection will occur at a future date to ensure compliance with Rule 1004 standards.
