Inspection Photos

Operator: KERR MCGEE OIL & GAS ONSHORE LP
- 47120

Location ID: 318950

Inspection Doc. Number: 682503059
Weld County, CO

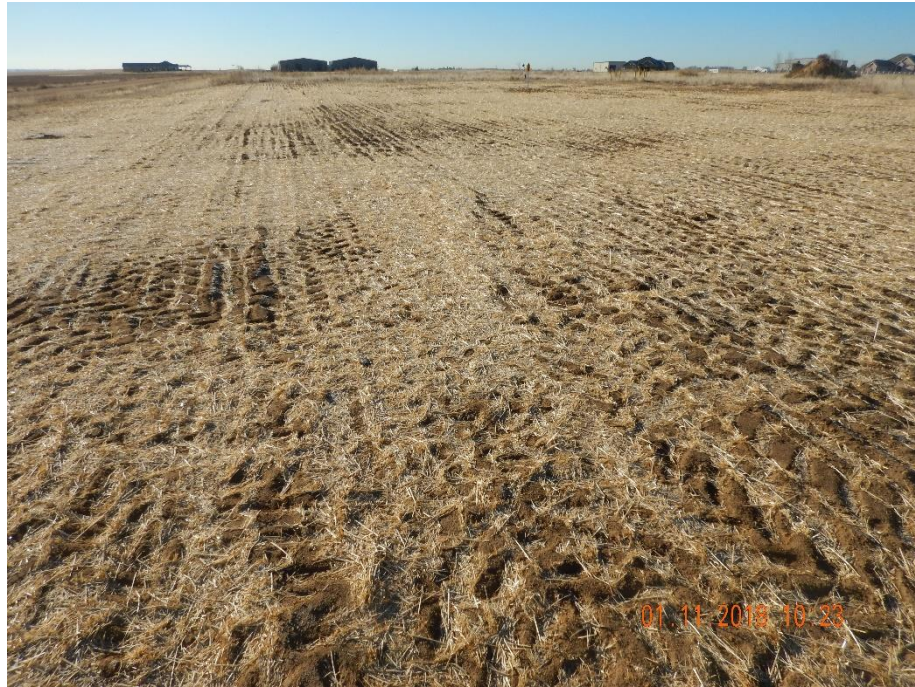
Photo 1: Photo taken from the northeast corner of the former tank battery location, facing south. Photo shows reclamation in-process.

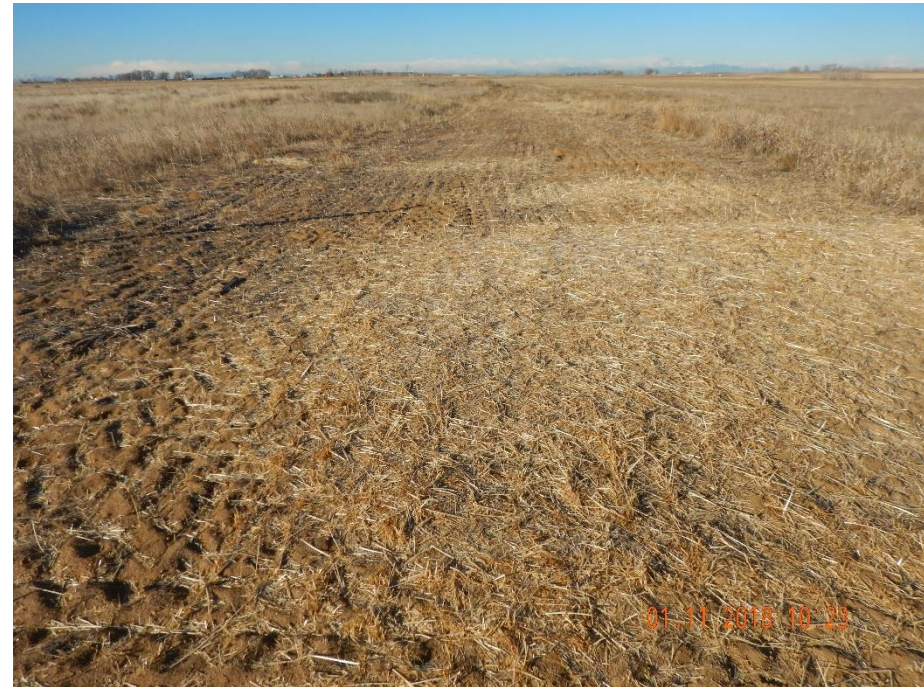
Photo 2: Photo taken from the west end of the former battery location, facing east. Photo shows reclamation of the access road leading to well.

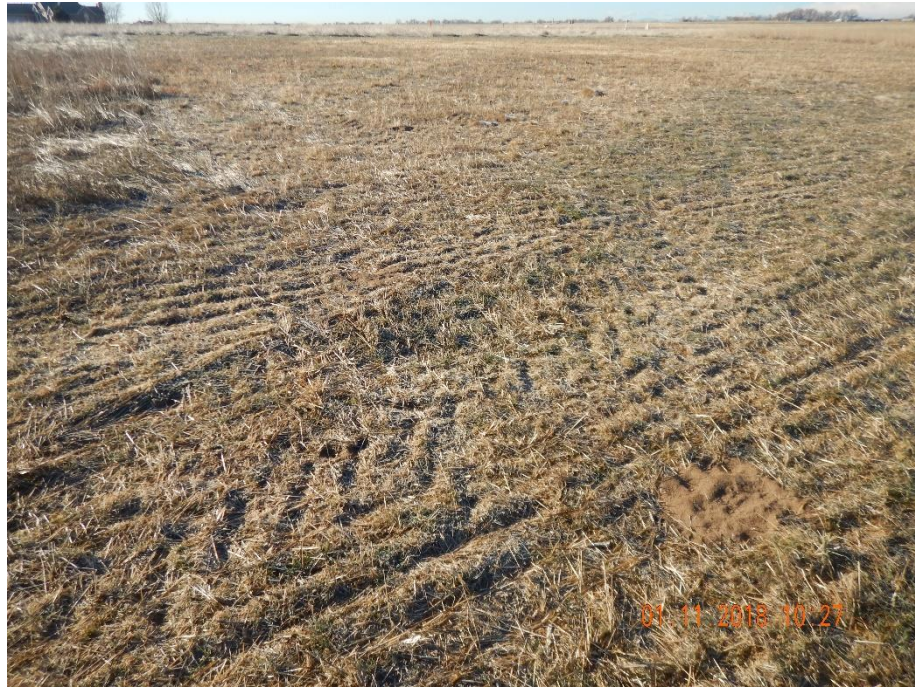
Photo 3: Photo taken from the northeast corner of the well location, facing south. Photo shows reclamation in-process.

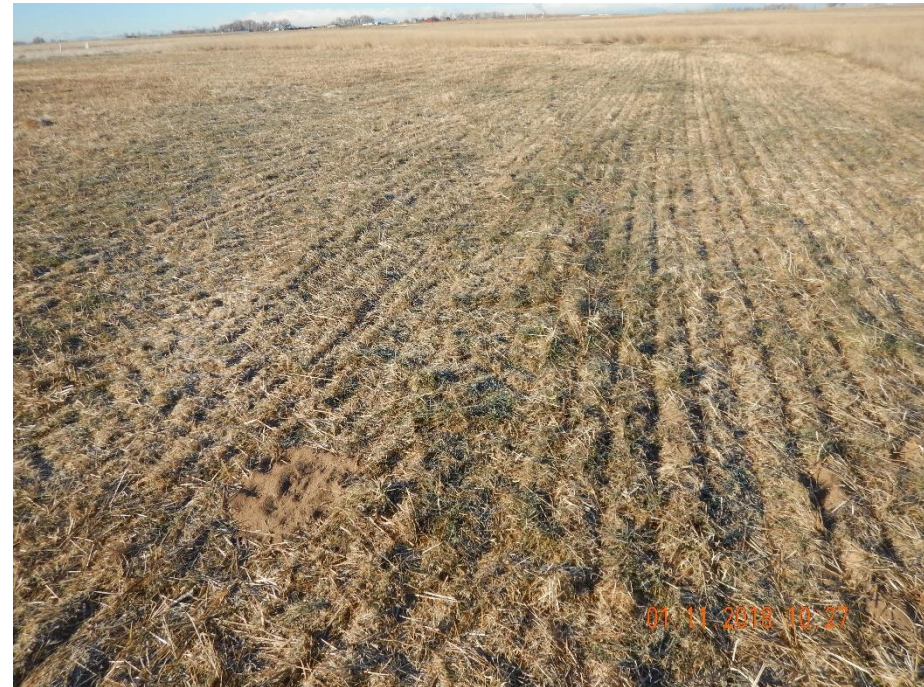
Photo 4: Photo taken from the northeast corner of the well location, facing west. Photo shows reclamation in-process.

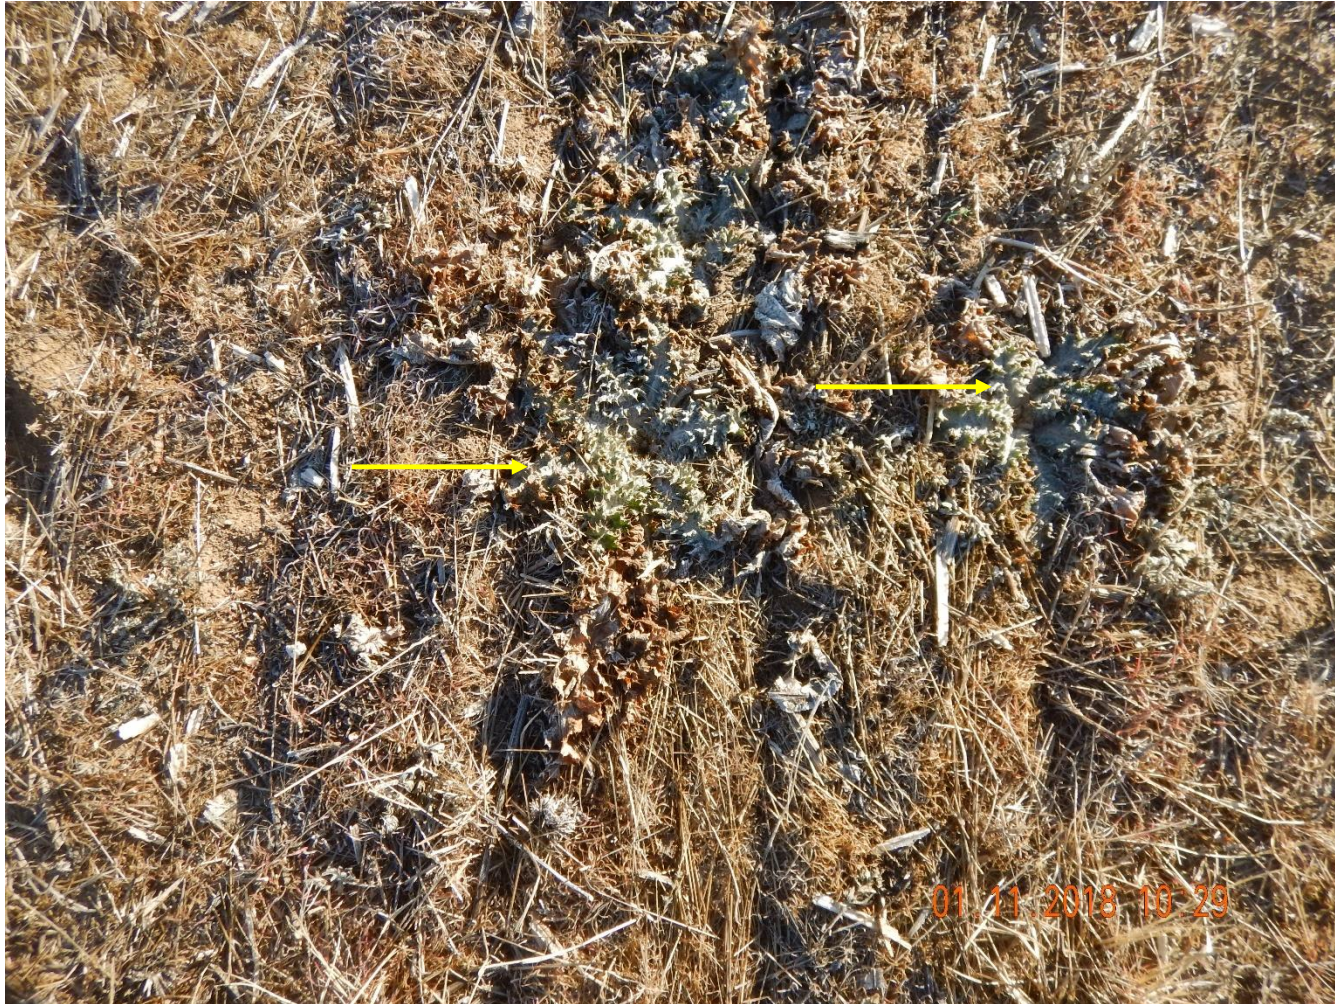
Photo 5: Photo taken from the access road. Previous inspections documented Scotch thistle present on well/battery locations and access road. This is a Colorado State listed noxious weed requiring management. Operator appears to have performed weed management during reclamation. However, thistle rosettes from new growth post reclamation was found along access road. Weed likely present on both well and battery location. On-going weed management and monitoring will need to be conducted.
