Flowline and Final Reclamation Inspection

Date 7-25-2017

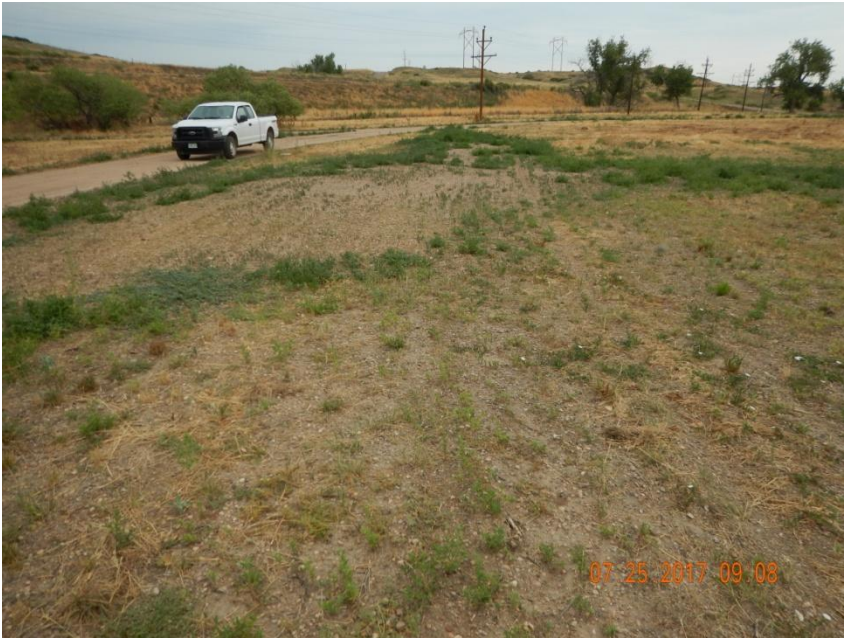
Photo 1. Photo taken from the southern battery location, facing North. Appears gravel has not been removed from location and subsequent reclamation activities per Rule 1004 have not been performed. Weedy, annual vegetation was observed as well as a List C noxious weed, Puncture vine.

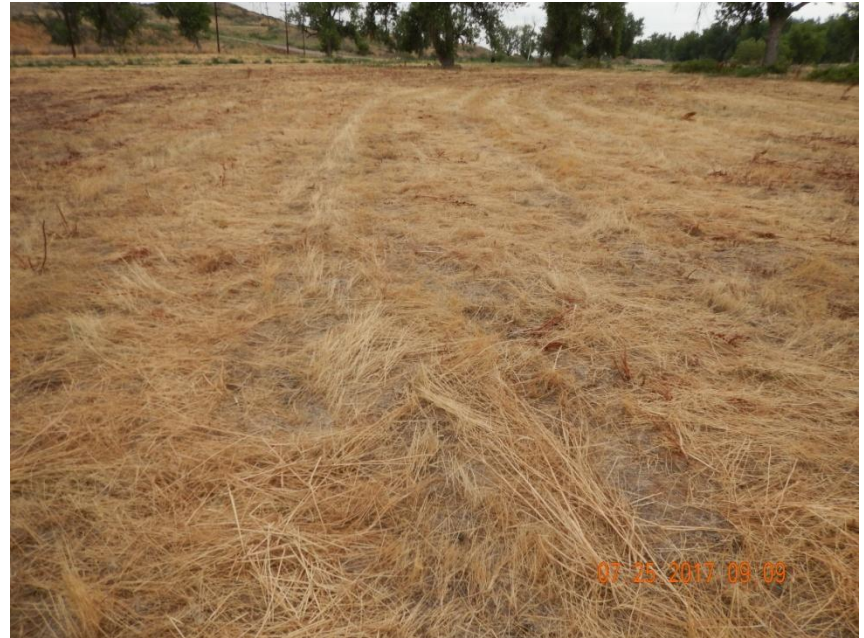
Photo 2. Reference photo taken east of the location, facing North. Battery location is not reflective of reference area vegetative levels.
