# Interim Reclamation and Stormwater Inspection

Operator: BONANZA CREEK ENERGY OPERATING COMPANY LLC - #8960

Location ID: 438730

Inspection Photos  
Location Name: State Pronghorn /V-32 Pad  
Location ID: 438730

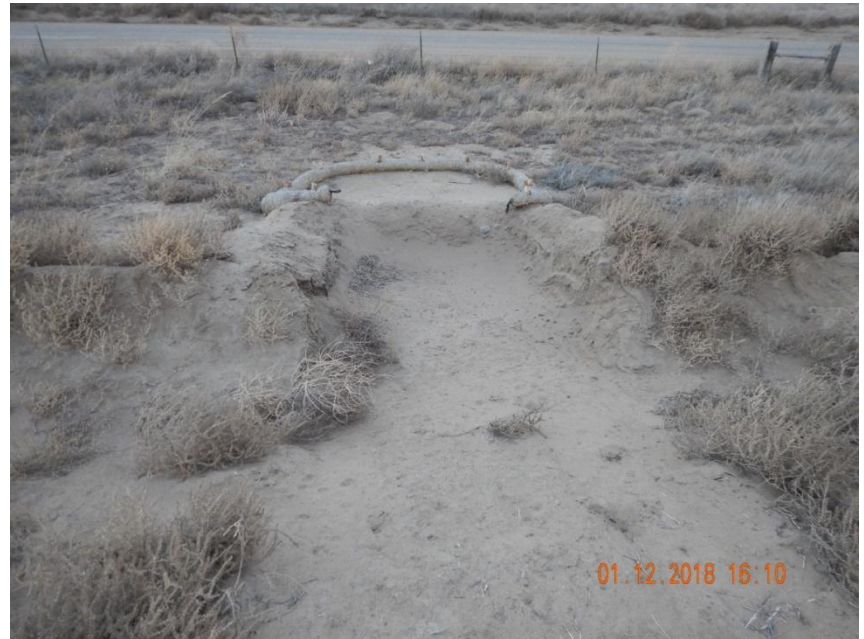
**Photo 2.** Photo taken from the eastern location, facing East. Sediment trap in need of maintenance- sediment accumulation.

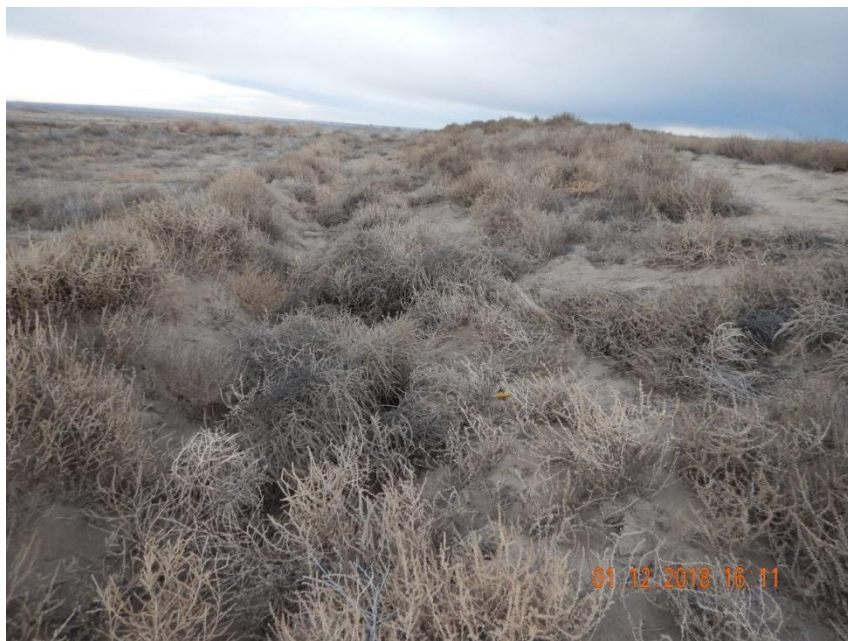
**Photo 3.** Photo taken from the southeastern location, facing South. Photo indicates unmanaged weed debris.

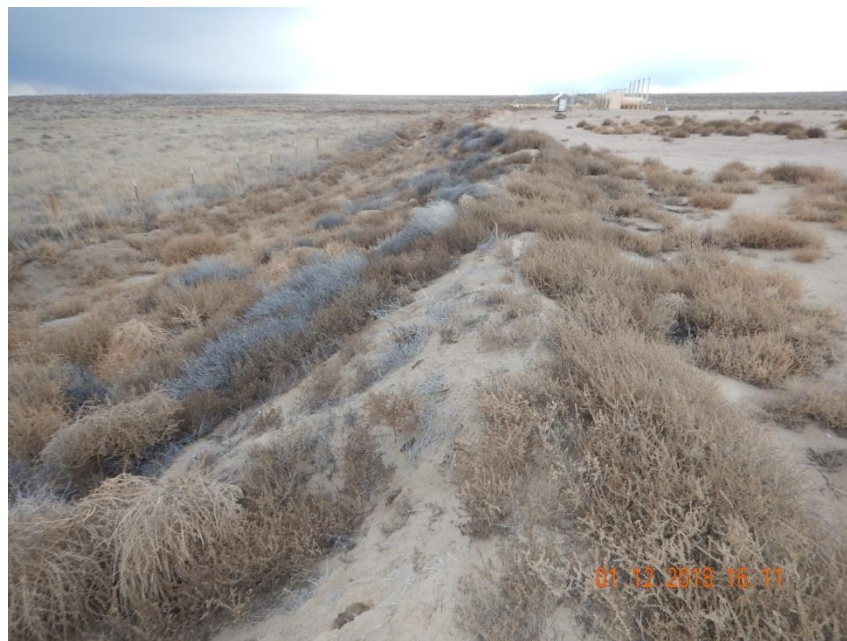
**Photo 4.** Photo taken from the southeastern location, facing West. See comments under Photo 3.

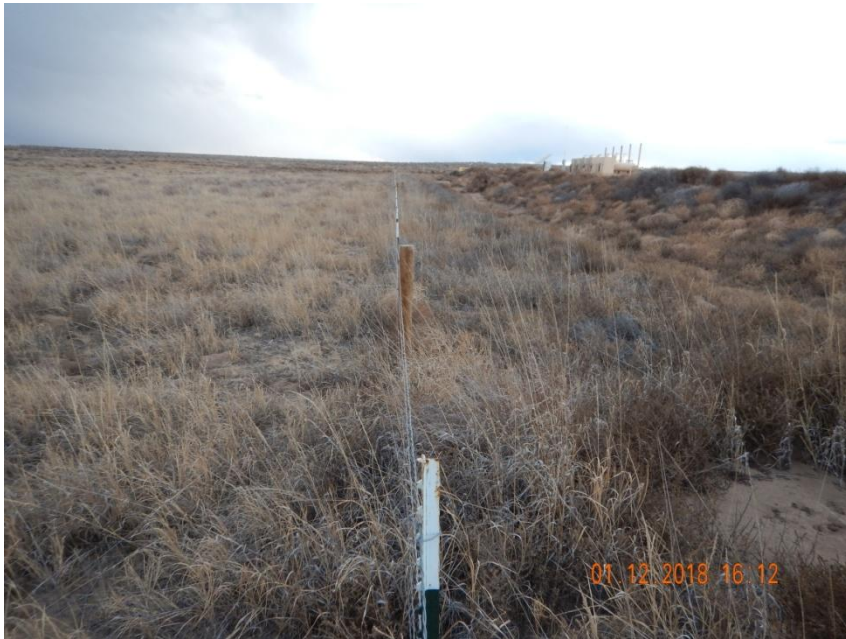
**Photo 5.** Photo taken from the southeastern perimeter of location, facing West. Interim areas are not reflective of reference area vegetative levels.

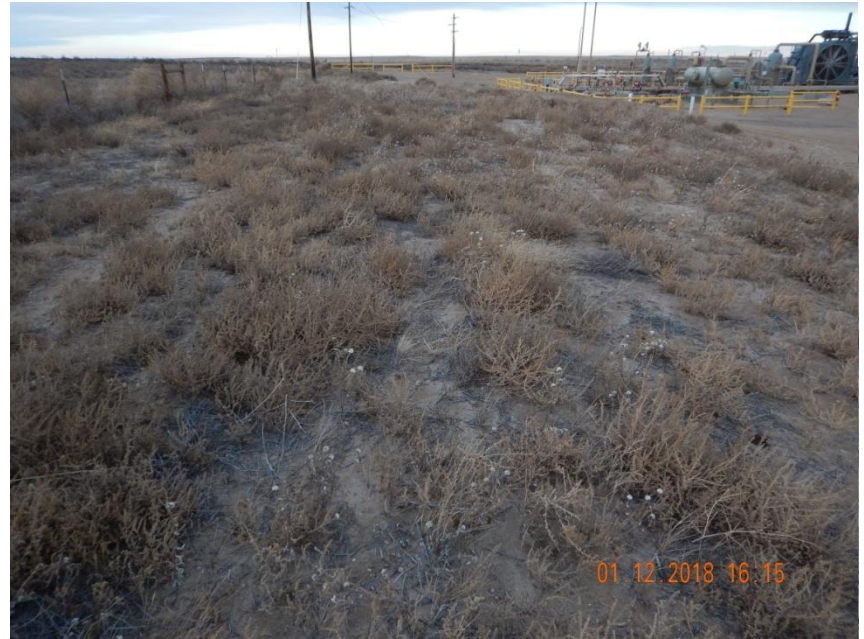
**Photo 6.** Photo taken from the western location, facing North. See comments under Photo 3.
