Final Reclamation Inspection

Operator: FOUNDATION ENERGY MANAGEMENT LLC- #10112

Location ID: 327492 (well location and access road)

Inspection Photos
Location Name: ANDREWS #9-7
Location ID: 327492

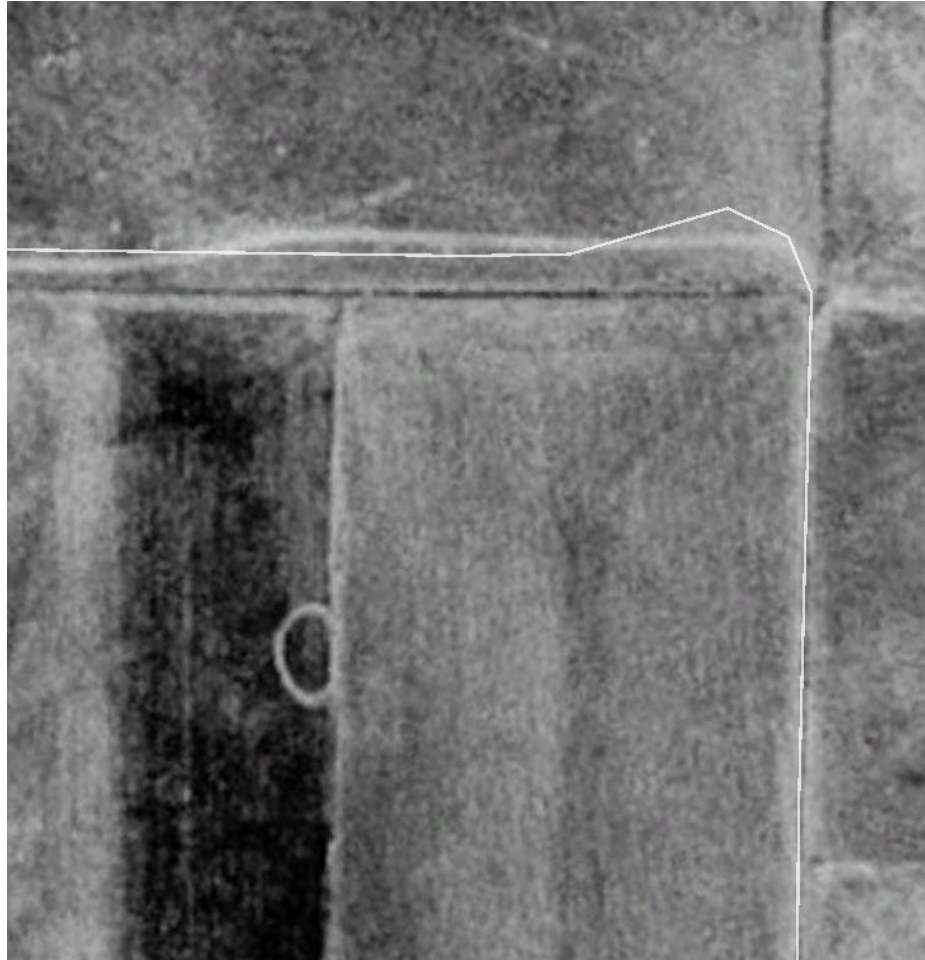
Google Earth aerial imagery taken October 9, 1989 illustrating the access road was pre-existing prior to oil and gas operations.

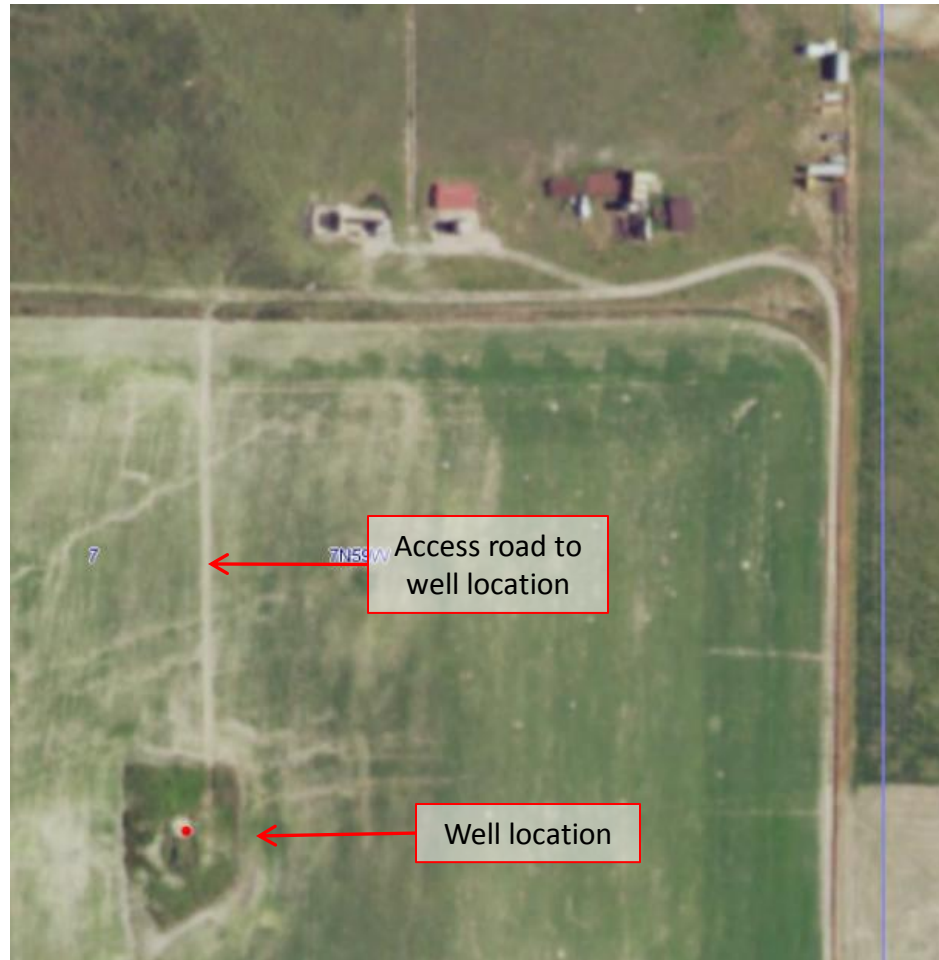
Aerial imagery from COGCC GISOnline database taken in 2015 illustrating the well location and battery location during operations. This is the most recent aerial imagery.

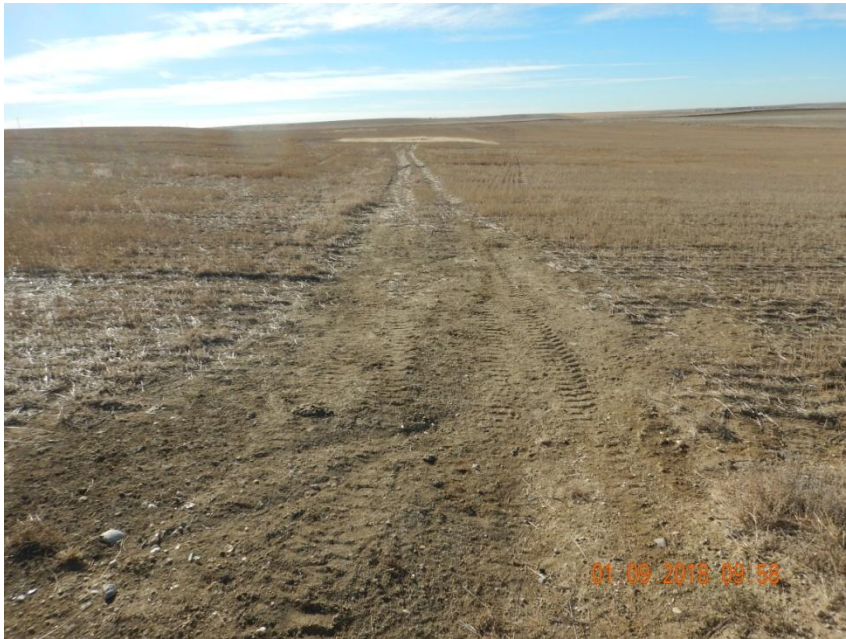
Photo 1. Photo taken from the access road to the well location, facing South. Operator has failed to perform reclamation activities within 3-months of plugging the well on cropland. Access road with gravel remains in place.

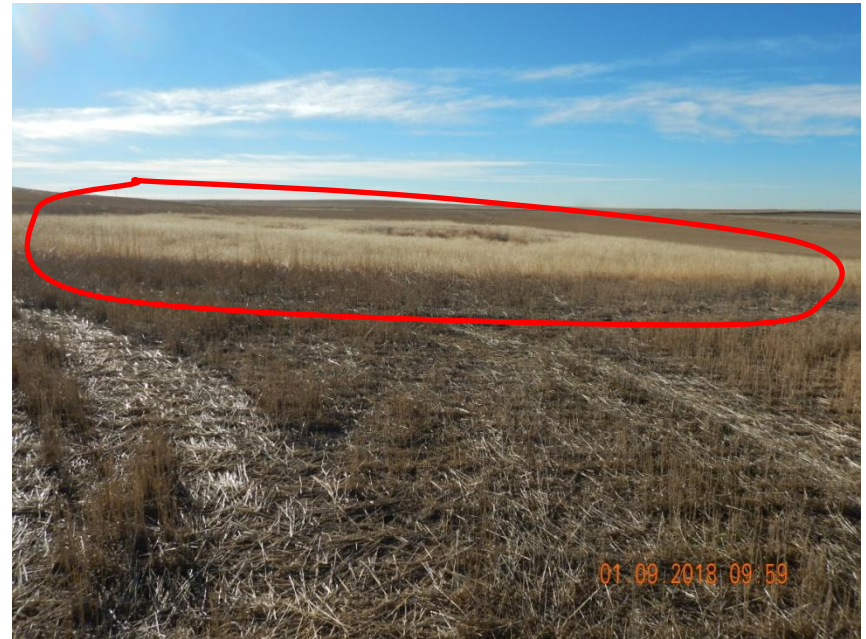
Photo 2. Photo taken north of the well location, facing South. Well location with gravel remains in place.

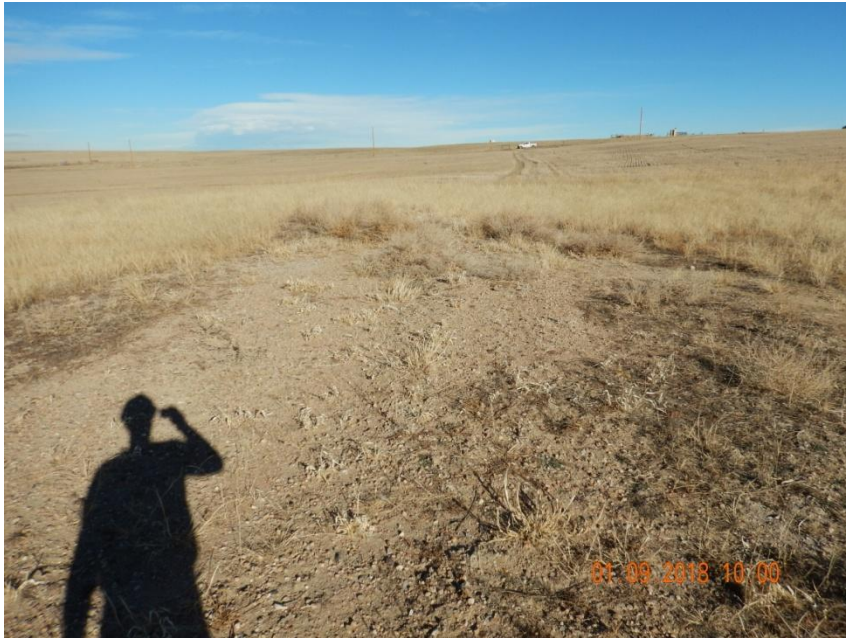
Photo 3. Photo taken from the well location, facing North. See comments under Photo 2.

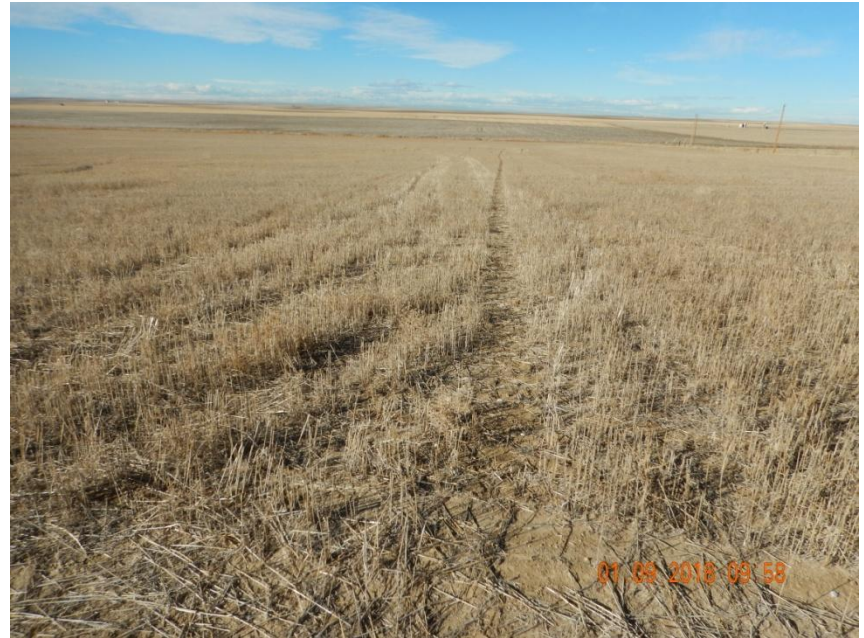
Photo 4. Reference cropland photo taken north of the well location, facing West.
