Final Reclamation Inspection

Operator: FOUNDATION ENERGY MANAGEMENT LLC- #10112

Location ID: 327492 (Tank battery location)

Inspection Photos
Location Name: Andrews Tank Battery
Location ID: 327492

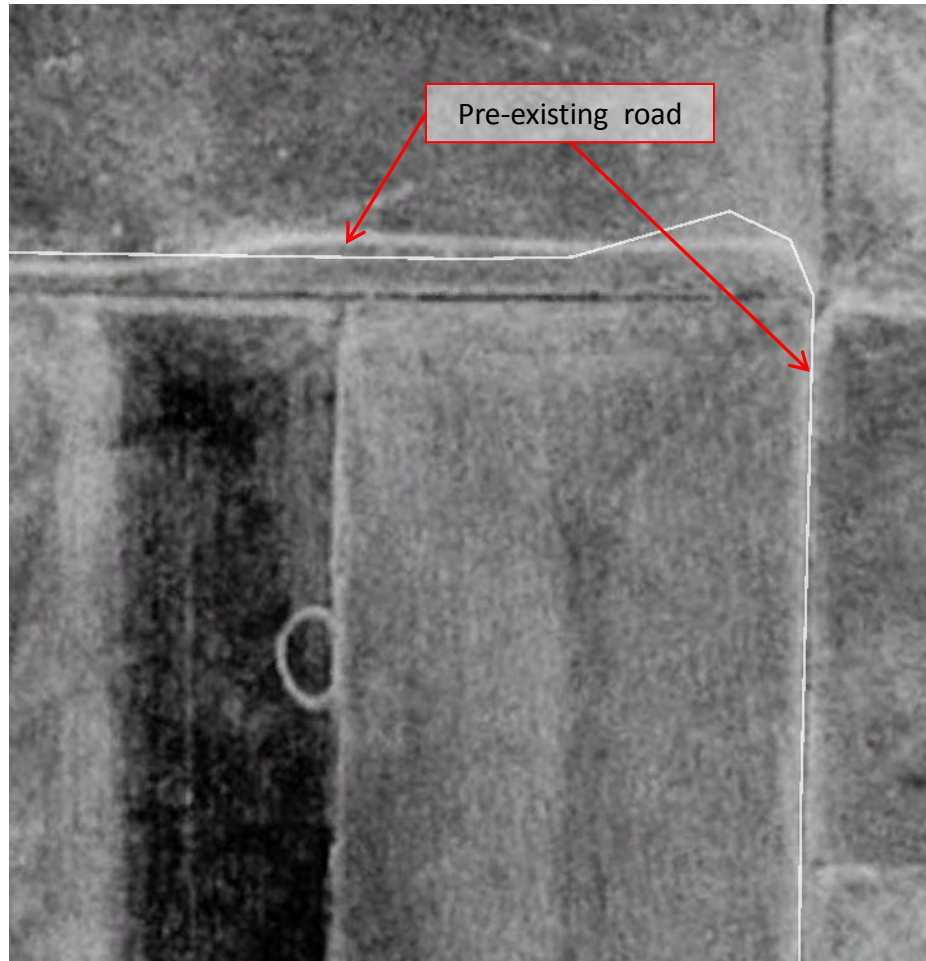
Google Earth aerial imagery taken October 9, 1989 illustrating the access road was pre-existing prior to oil and gas operations.

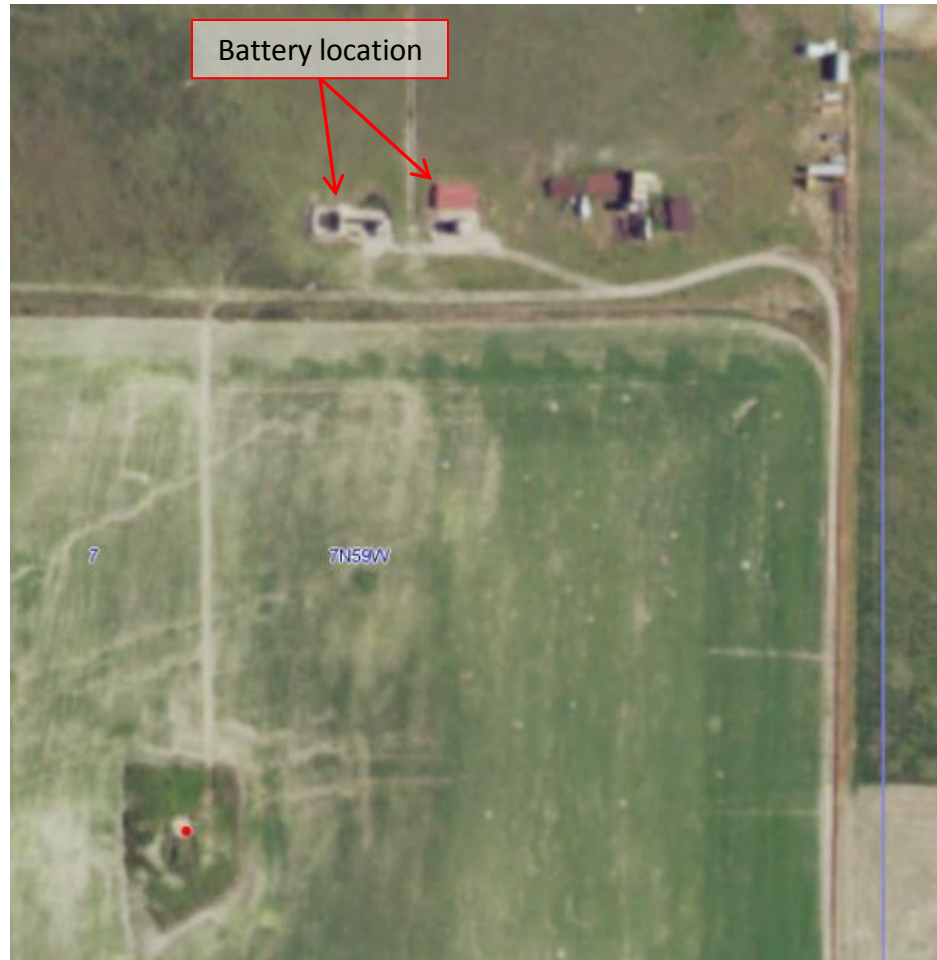
Aerial imagery from COGCC GISOnline database taken in 2015 illustrating the well location and battery location during operations. This is the most recent aerial imagery.

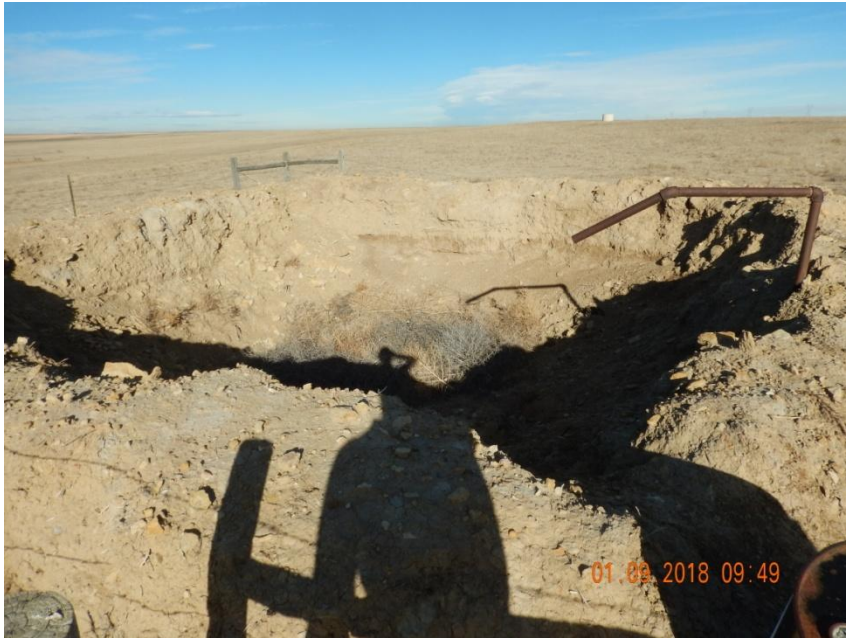
Photo 1. Photo taken from the pit at the battery location, facing North. Operator has failed to backfill pit per Rule 1004. Operator has failed to comply with Rule 902.d.

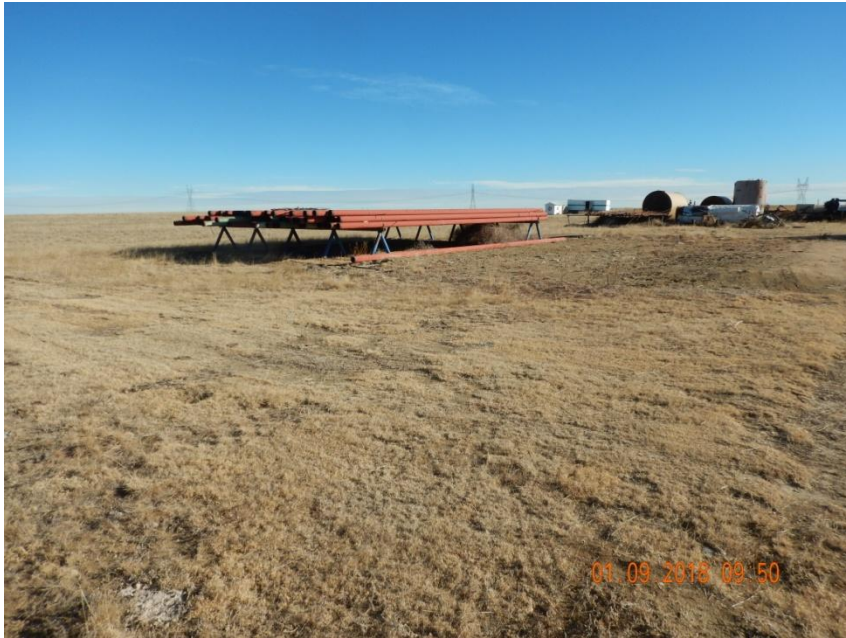
Photo 3. Photo taken from battery location, facing East. Operator has failed to remove unused equipment.

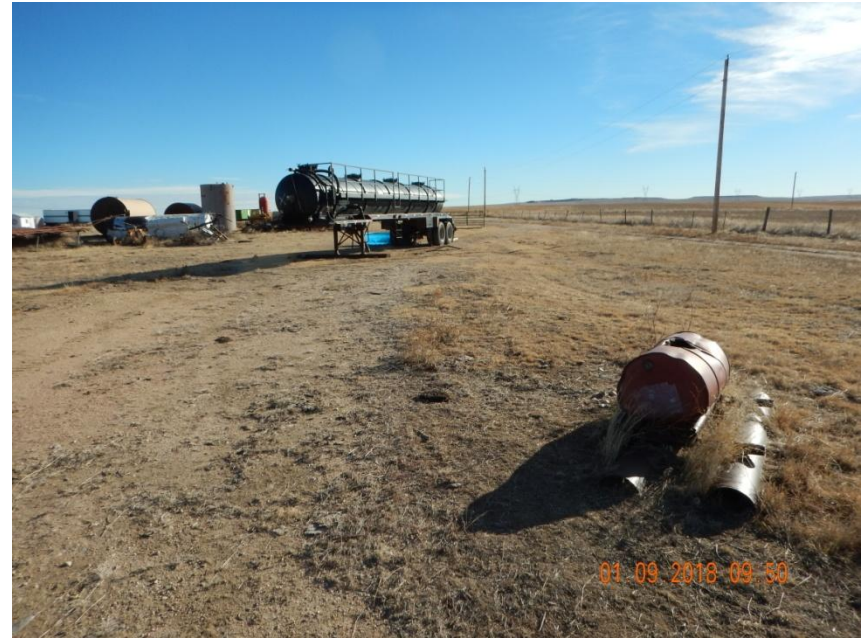
Photo 4. Photo taken from battery location, facing East. See comments under Photo 3.

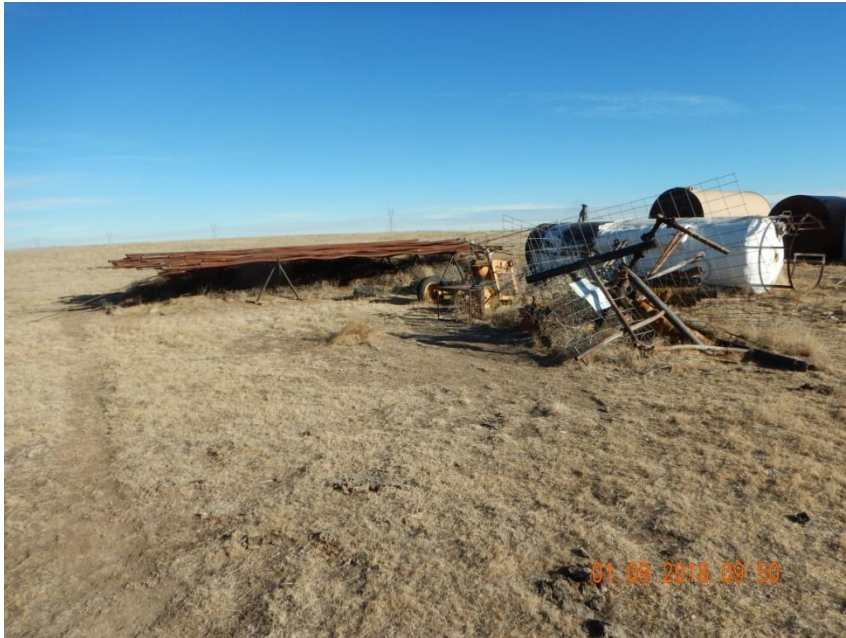
Photo 5. Photo taken from battery location, facing East.
See comments under Photo 3.

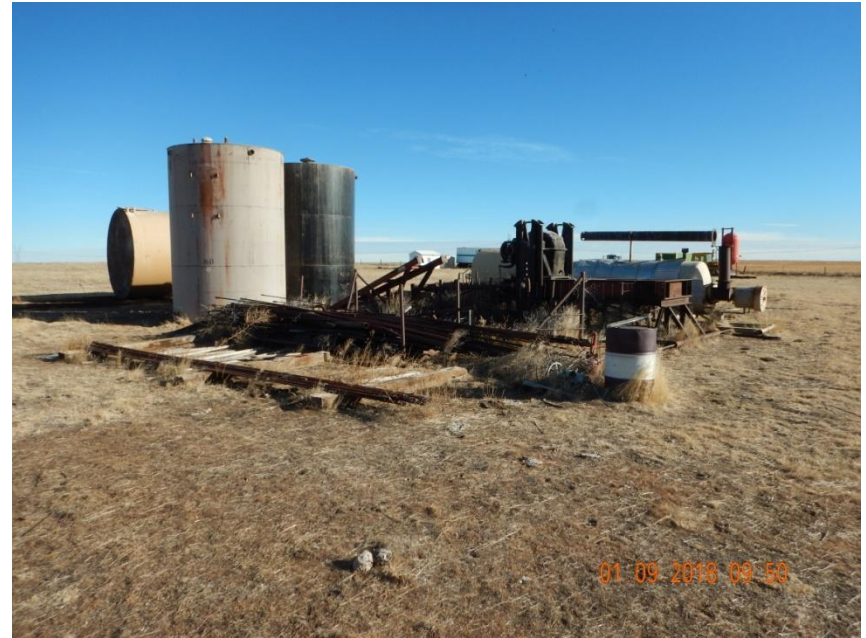
Photo 6. Photo taken from battery location, facing East.
See comments under Photo 3.
