# Interim Reclamation Inspection

Operator: BAYSWATER EXPLORATION & PRODUCTION LLC- #10261

Location ID: 433400

Inspection Photos  
Location Name: Vair /18I-Pad  
Location ID: 433400

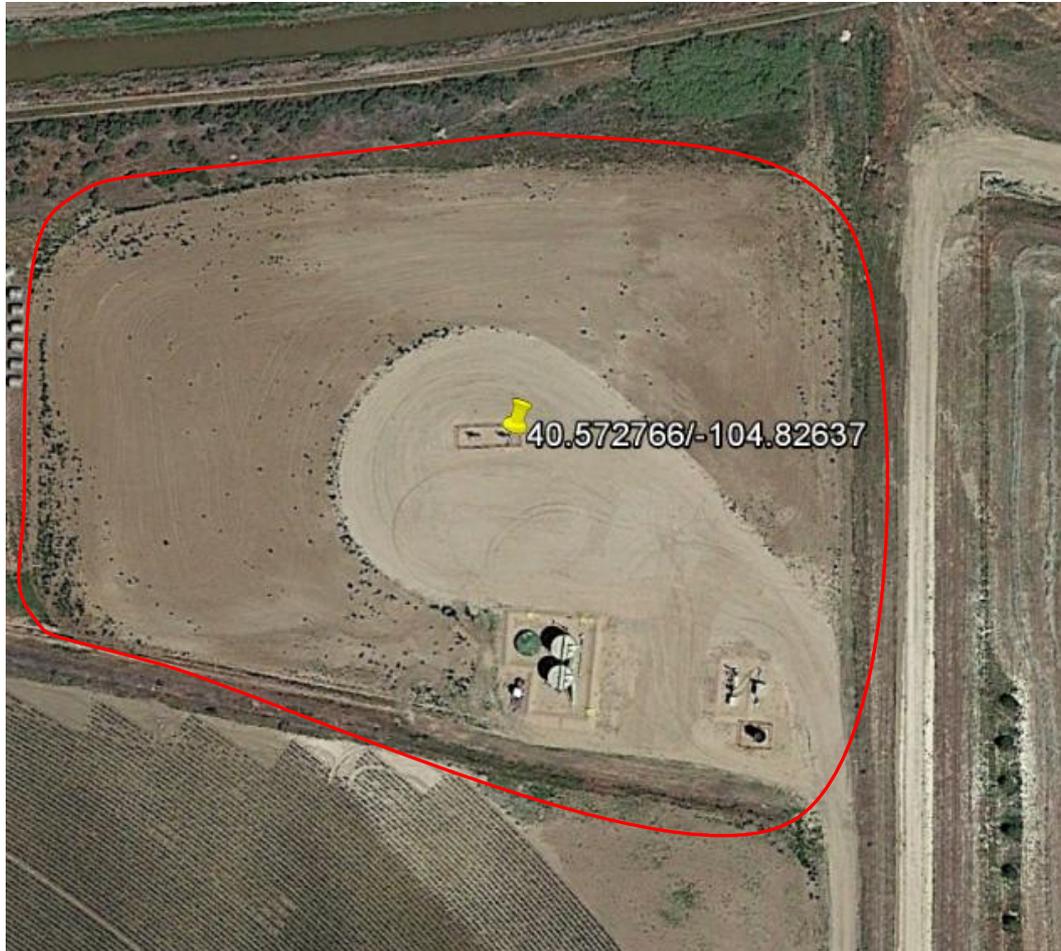
Aerial imagery taken June 19, 2014 post drilling operations of the Vair /18I-Pad. Red-line indicates disturbance area.

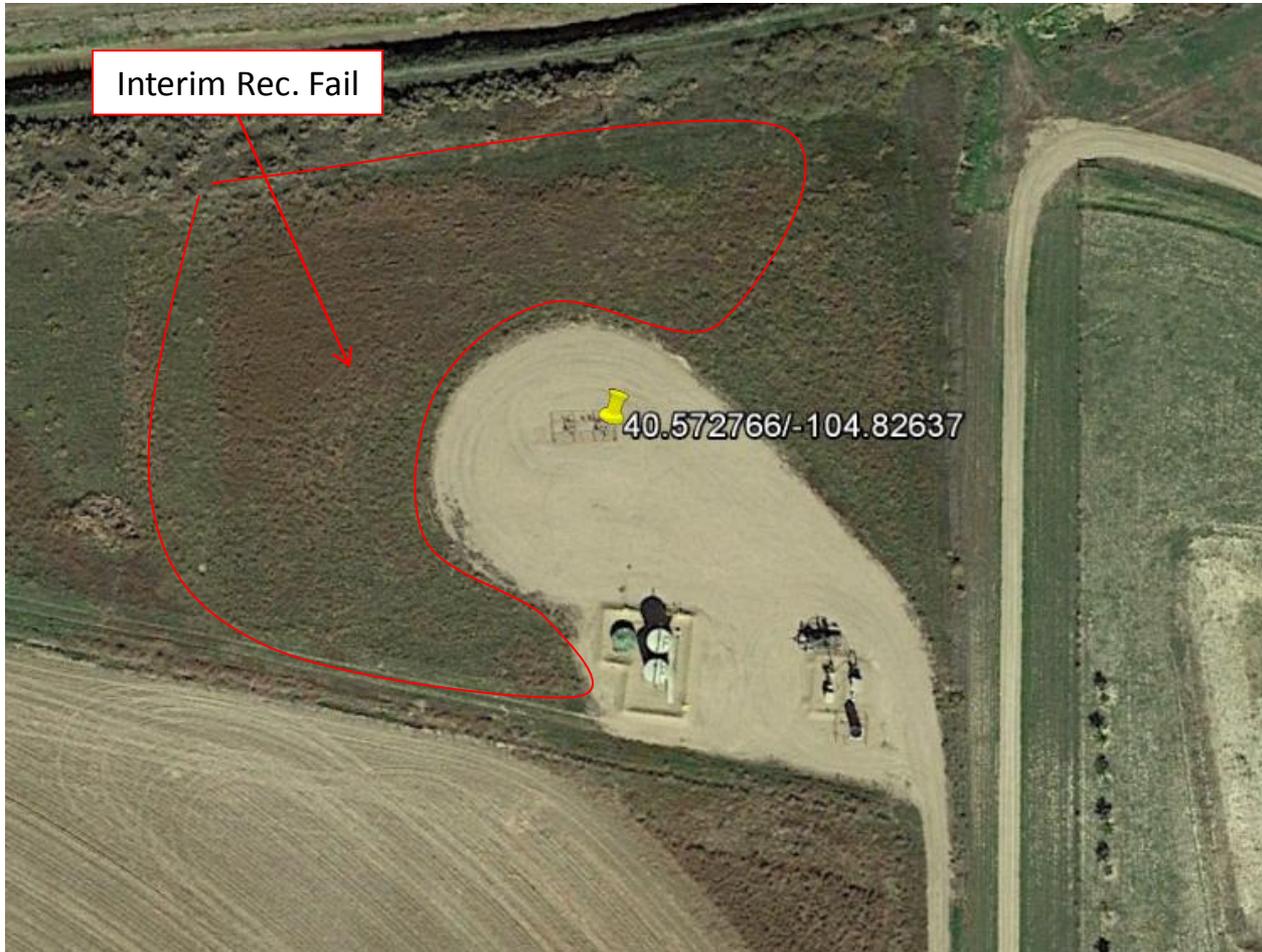
Aerial imagery taken October 14, 2017 post drilling operations of the Vair /18I-Pad. Portions of the northern and western interim do not meet Rule 1003 standards, as weedy, annual vegetation (Kochia) dominates the area. It appears portions of the northeastern and eastern interim areas would meet Rule 1003 standards- see the following photos for more detail.

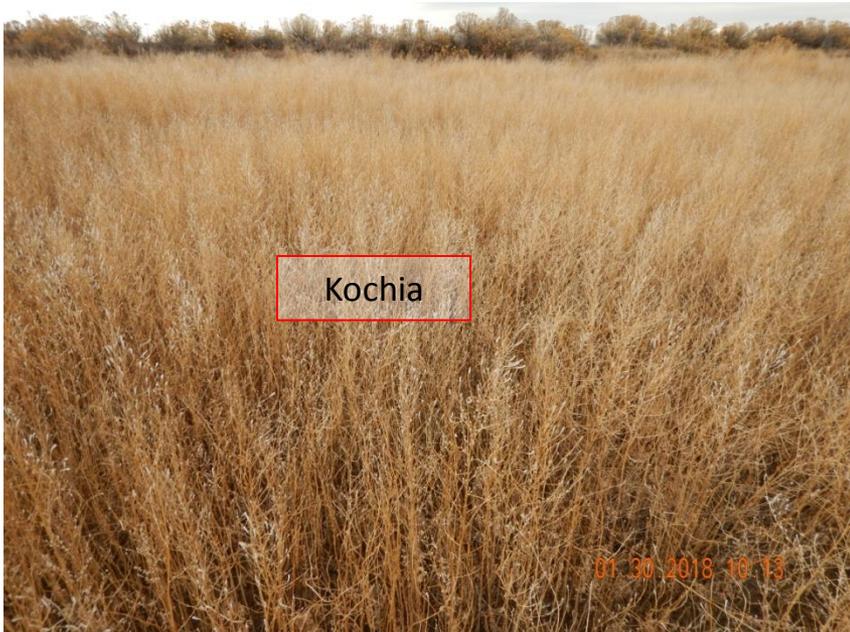
**Photo 1.** Photo taken from the western interim area, facing North. This area does not meet Rule 1003 standards, as weedy, annual vegetation (Kochia) dominates the area which is not reflective of reference area vegetative levels.

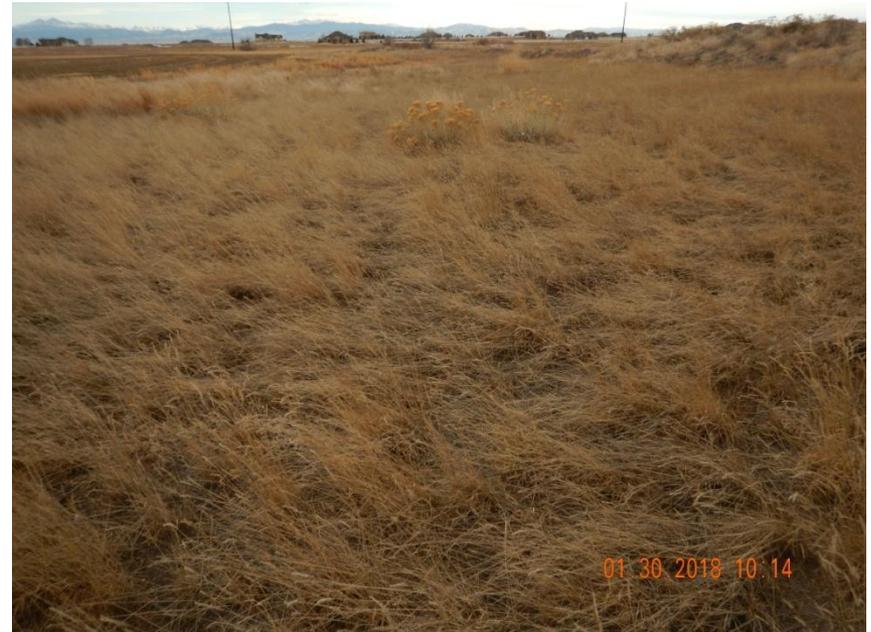
**Photo 2.** Reference photo taken just west of the western interim area, facing West. Reference area vegetation consist mostly of Crested wheatgrass (*Agropyron cristatum*) and Rabbitbrush.

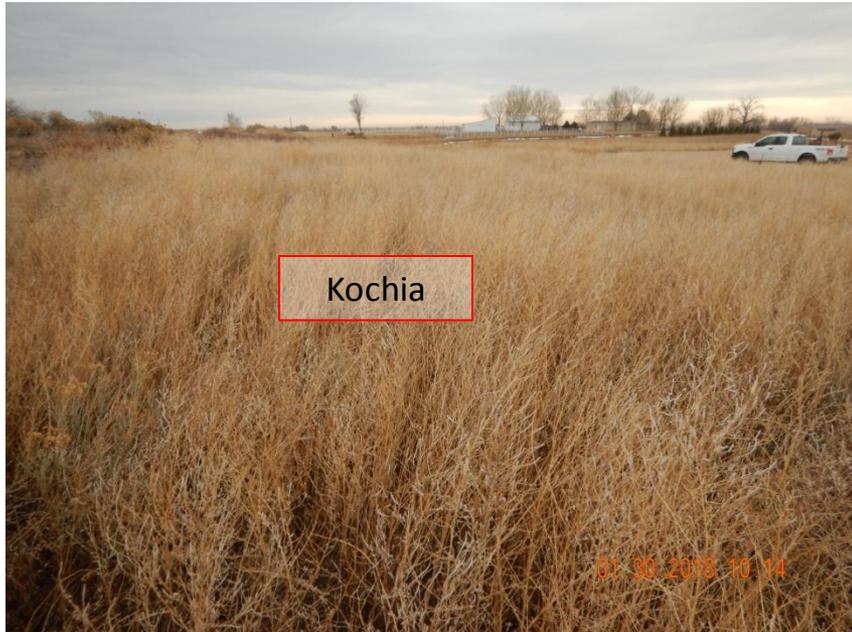
**Photo 3.** Photo taken from the northwestern interim area, facing East. See comments under Photo 1.

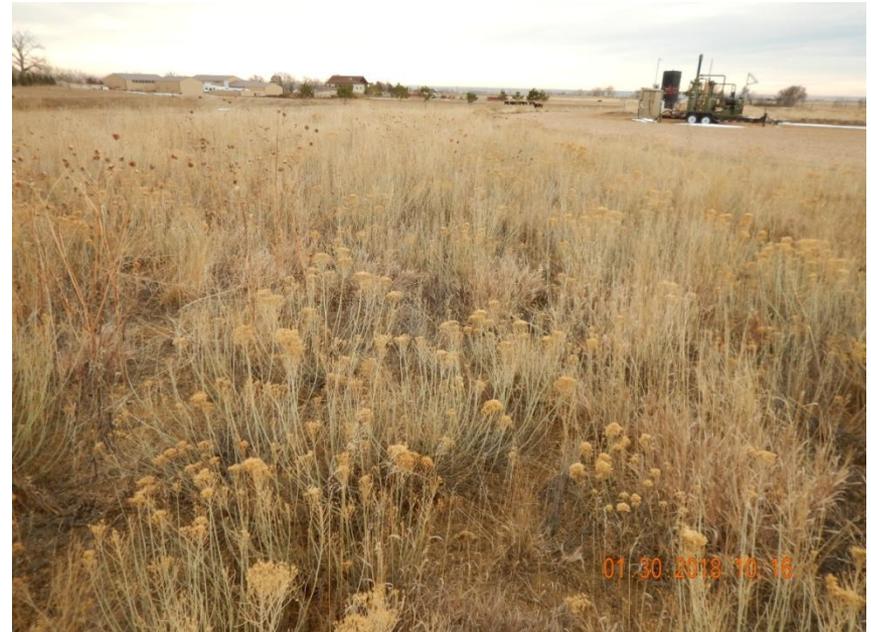
**Photo 4.** Photo taken from the eastern interim area, facing South. This area appears to meet Rule 1003 standards. Rabbitbrush appears to be at a higher density than Crested wheatgrass but Kochia did not appear to have a significant establishment.

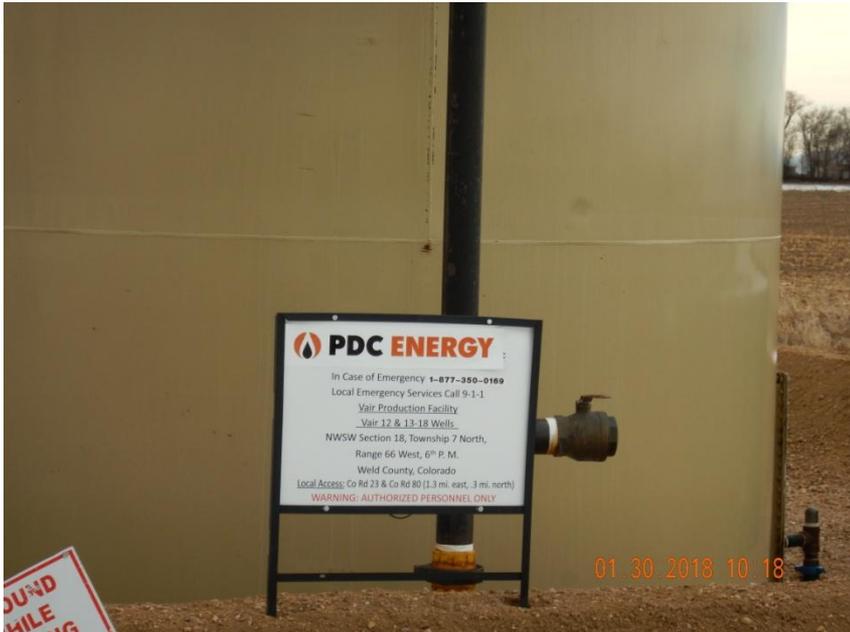
**Photo 5.** Photo taken of the tank battery sign at location. PDC has just acquired this location on January 8, 2018.

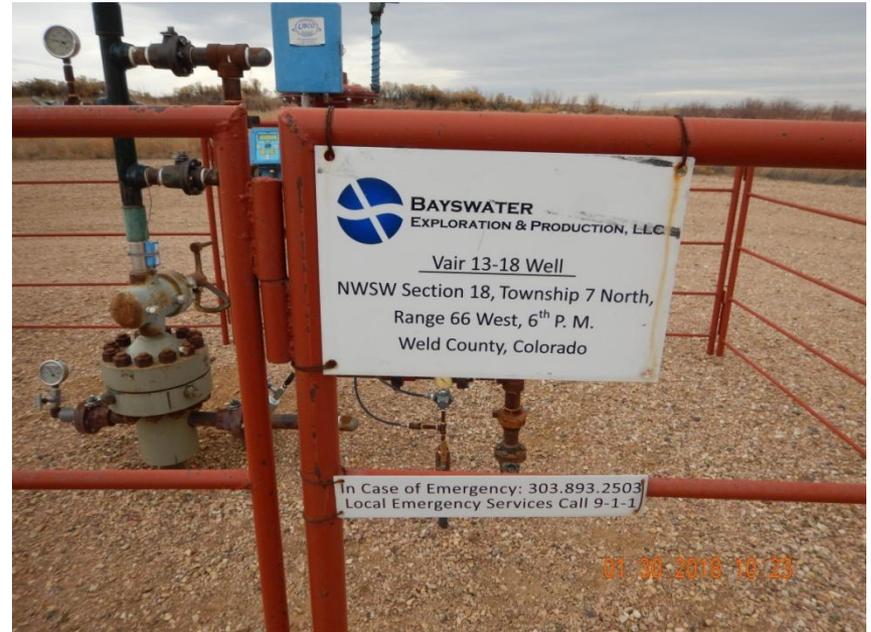
**Photo 6.** Photo taken of the well head sign at location. The previous Operator sign is not reflective of the current Operator. PDC shall comply with Rule 210.b.
