# Inspection Photos

Operator: VISTA OPERATING INC - 100128

Location ID: 317407

Inspection Doc. Number: 682503116

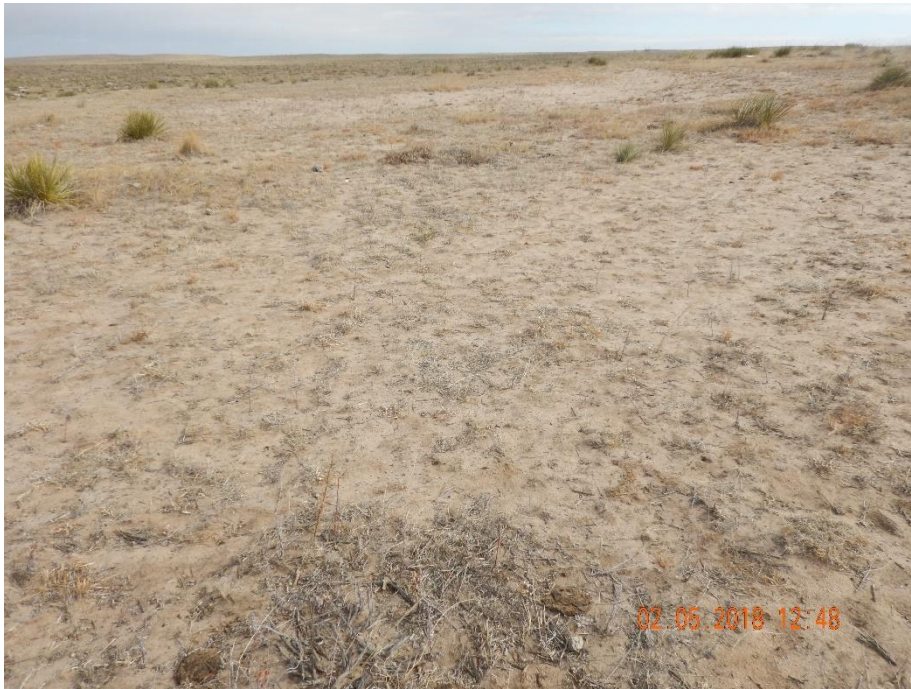
**Photo 1:** Photo taken from the west end of the location, facing east. Photo shows location remains predominantly bare and exposed soil. Unable to find evidence that additional reclamation activities have been conducted.

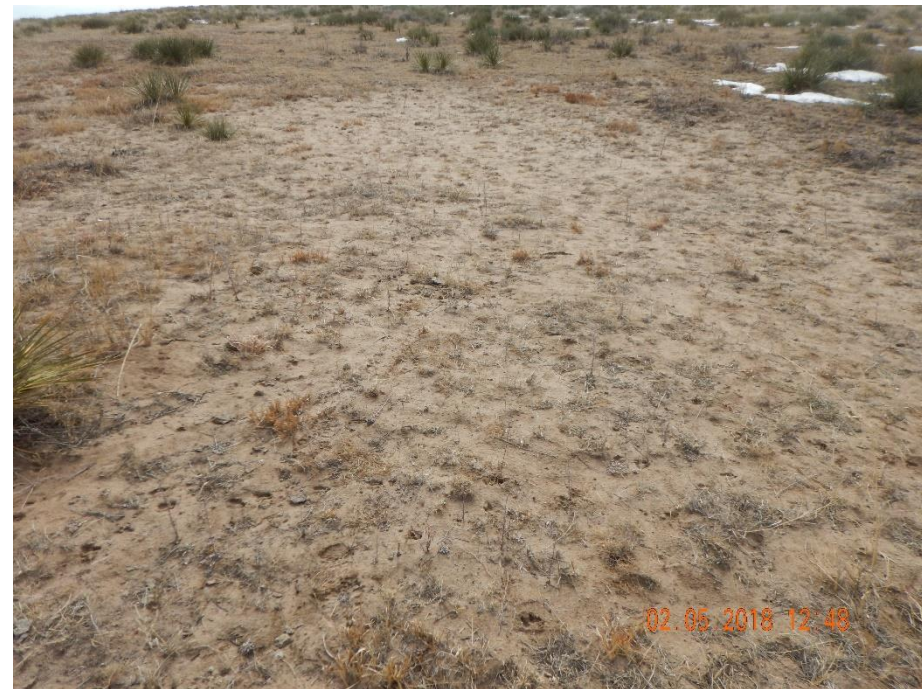
**Photo 2:** taken from the west end of the location, facing north. Photo shows location remains predominantly bare and exposed soil. Unable to find evidence that additional reclamation activities have been conducted.

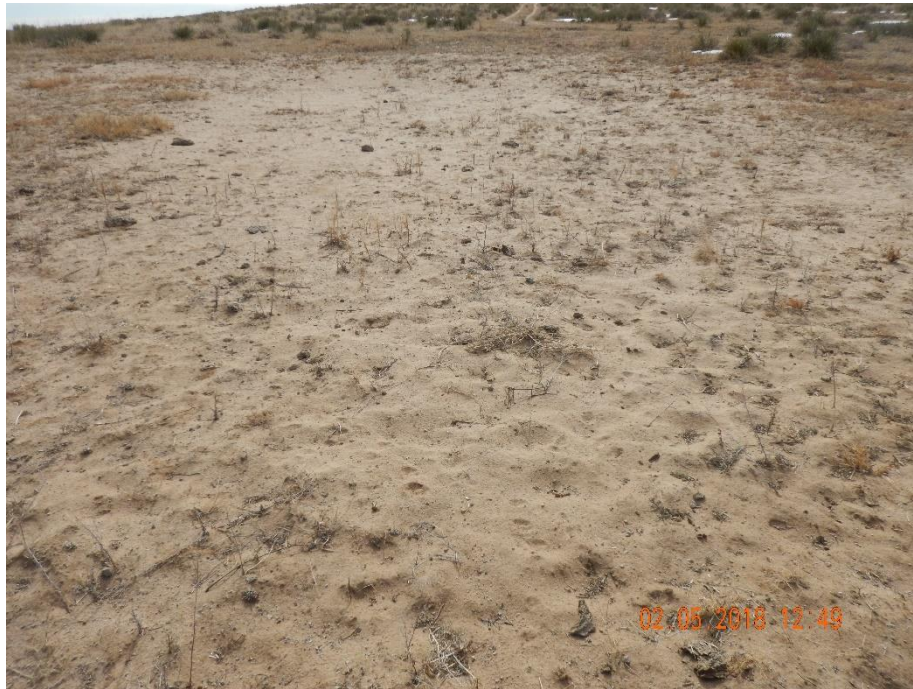
**Photo 3:** taken from the south end of the location, facing north. Photo shows location remains predominantly bare and exposed soil. Unable to find evidence that additional reclamation activities have been conducted.

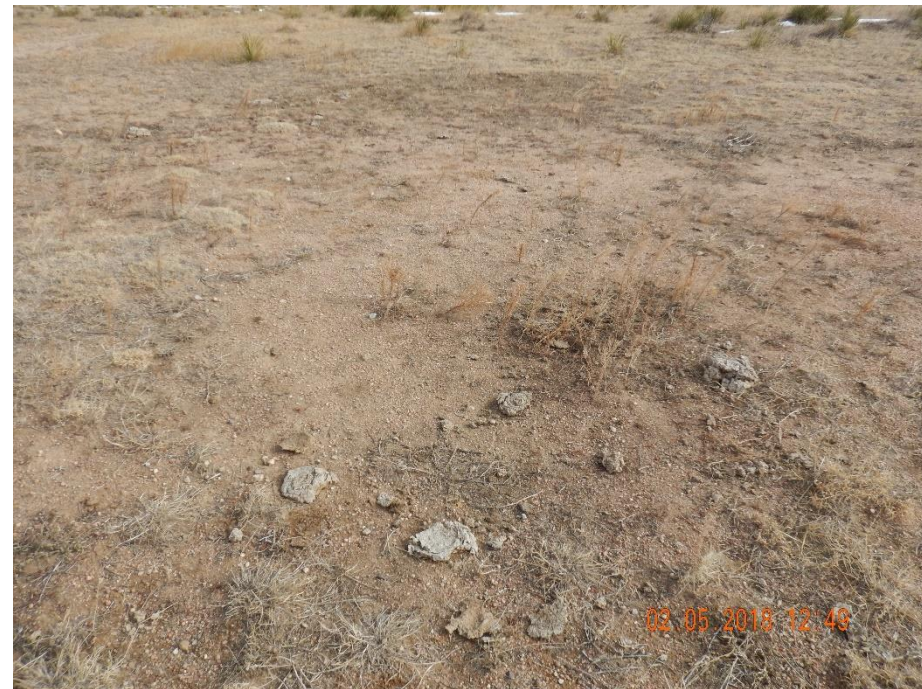
**Photo 4:** Photo taken the north end of the location. Photo shows location remains predominantly bare and exposed soil. Unable to find evidence that additional reclamation activities have been conducted.

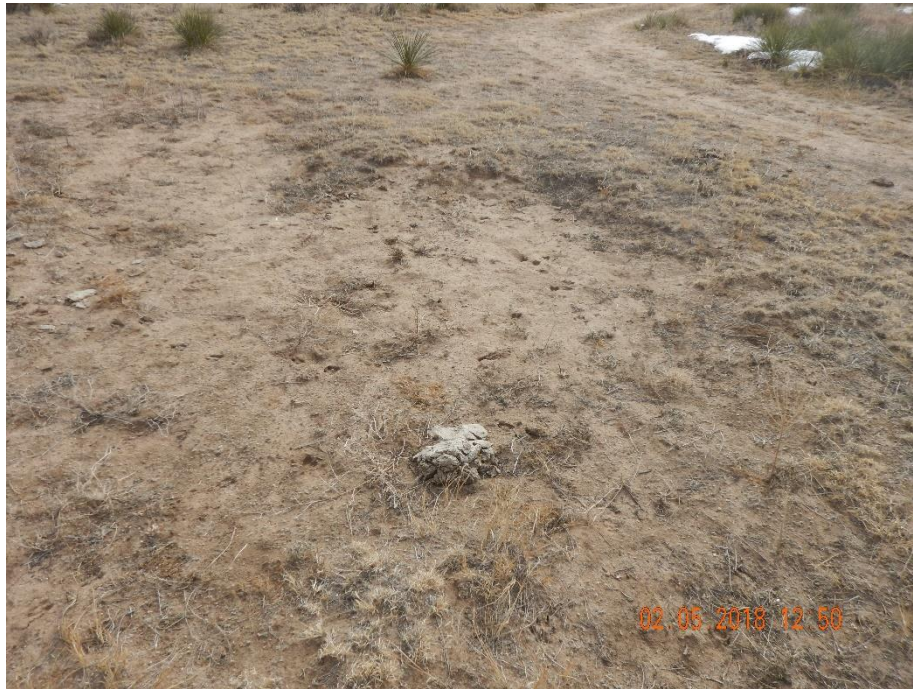
**Photo 5:** Photo taken from the north end of the location, facing north. Photo shows erosion degradation cutting up hill from location.

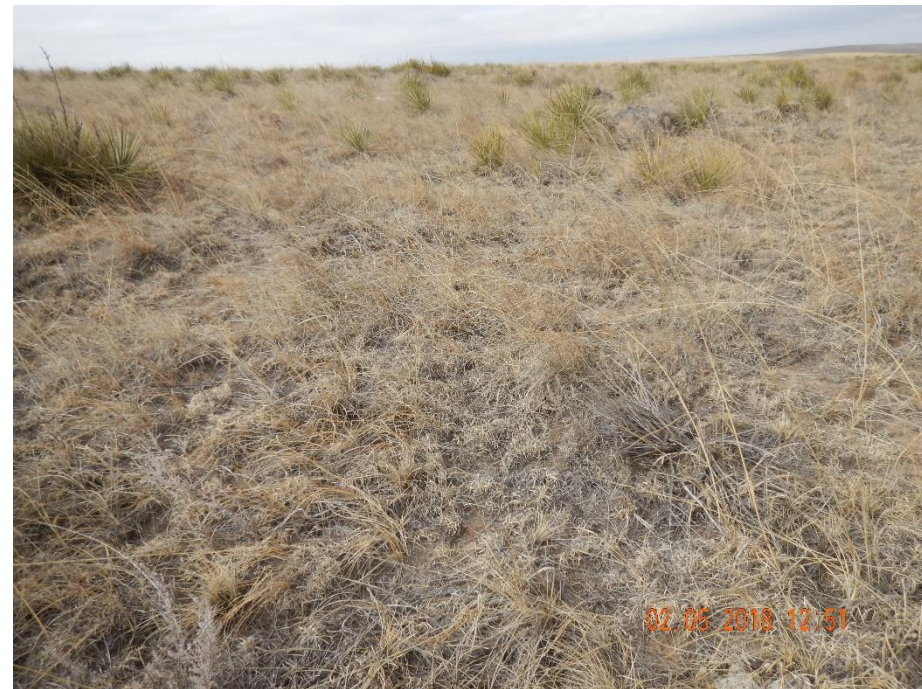
**Photo 6:** Photo taken from the adjacent reference area. Photo shows vegetation to be compared to the disturbance. Vegetation seen is predominantly prairie sandreed, blue grama, buffalo grass, sand dropseed, yucca, etc...
