Inspection Photos

Operator: GRAND MESA OPERATING CO - 35080

Location ID: 453932

Inspection Doc. Number: 682503150

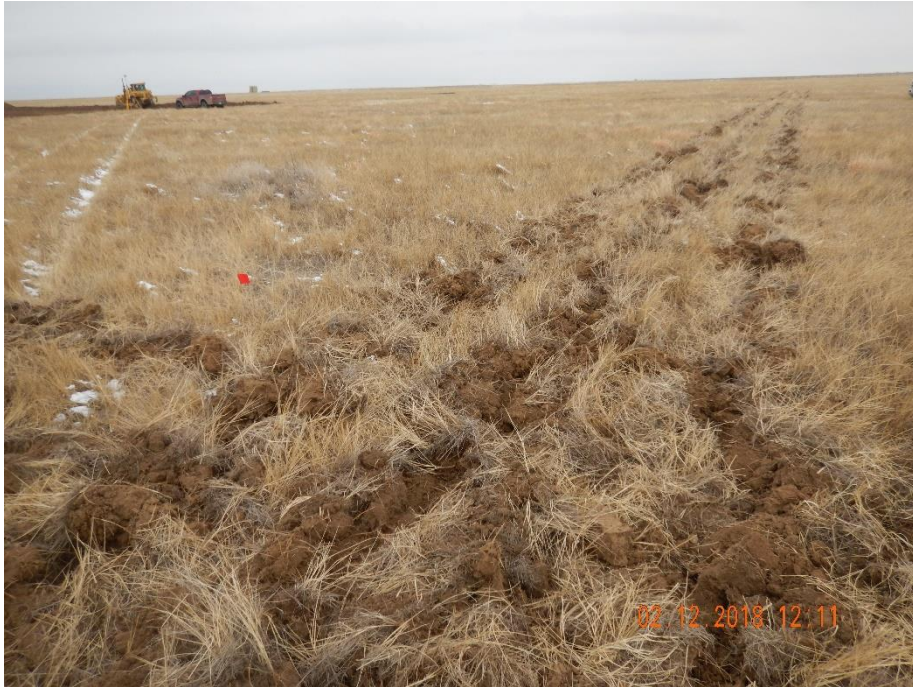
Photo 1: Photos 1-10 show surface roughening stormwater BMP implemented along the perimeter of the location prior to construction activities.

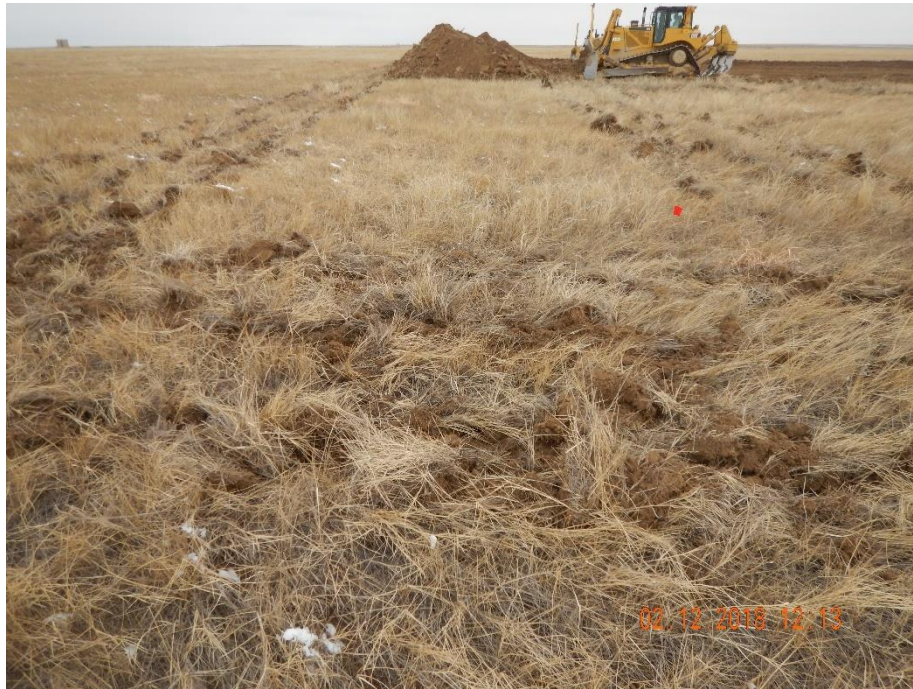
Photo 3: Photo shows operator expanded surface roughening BMPs as needed to better suit the size of the location during construction activities.

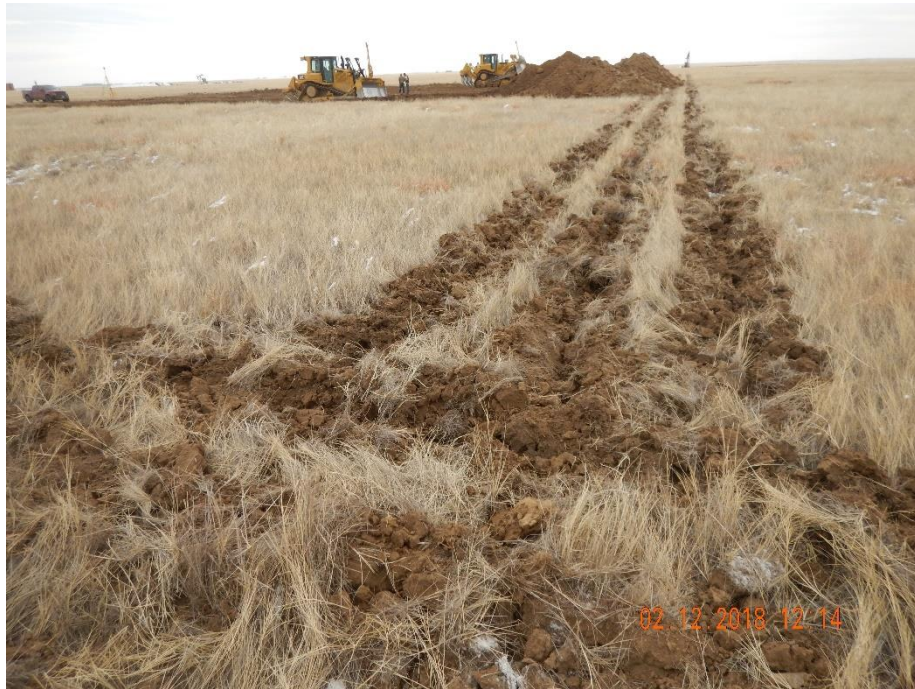
Photo 5: Operator was in the process of salvaging topsoil at time of inspection.

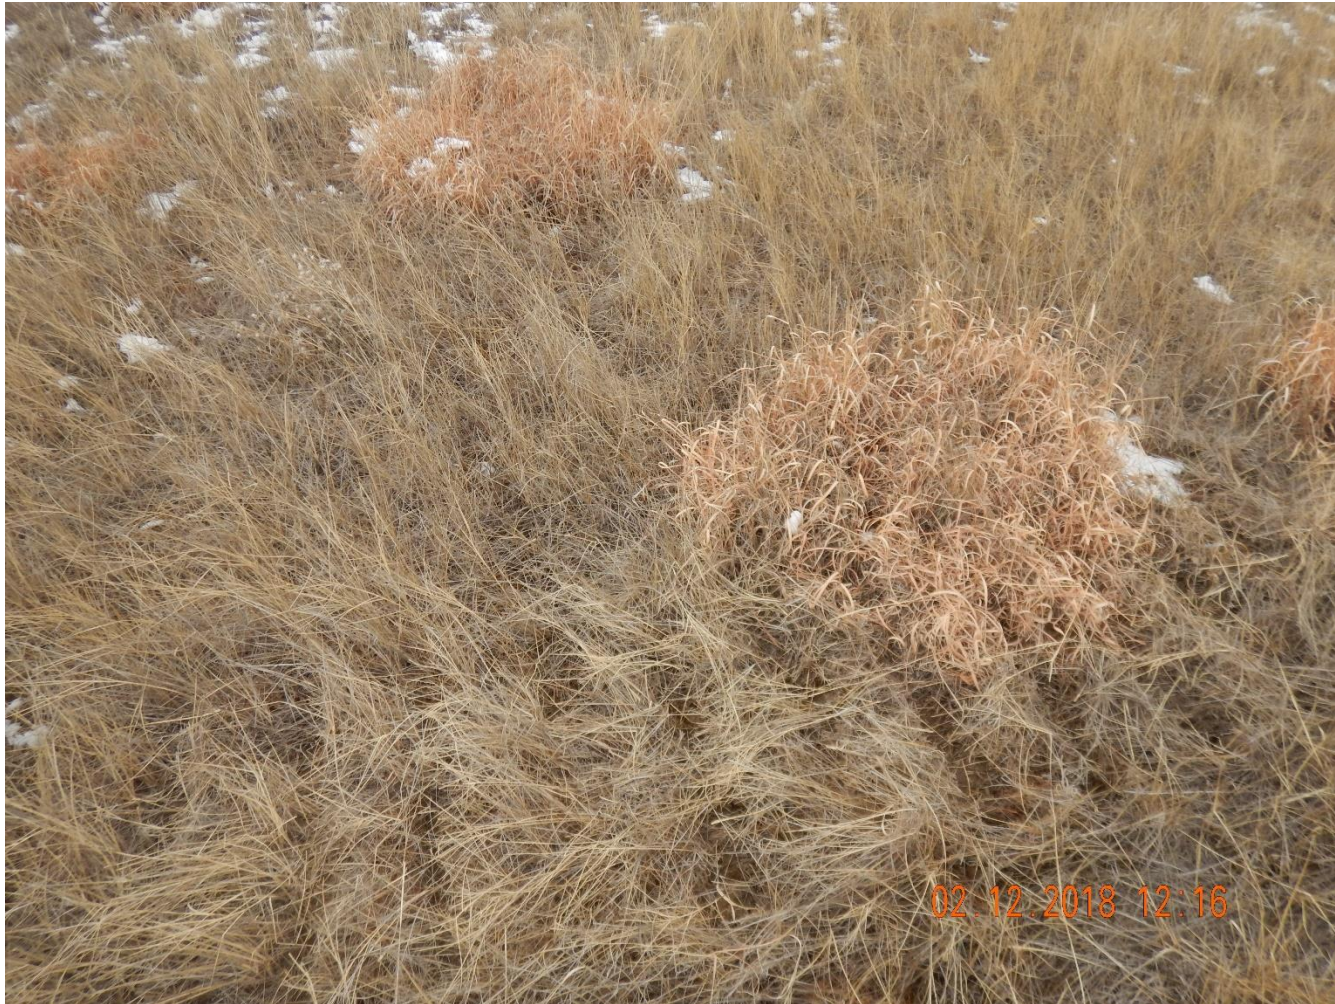
Photo 11: Photo of vegetation on the adjacent reference area. Vegetation observed predominantly Western Wheatgrass, sideoats/blue grama, smooth brome, sand dropsed, threeawn, etc...
