Inspection Photos

Operator: GRAND MESA OPERATING CO - 35080

Location ID: 448313

Inspection Doc. Number: 682503157

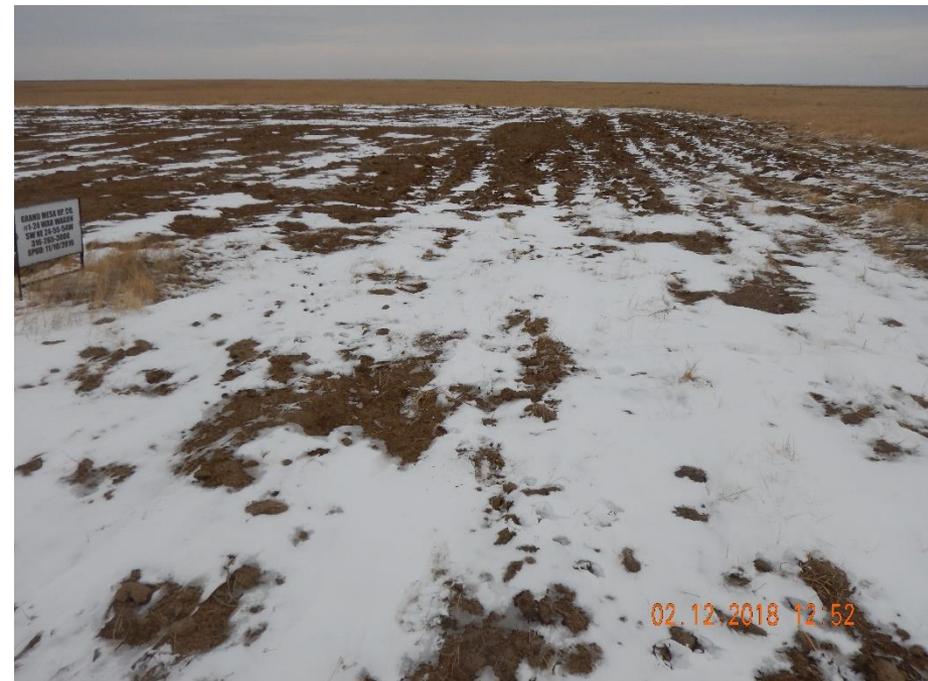
Photo 2: Photo taken from the south end of the location, facing east. Photos 2-5 show an overview of the location from east, north to west. Photos show some reclamation activities appear to have been conducted, however, unable to find evidence that revegetation activities have been conducted in accordance to 1004.

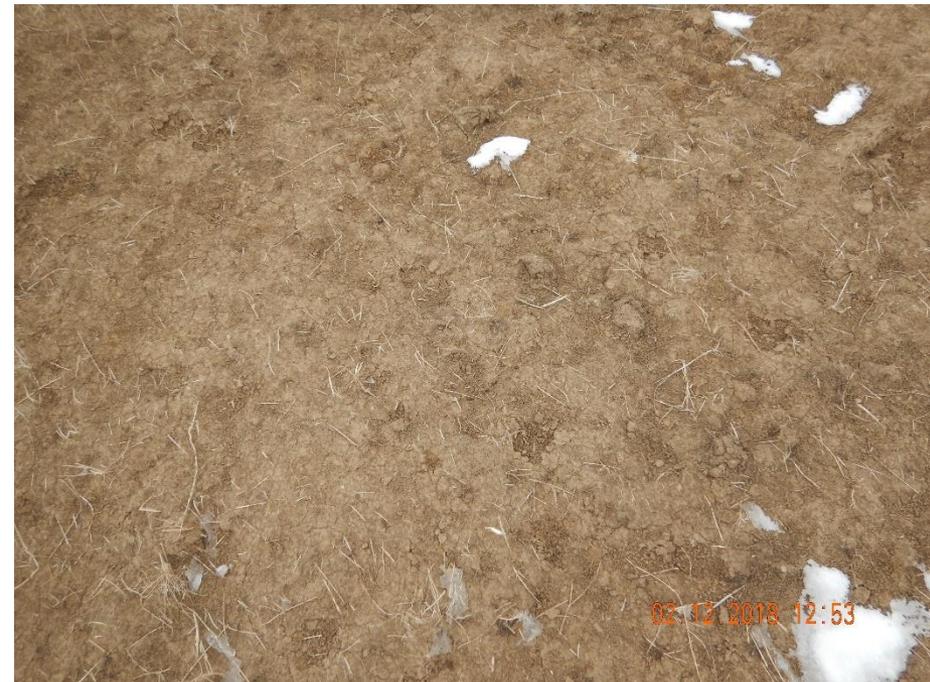
Photo 6: Photo of soils on location. Unable to find evidence that revegetation activities have been conducted in accordance to 1004.

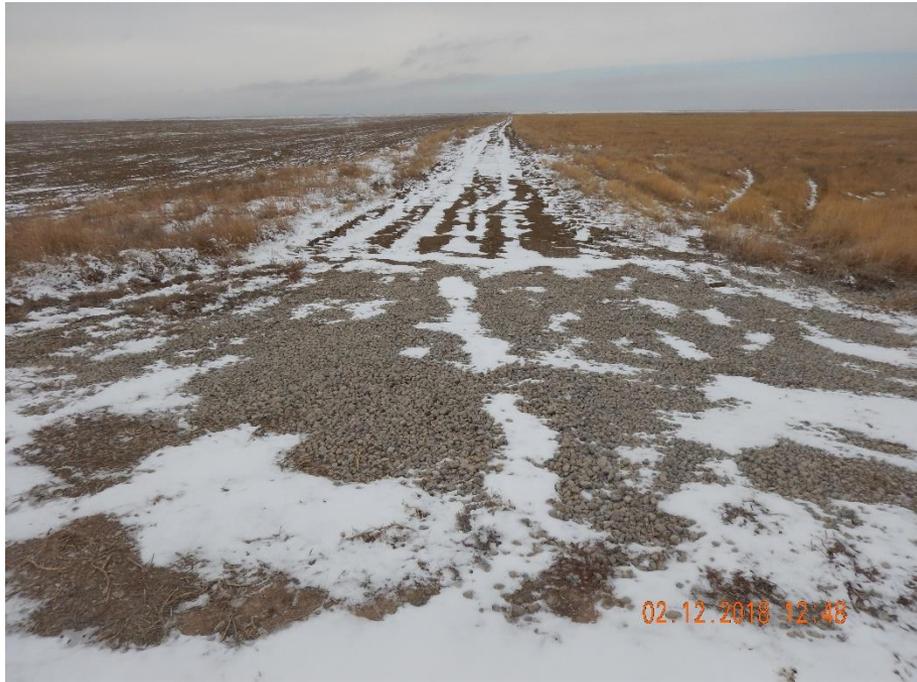
Photo 9: Photo taken from the access road entrance, facing west. Photo show gravel (vehicle tracking BMP) has not been removed.

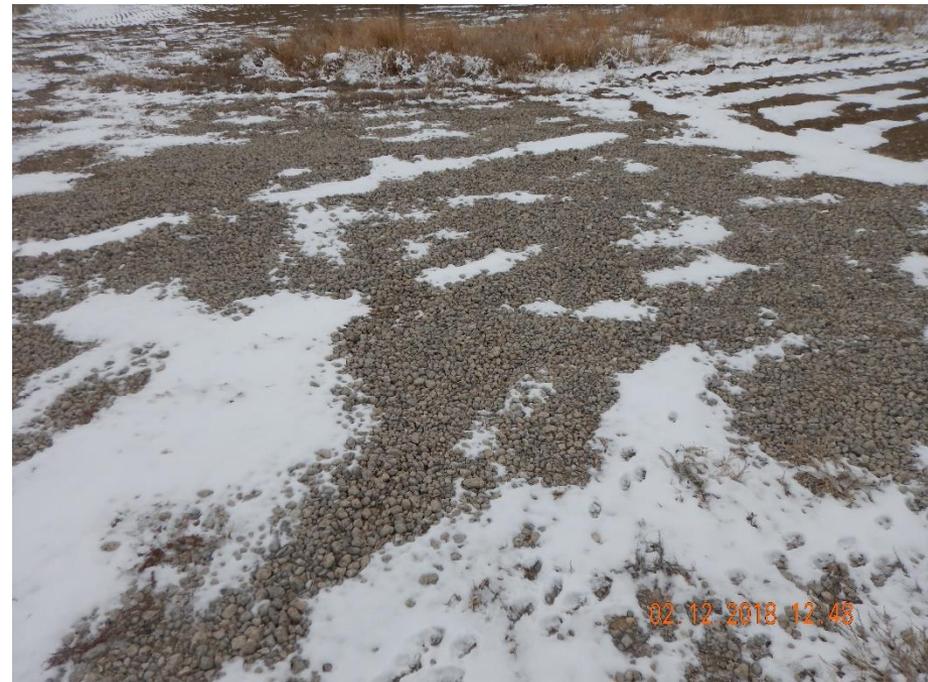
Photo 10: Photo taken from the access road entrance. Photo show gravel (vehicle tracking BMP) has not been removed.
