# Final Reclamation Inspection

Operator: NGL WATER SOLUTIONS DJ LLC - 10373

API: 05-123-16804

Inspection Photos  
Location Name: CONQUEST SWD #1-8  
API: 05-123-16804

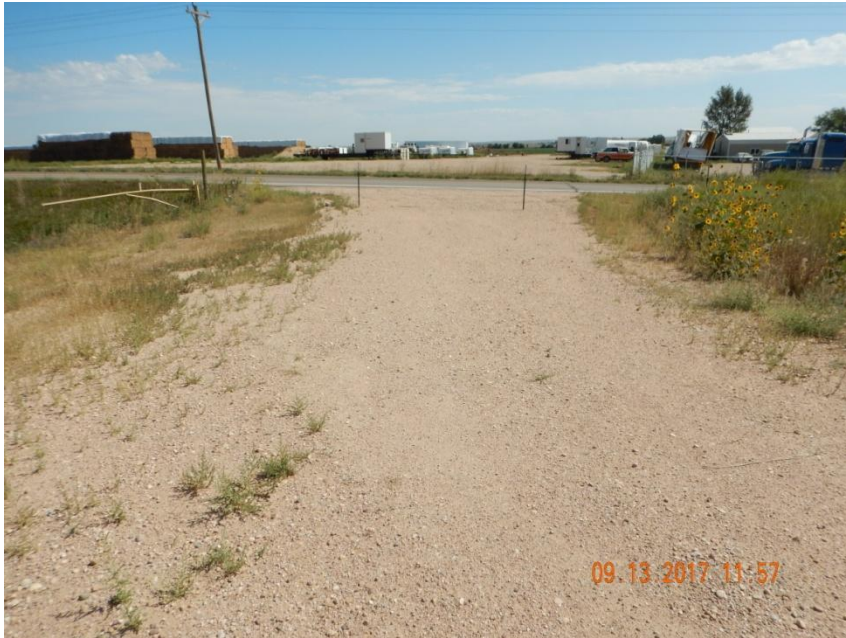
**Photo 1.** Photo taken from an access road off CR 53 on September 13, 2017, facing East. Access road is no longer in use per Weld County requirements as described by an Operator representative. Access road will have to be reclaimed per Rule 1004.

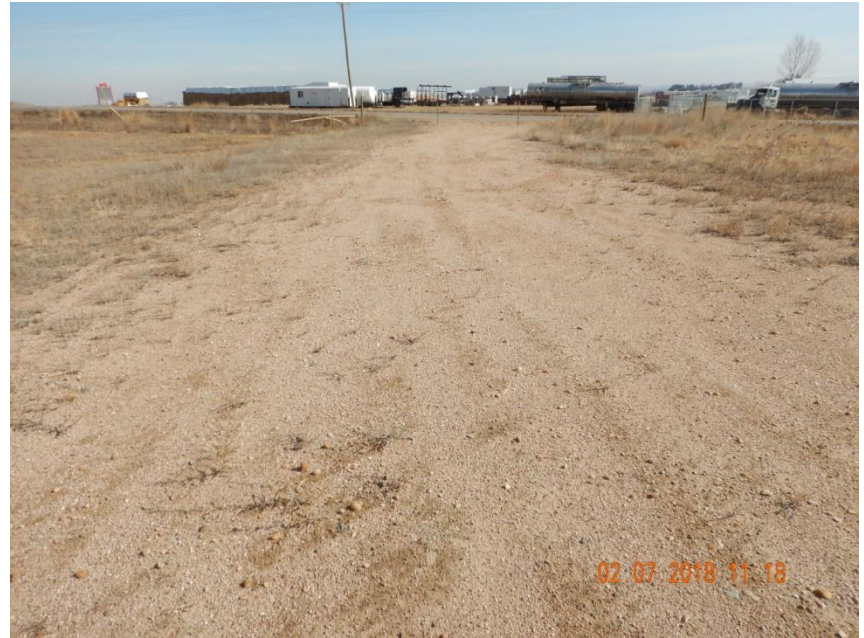
**Photo 2.** Photo taken from an access road off CR 53 on February 7, 2018, facing East. Operator has failed to perform final reclamation activities by the corrective action date of November 15, 2017.

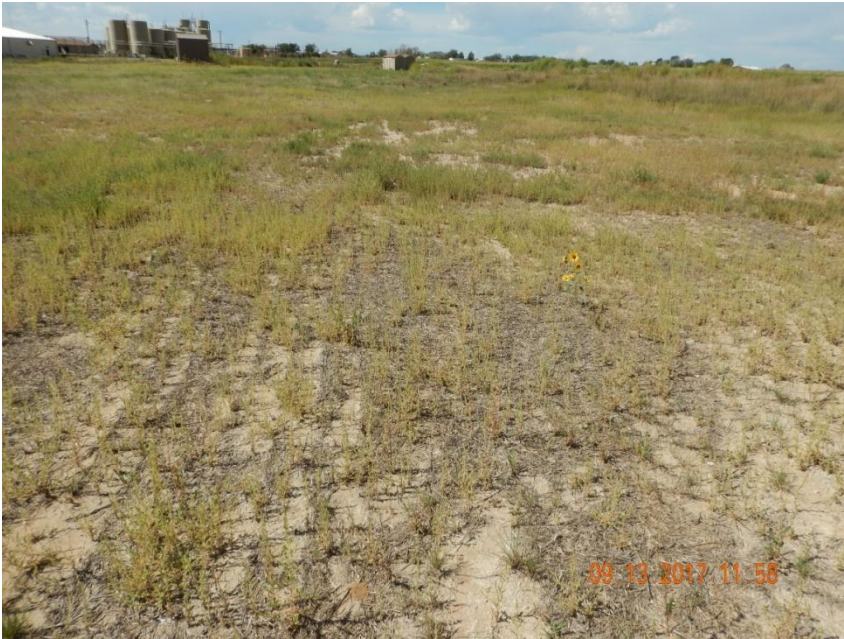
**Photo 3.** Photo taken from the approximate central reclamation area on September 13, 2017, facing West. Photo illustrates little to no germination throughout the reclamation area. Most of the green foliage in the photo is that of Russian thistle/Kochia.

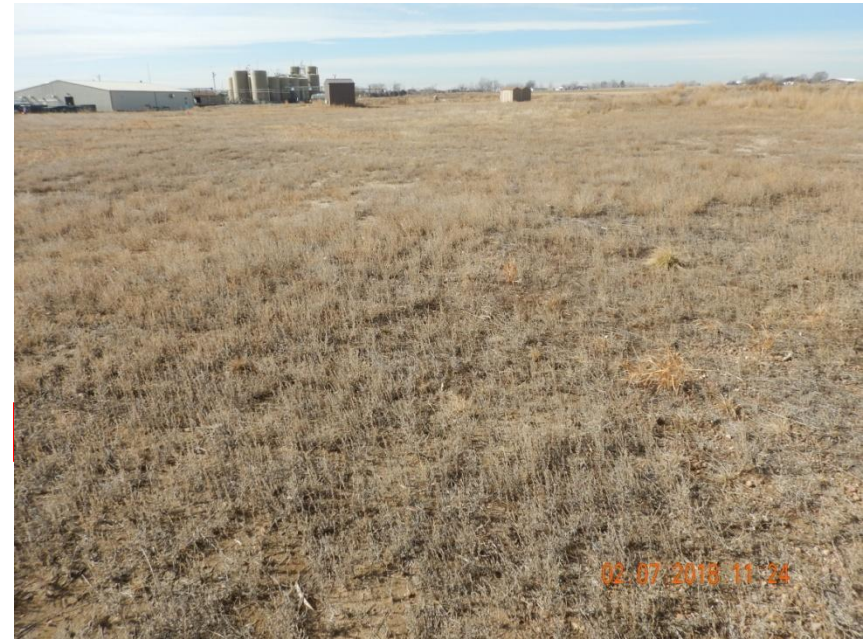
**Photo 4.** Photo taken from the approximate central reclamation area on February 7, 2018, facing West. Weedy, annual vegetation remains (Russian thistle/Kochia). Operator has failed to perform final reclamation activities by the corrective action date of November 15, 2017.

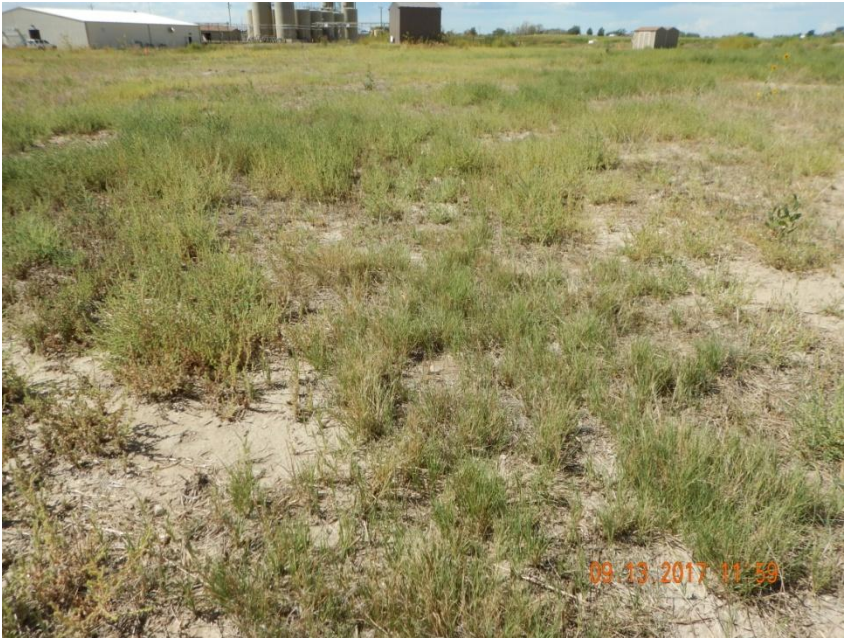
**Photo 5.** Photo taken from the western reclamation area on September 13, 2017, facing West. Photo illustrates a patch of desirable vegetative growth mixed with Russian thistle.

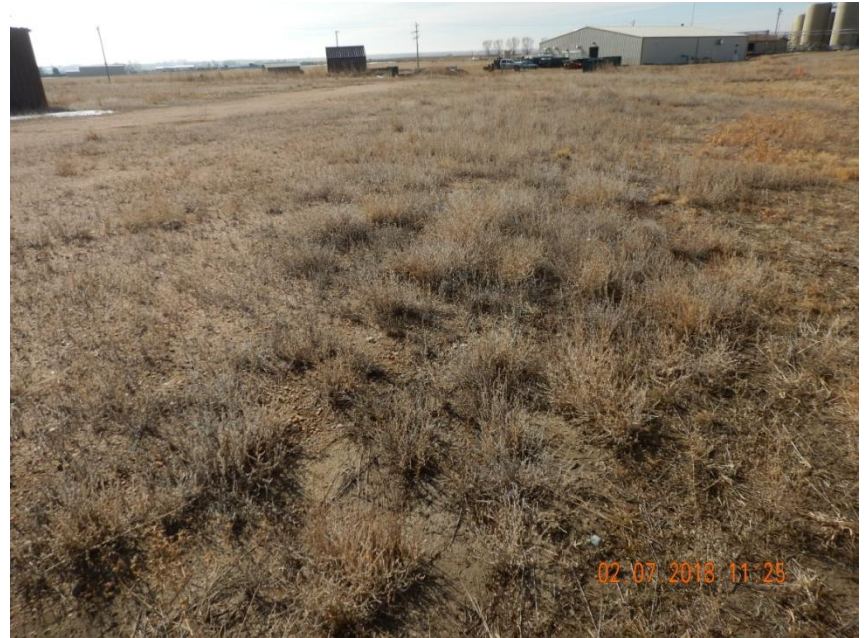
**Photo 6.** Photo taken from the western reclamation area on February 7, 2018, facing West. See comments under Photo 4.

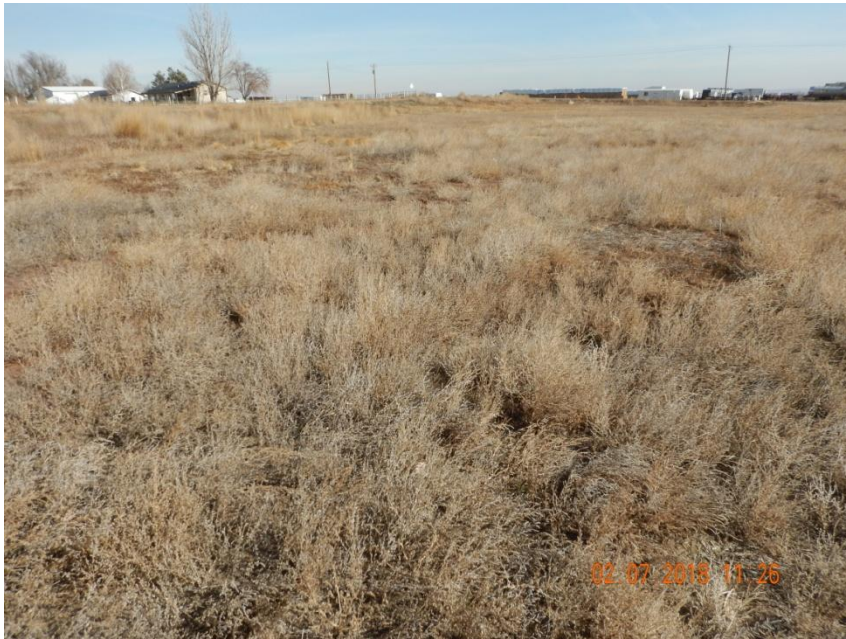
**Photo 7.** Photo taken from the western reclamation area on February 7, 2018, facing West. See comments under Photo 4.

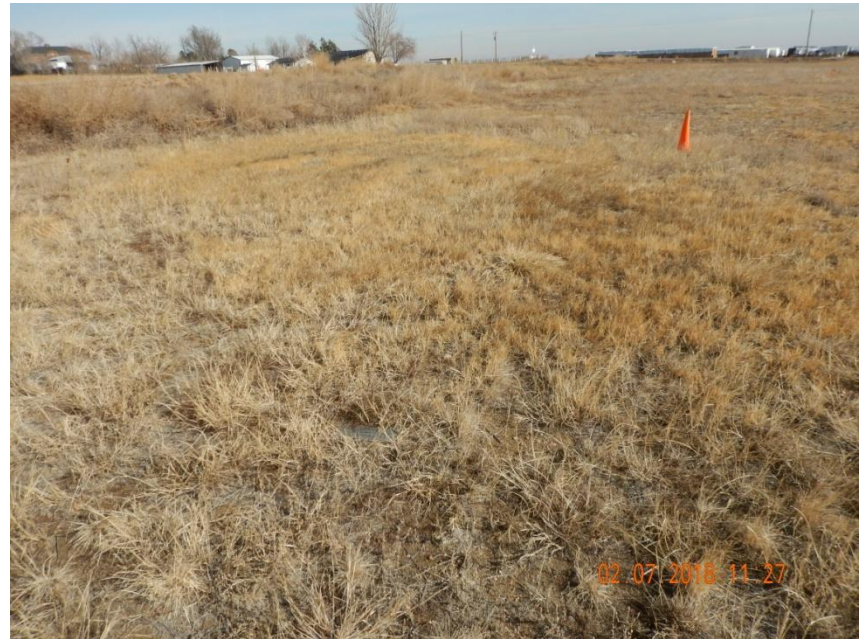
**Photo 8.** Reference photo taken just west of the western reclamation area. Photo illustrates the vegetative growth that is not reflective throughout the reclamation area.
