**COLORADO**  
Oil & Gas Conservation  
Commission  
Department of Natural Resources

Inspection Photos: Black Hills Federal Loc#312741

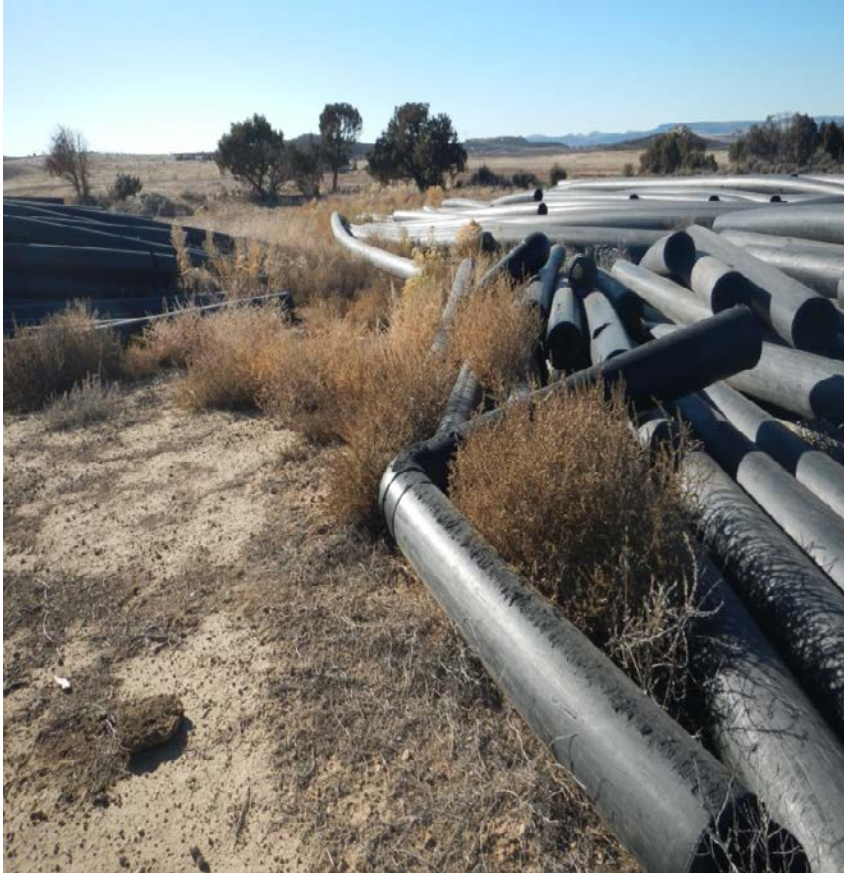
Photo#2:

Piles of Poly Pipe stored on East & West sides of Location. Note Weeds that have grown in Pipe Piles and have now become Debris.

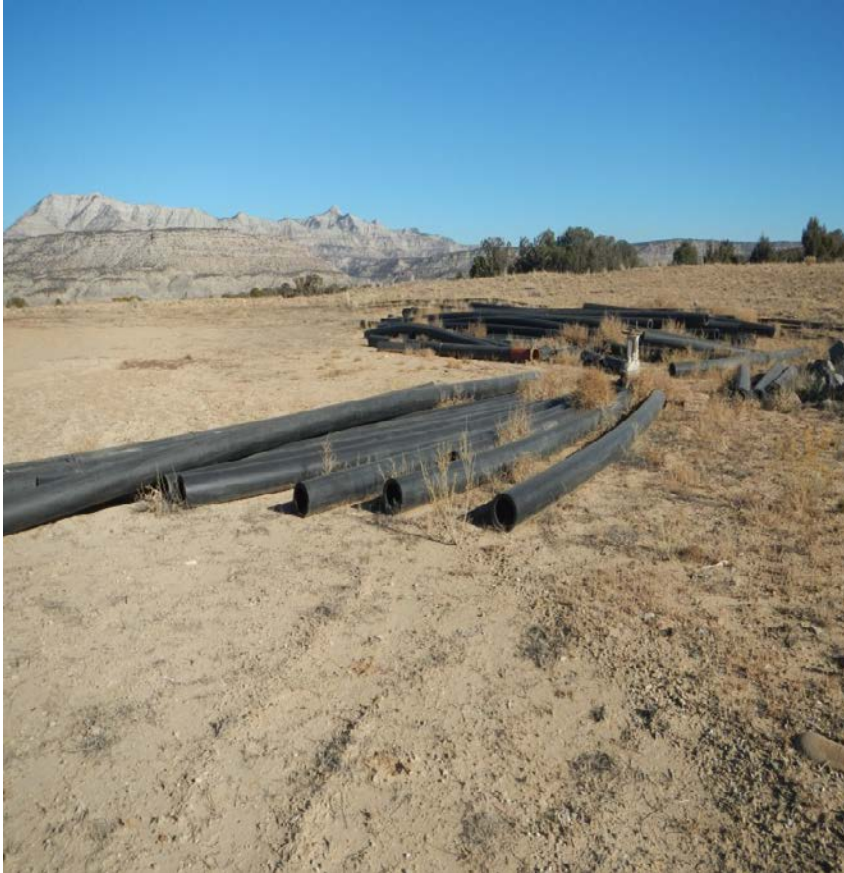
Photo#4:

Piles of Poly Pipe stored on East & West sides of Location. Note Weeds that have grown in Pipe Piles and have now become Debris.

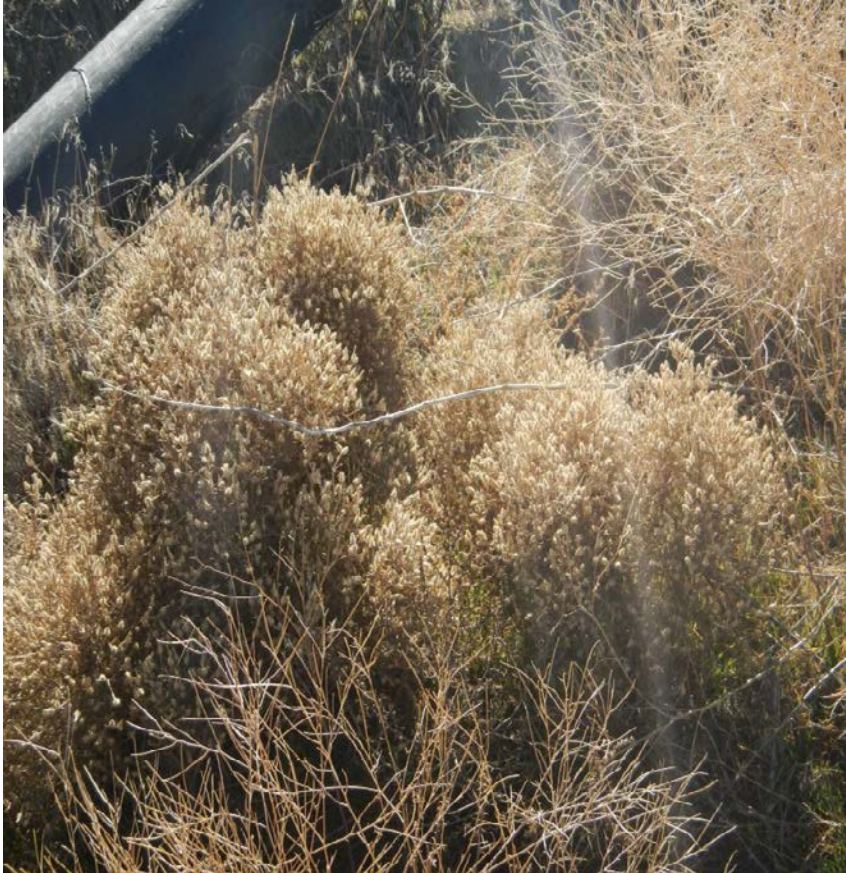
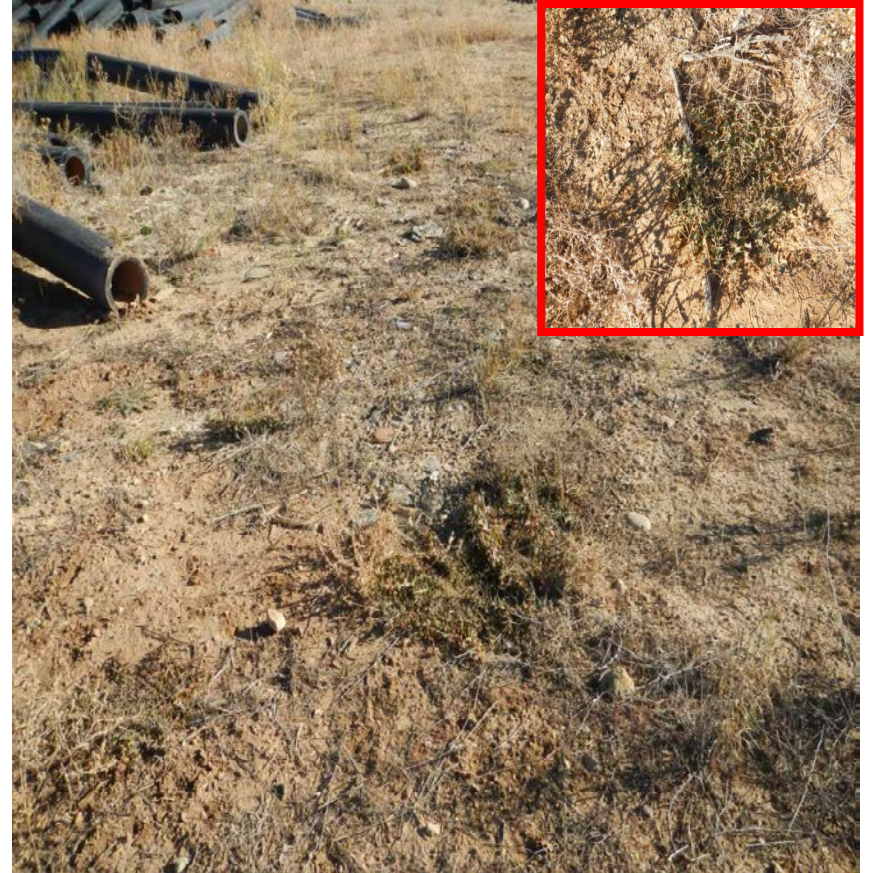
Photo#6:

Noxious Weeds On Site; Knapweed & Thistle.

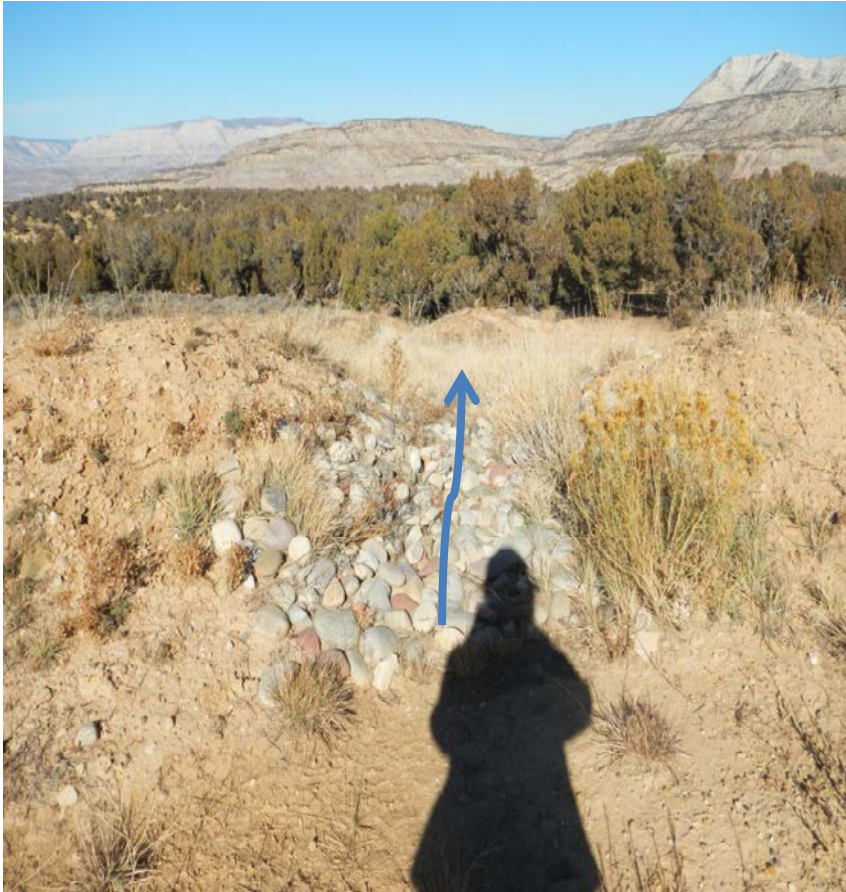
Photo#8: Main BMP at center of N Pad Berm, flows North.

Arrows indicate Stormwater Flow & Sediment Migration.

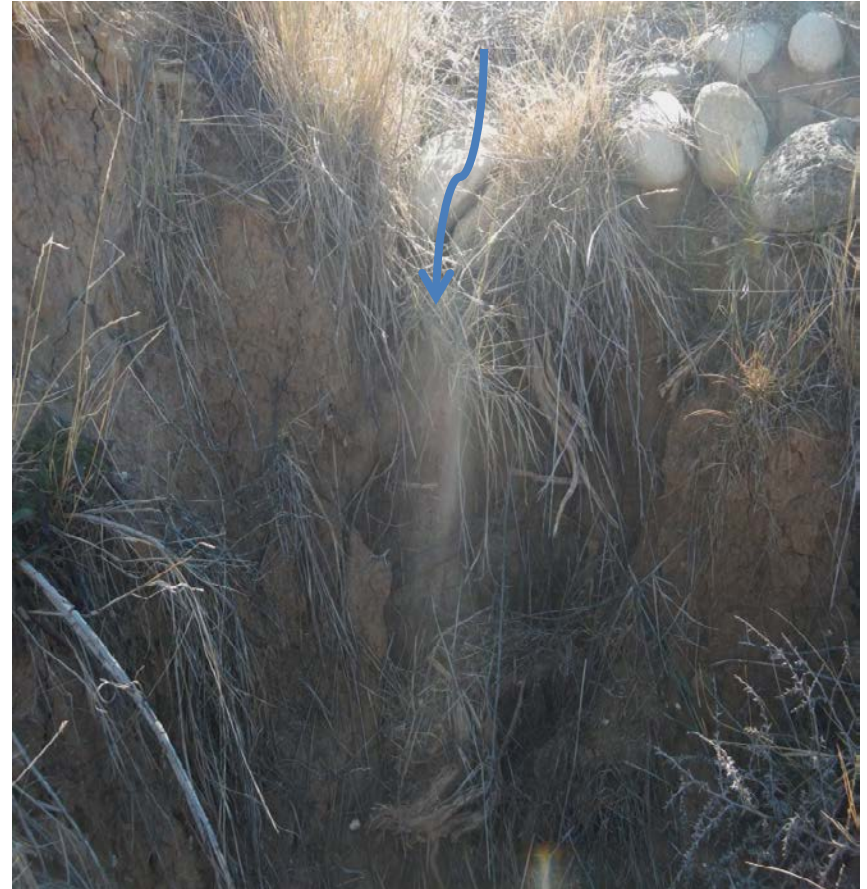
Photo#9: Point where SW discharges to Sediment Trap. BMP needs maintenance.

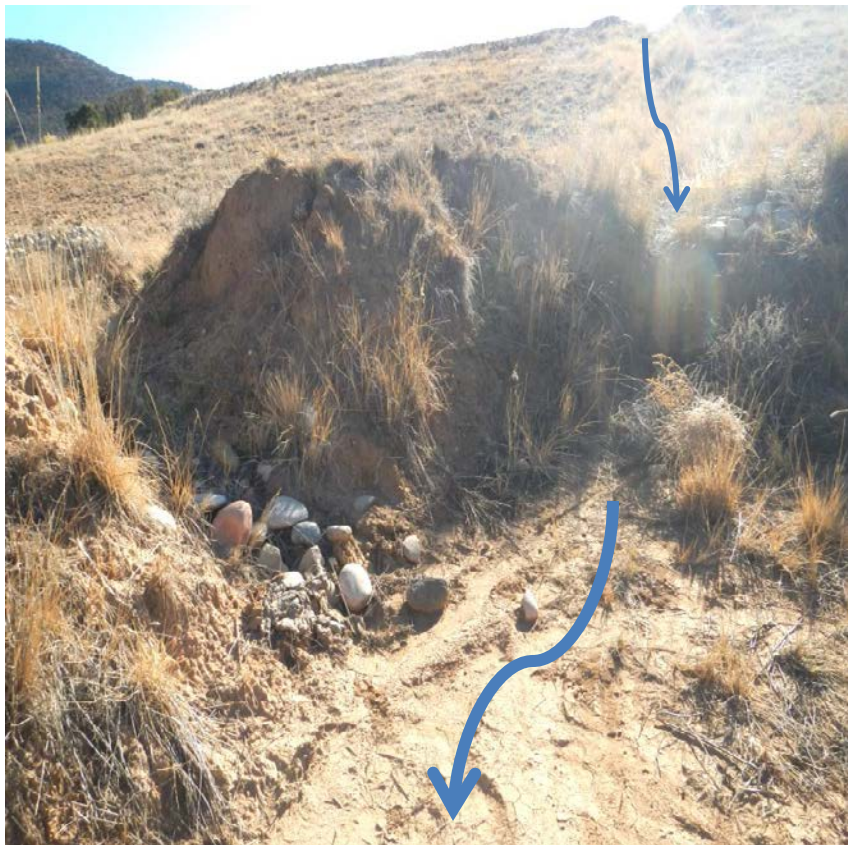
Photo#10: Shows SW Flow from Photo#8 into  
Sediment Retention area.

Arrows indicate Stormwater Flow & Sediment Migration.

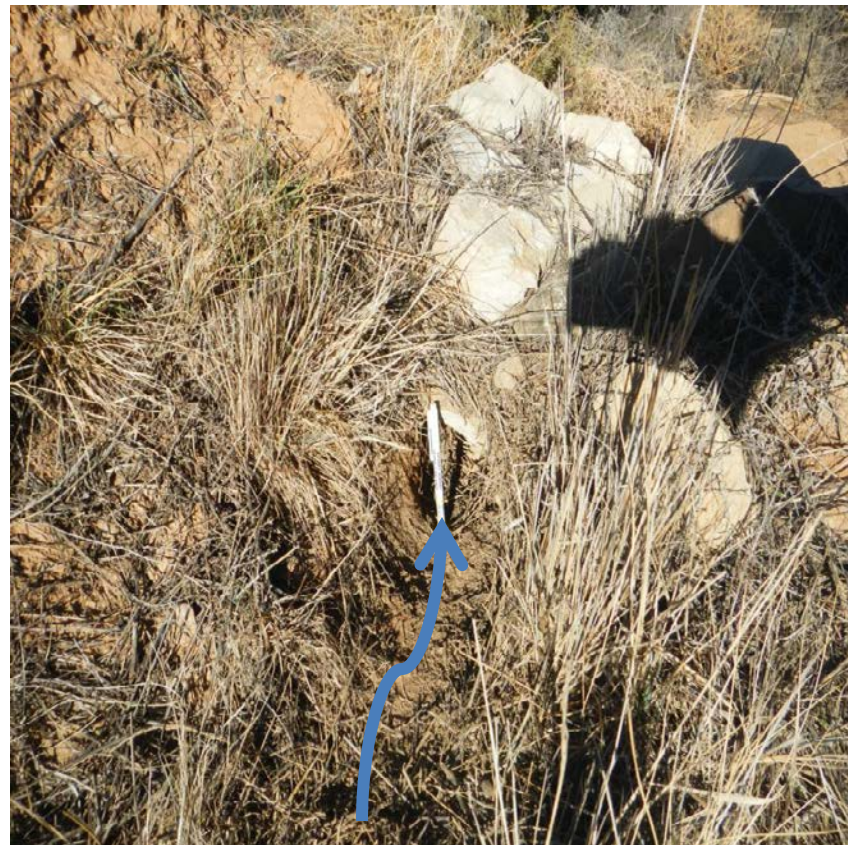
Photo#11: SW exits BMP below Photo#10; undercutting  
Rock Armor at Point Pen identifies hole.

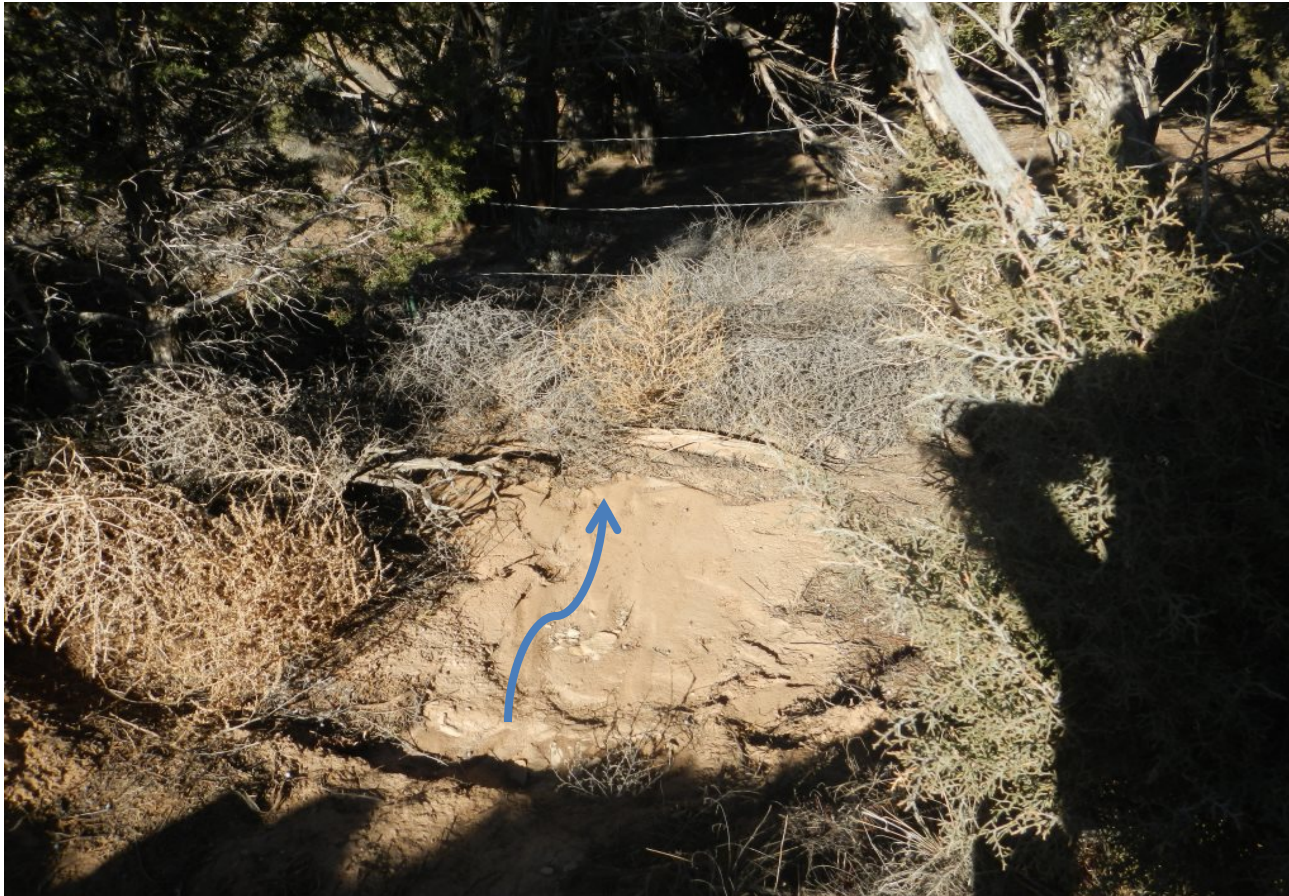
Photo#12:

View of Drainage area at below Photos #10 & 11; where Sediment is migrating off Site.  
Arrows indicate Stormwater Flow & Sediment Migration.

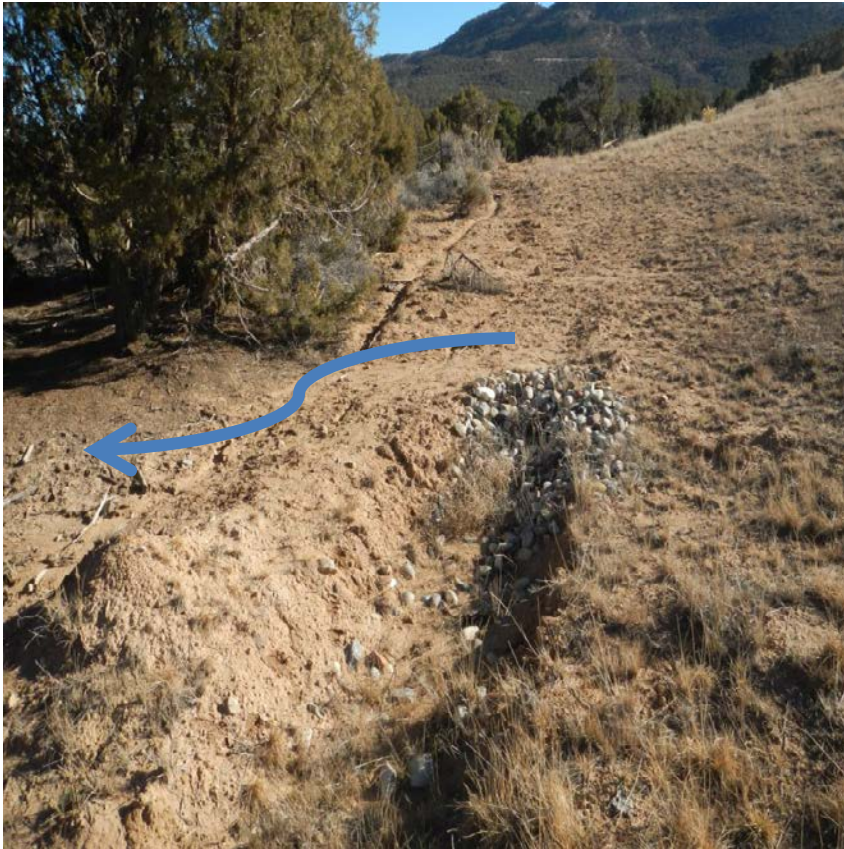
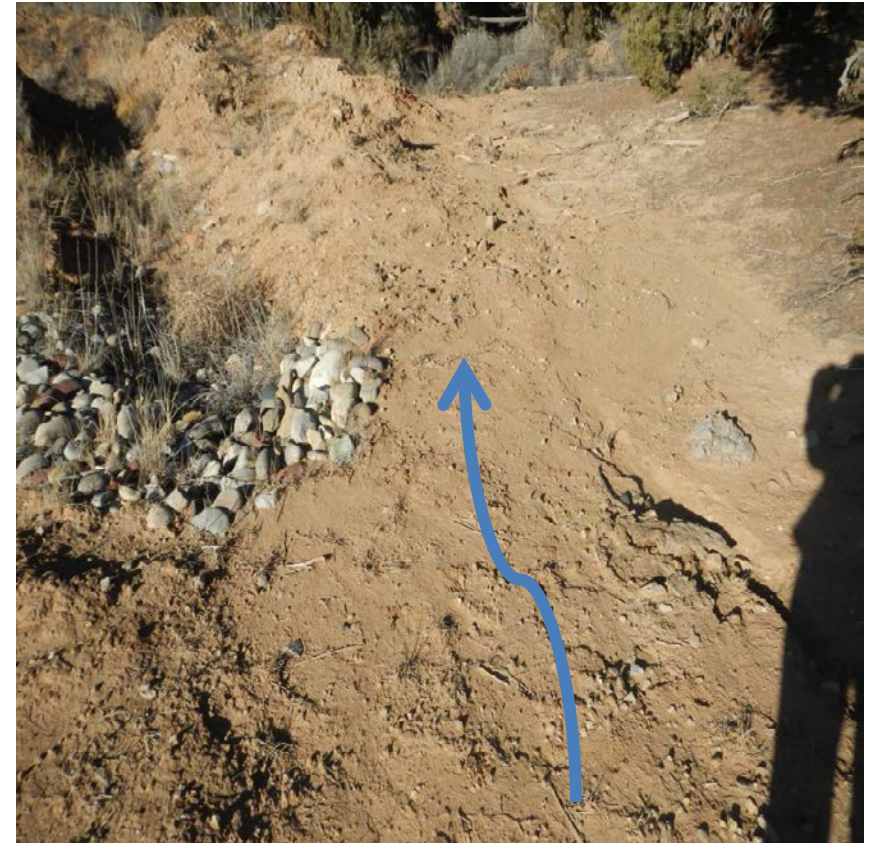
Photo#13:

Rocked drain area to East that receives SW flow along base of Slope is being bypassed & sediment diverting to North & off Site. Arrows indicate Stormwater Flow & Sediment Migration.
