March 19, 2018

**RE: COGCC Spill/Release Point #453835 BNN Western Horsetail #19-N SWD Facility  
Oil and Produced Water Spill Soil Sampling Report, Olsson Project #018-0595**

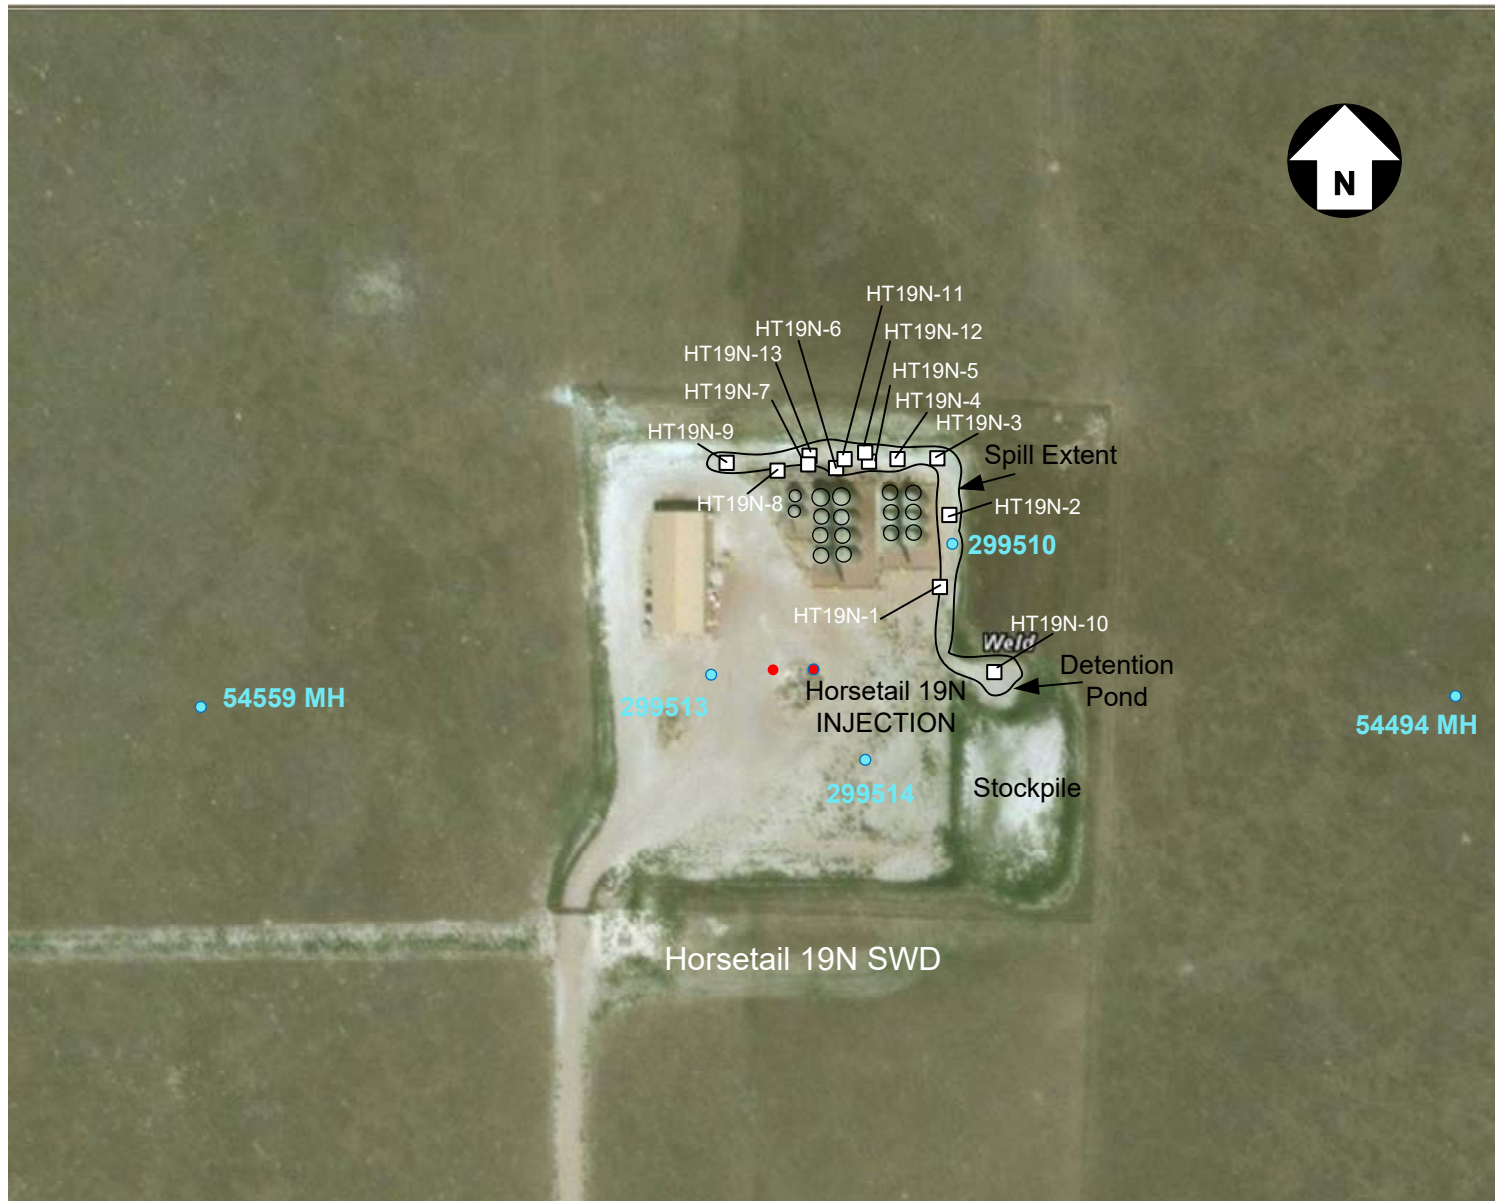
#### Site Map

The produced water release extended along the north side of the site and around to the east of the processed produced water tank battery and into the detention pond on the east side of the Horsetail 19N location. Olsson collected a total of ten soil samples from the spill area following excavation.

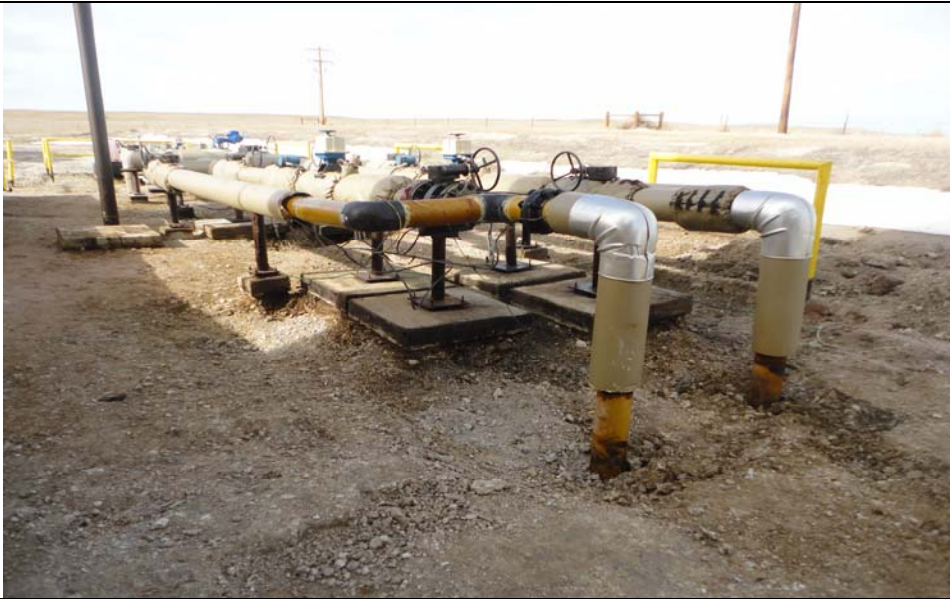
**Subject:** A 100 barrel produced water were released outside containment on January 25, 2018 as a result of a broken fiberglass pipe joint on the north side of the Horsetail 19N tank battery. The spill remained on location.

On January 25, 2018, an aboveground fiberglass pipe failed at a joint outside of secondary containment prior to going into the inlet 750-bbl capacity gunbarrel separation tank. Approximately 100 barrels of produced water containing less than one barrel of crude oil was released to the ground. The pipe was isolated following discovery and the spill was contained on location. The pooled liquid was collected using a vacuum truck and the impacted soils were excavated and stockpiled in a lined containment on location.

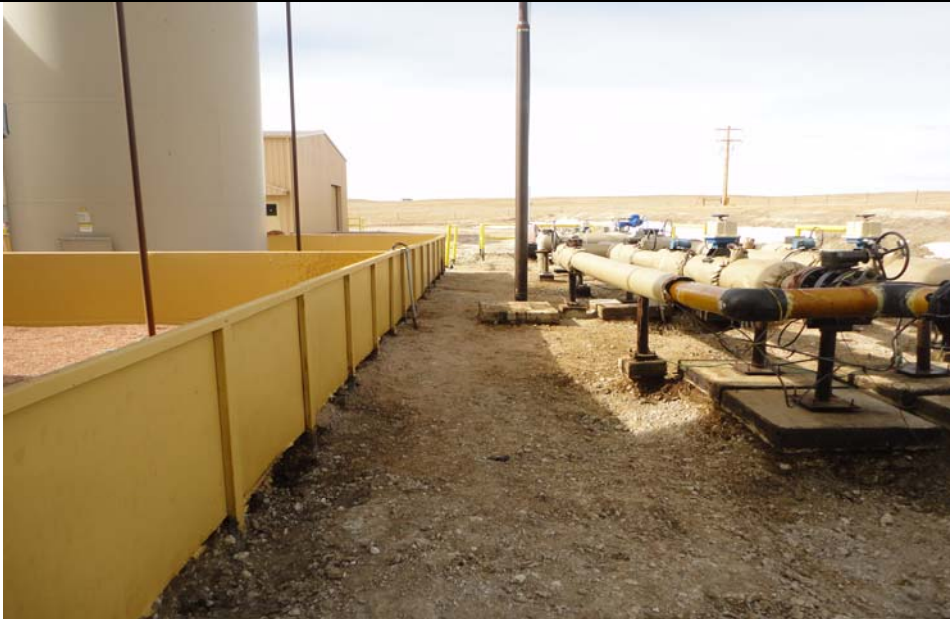
**Subject:** M&E Oilfield Services excavated impacted soil in the area of the spill using a skid steer and hand tools. Excavation activities were ongoing as of February 8, 2018. Confirmation soil sample, HT19N-6 was collected beneath the piping at the point of release to assess progress.

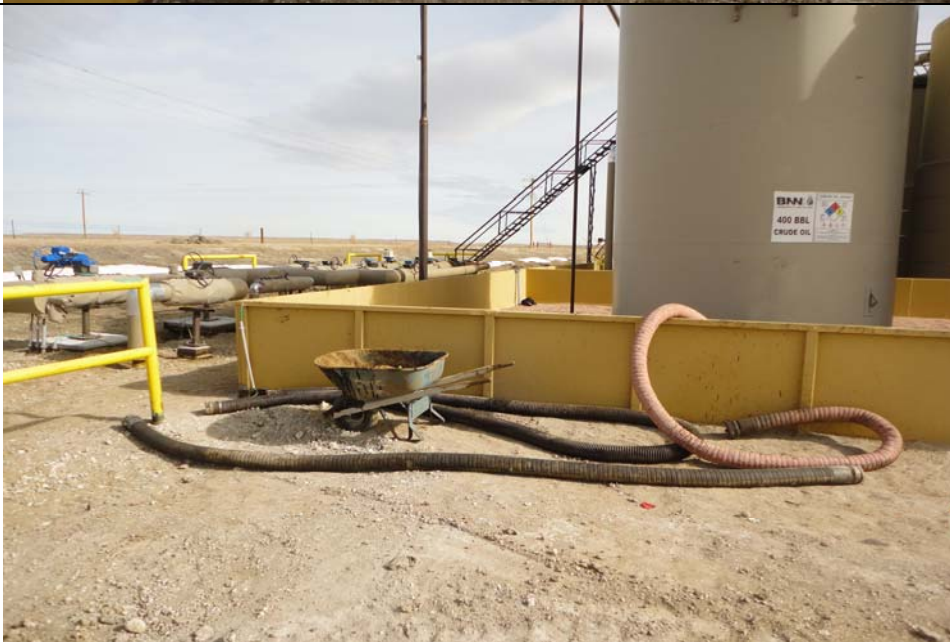
**Subject:** M&E used a vacuum truck to recover produced water at the time of the January 25, 2018 release following its discovery. Olsson collected confirmation soil sample HT19N-7 near the piping and the northwest corner of the containment.

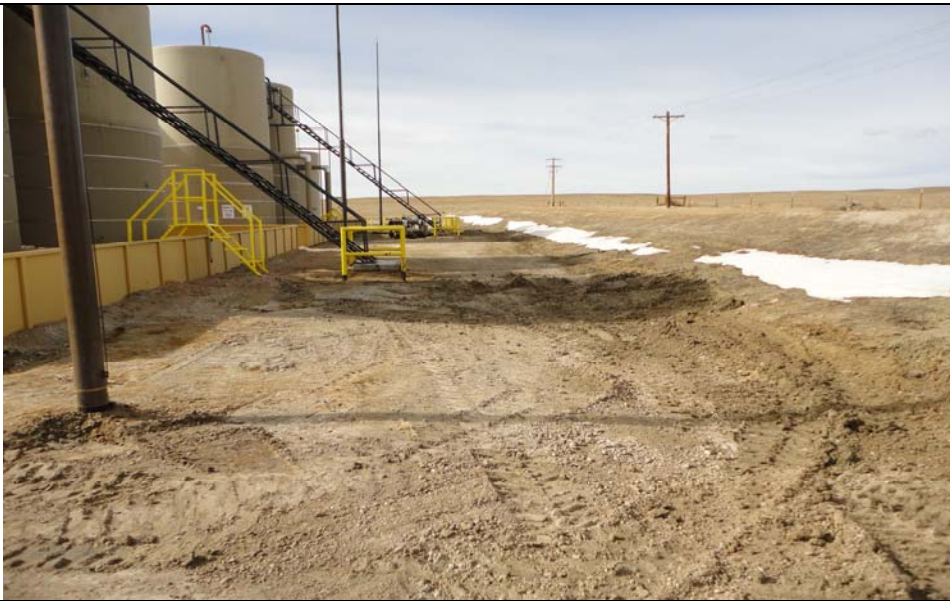
**Subject:** The produced water release extended along the north part of the Horsetail 19N pad and flowed east beyond the filtered produced water tank battery. Confirmation soil sample, HT19N-3 was collected near the northeast lightning rod shown on the left hand side of the photo. Confirmation soil sample HT19N-4 was collected near the base of the tank stairs.

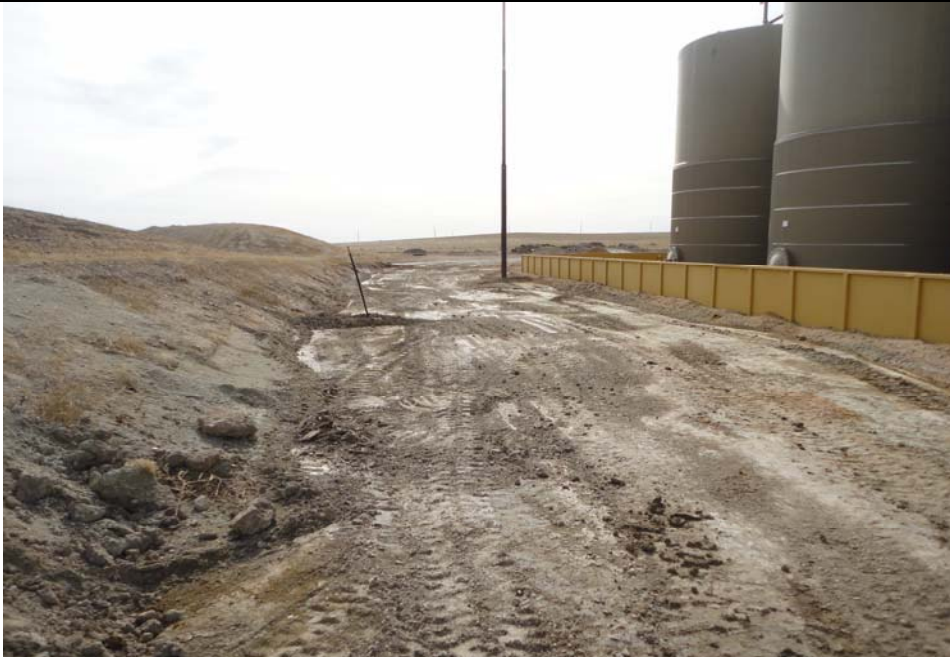
**Subject:** The produced water flowed to the south along the northeastern part of the Horsetail 19N pad and east of the filtered produced water tank battery. Olsson collected confirmation soil sample HT19N-2 between the monitoring well and lightning rod east of the tank battery.

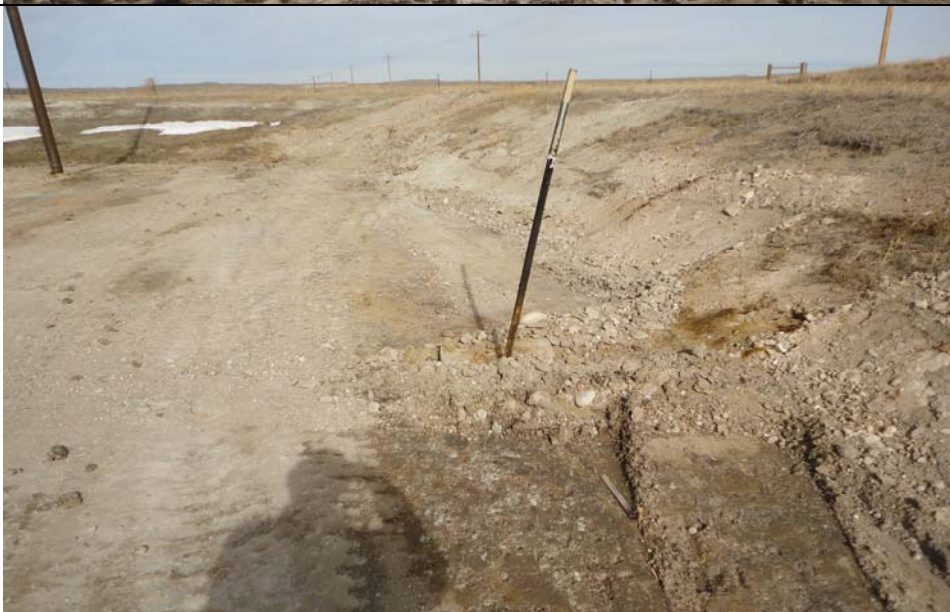
**Subject:** A flush mount groundwater monitoring well installed by Talon/LPE was located on the northwest side of the site. According to Division of Water Resource records the monitoring well was reportedly dry when installed.

A flush-mounted groundwater monitoring well was observed on the northeast corner of the east treated produced water tank battery. The concrete apron surrounding the well was damaged during soil excavation. A review of records from the previous owner indicate that the monitoring

well was reported dry at the time of installation, was required by Weld County under a use by special review (USR) permit, and not associated with a spill or remediation.

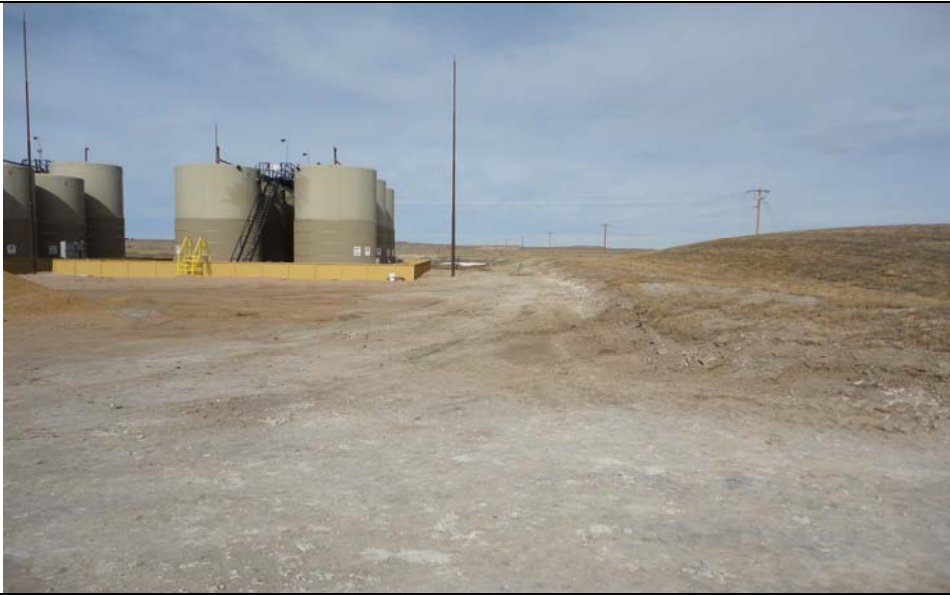
**Subject:** The produced water release extended along the east side of the Horsetail 19N pad past the filtered produced water tank battery and toward a detention pond. Olsson collected confirmation soil sample HT19N-1 near the southeast corner of the filtered water tank battery secondary containment.

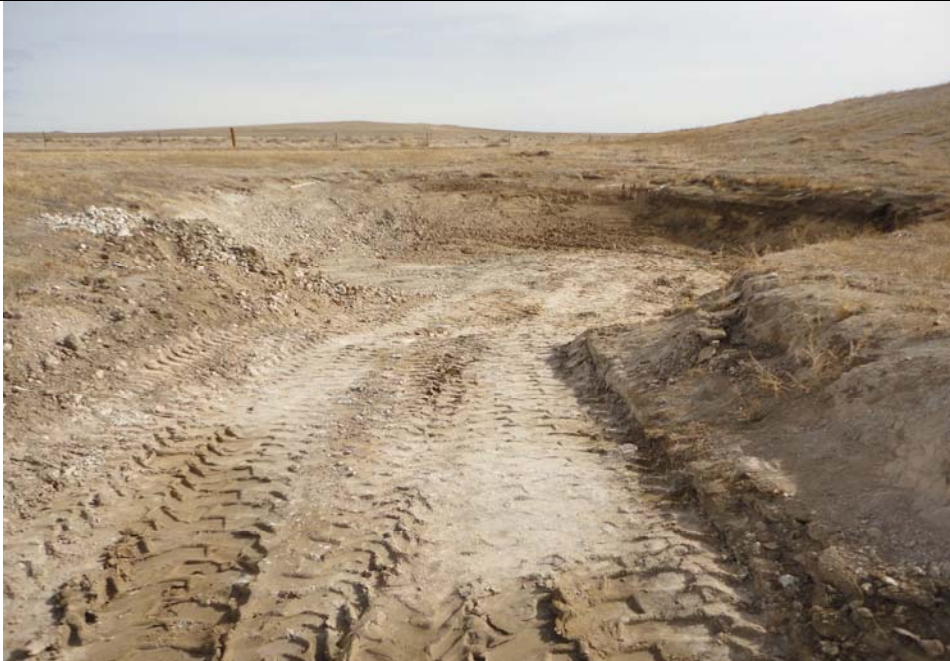
**Subject:** Photograph shows the detention pond on the east side of the Horsetail 19N pad following excavation. Confirmation soil sample HT19N-10 was collected from the base of the excavated detention pond.

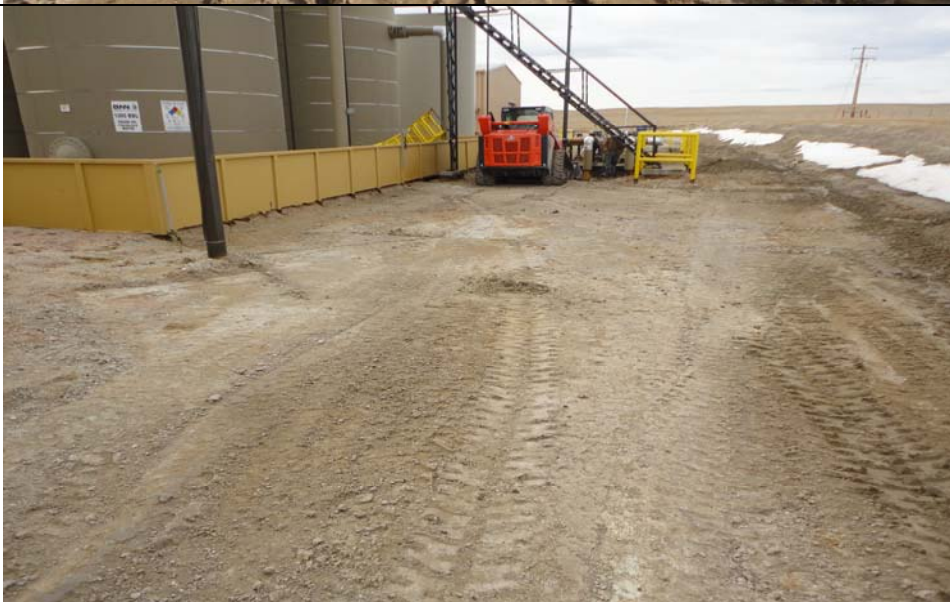
**Subject:** M & E Oilfield Services was retained to remove impacted soil at the site using a skid steer and hand tools. Excavation work was ongoing.

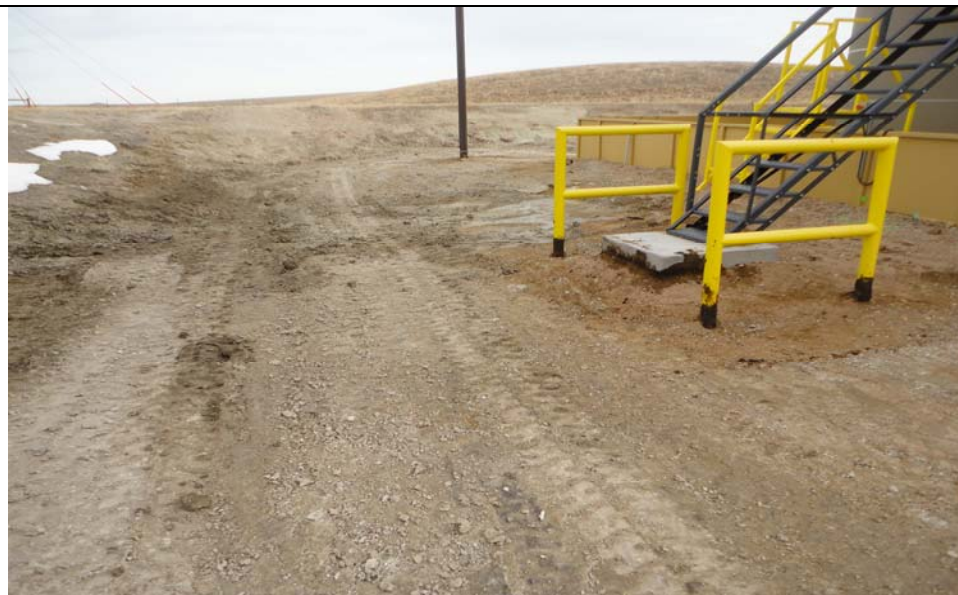
**Subject:** M&E Oilfield Services removed the impacted soils north and east of the filtered water tank battery using the skid steer. Olsson personnel collected confirmation soil sample HT19N-4 near the filtered produced water tank battery stairs.

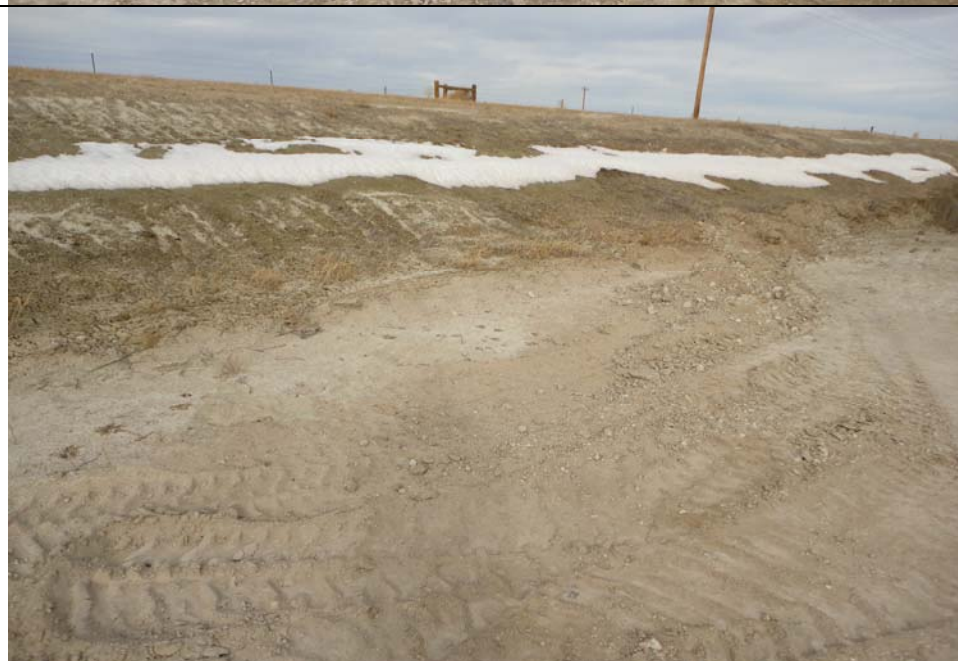
**Subject:** M&E removed the impacted soil along the north side of the Horsetail 19N pad to the west of the piping and base of the north berm. Shallow claystone or siltstone bedrock was present near the surface.

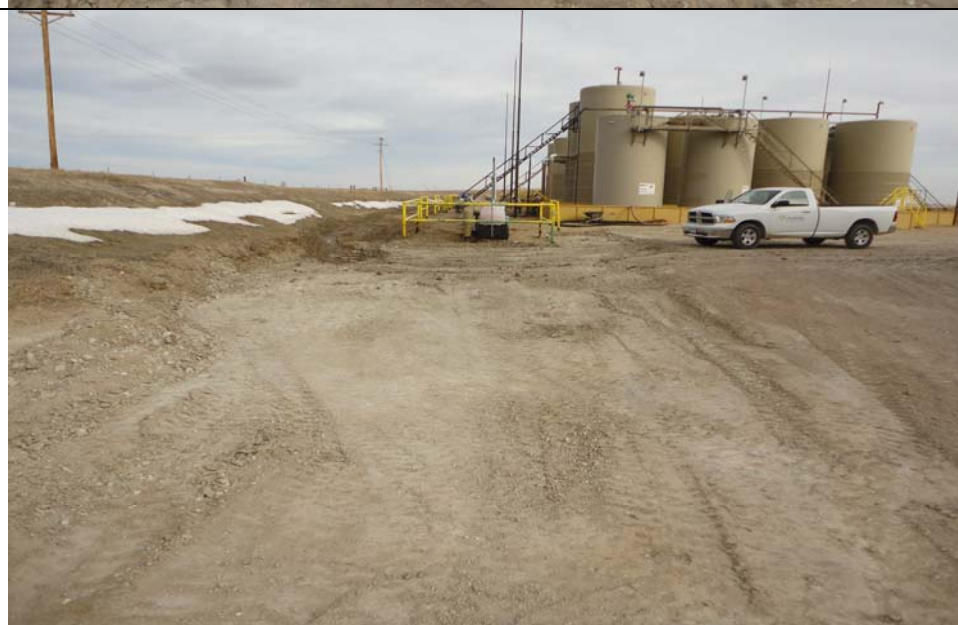
**Subject:** M&E had removed the impacted soils west of the aboveground piping run along the northwest side of the site using a skid steer.

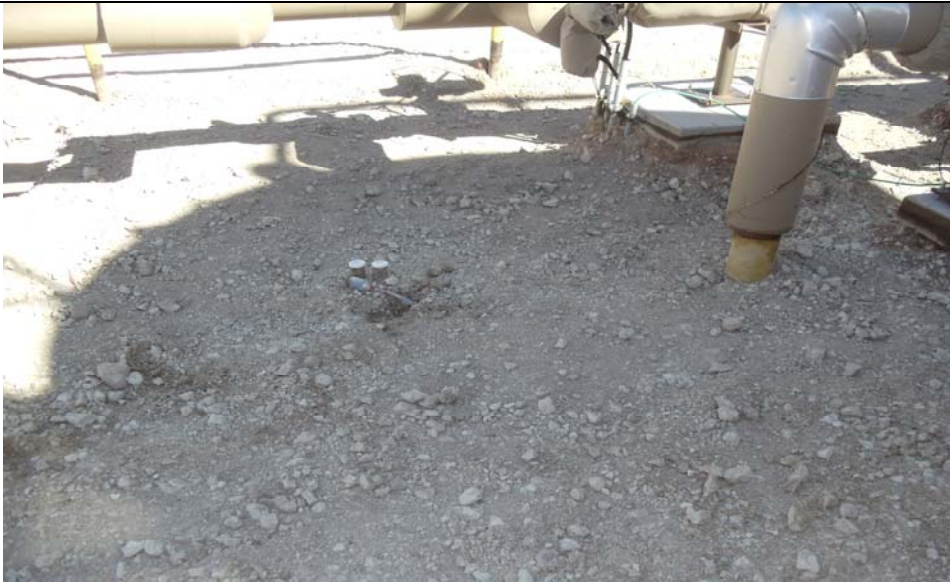
**Subject:** Following additional excavation at the site Olsson personnel collected soil sample HT19N-11 (near HT19-6) for confirmation.

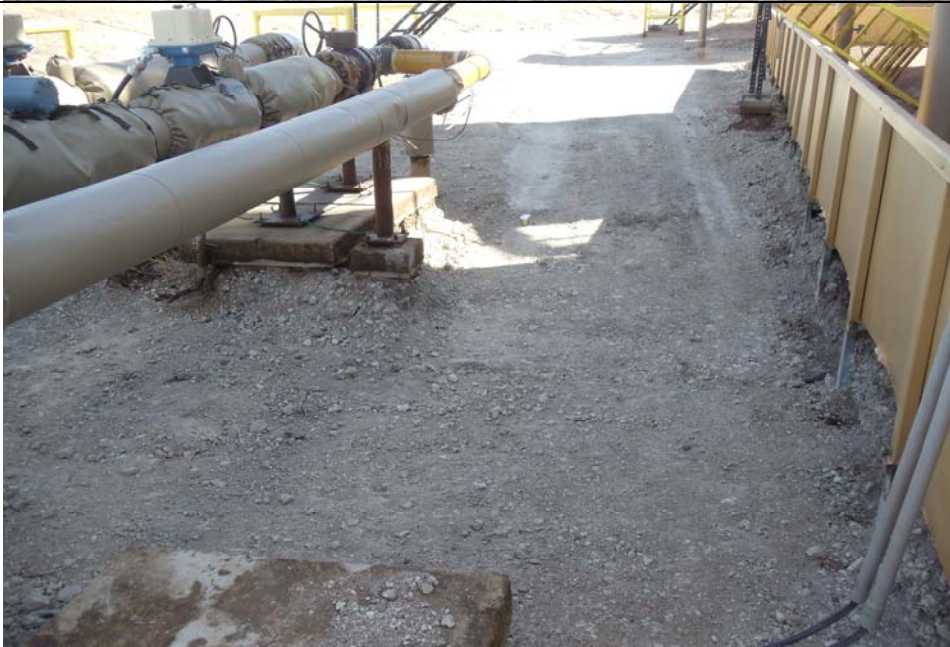
**Subject:** M&E performed additional excavation since the 02/08/2018 sampling event. Olsson collected confirmation soil samples near locations where previous soil samples had total petroleum hydrocarbons (TPH) as diesel range organics (DRO) above the COGCC Table 910-1 standard of 500 mg/kg.

Additional excavation was conducted beneath the aboveground piping runs on the north side of the tank battery where the release occurred. Olsson personnel collected three additional soil samples on March 6, 2018 from areas that had TPH-DRO concentrations above the Table 910-1 TPH-DRO level of 500 mg/kg. The samples were submitted to Origins for analysis of TPH-DRO. Olsson requested that if the concentrations of TPH-DRO in the confirmation soil samples were greater than 500 mg/kg, that the laboratory run naphthalene, 1-methylnaphthalene, and 2-methylnaphthalene. The other Table 910-1 parameters were not analyzed since the results of the February 8, 2018 sampling showed that they were not above their respective concentrations or levels.

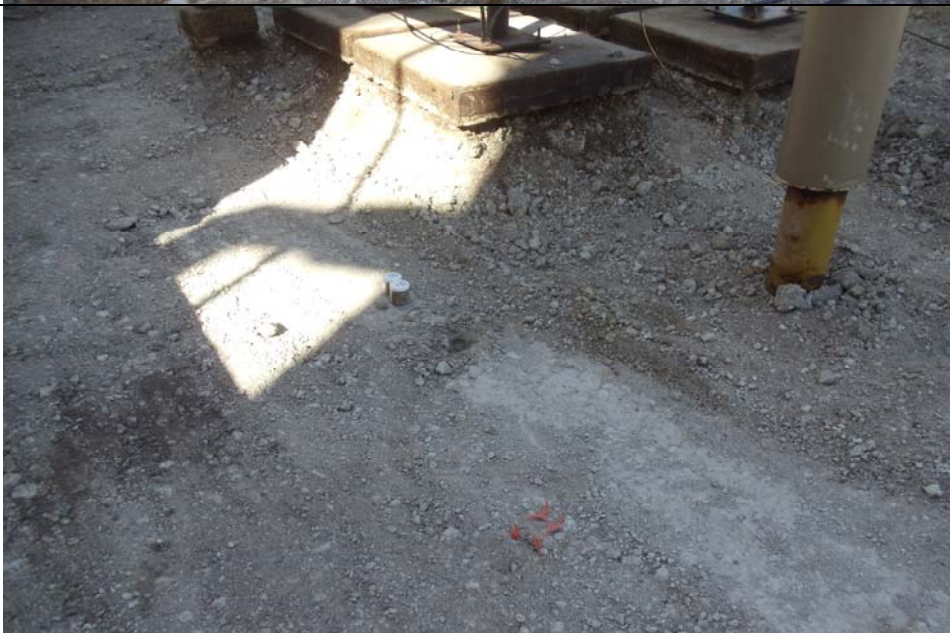
**Subject:** Photograph shows the location of confirmation soil sample HT19N-13 following additional excavation. Soil sample was located west of the point of release and previous soil sample HT19N-7 and the northwest corner of the raw produced water battery secondary containment.

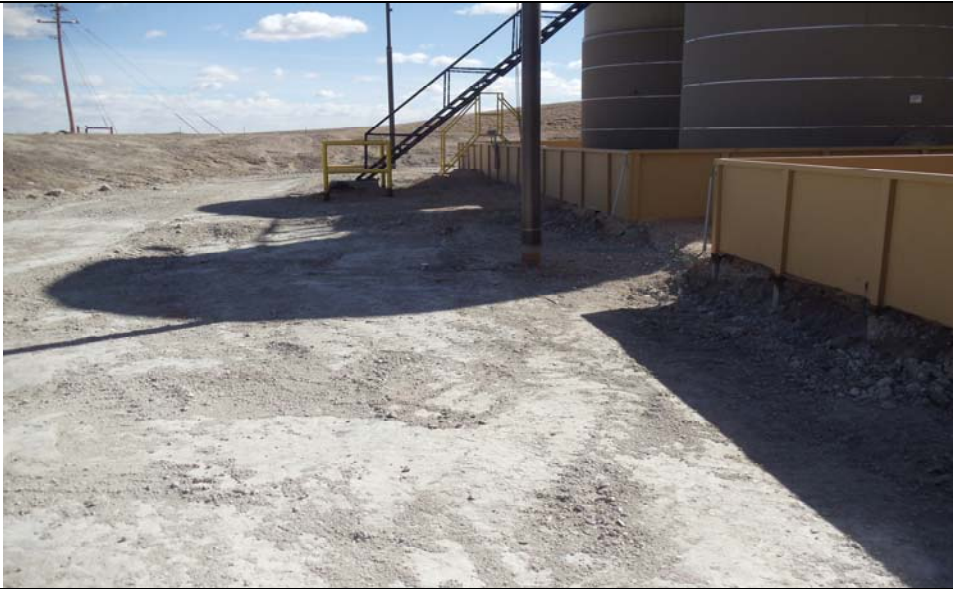
**Subject:** Olsson personnel collected confirmation soil sample, HT19N-12 near the lightning rod on the north side of both tank batteries.

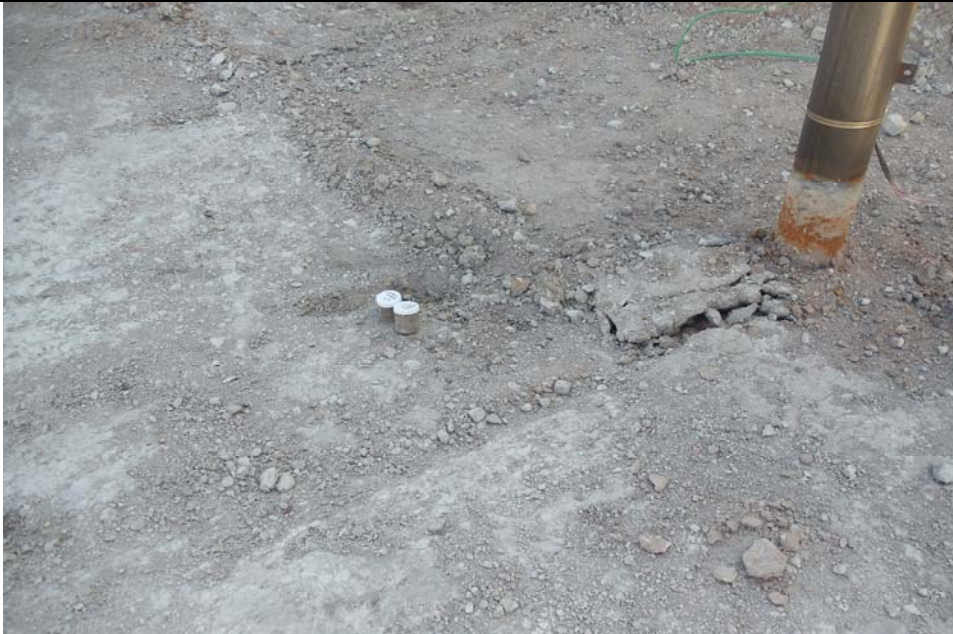
**Subject:** Confirmation soil sample, HT19N-12 was collected near the HT19N-5 sample location and the north lightning rod. Additional soil excavation had been performed.

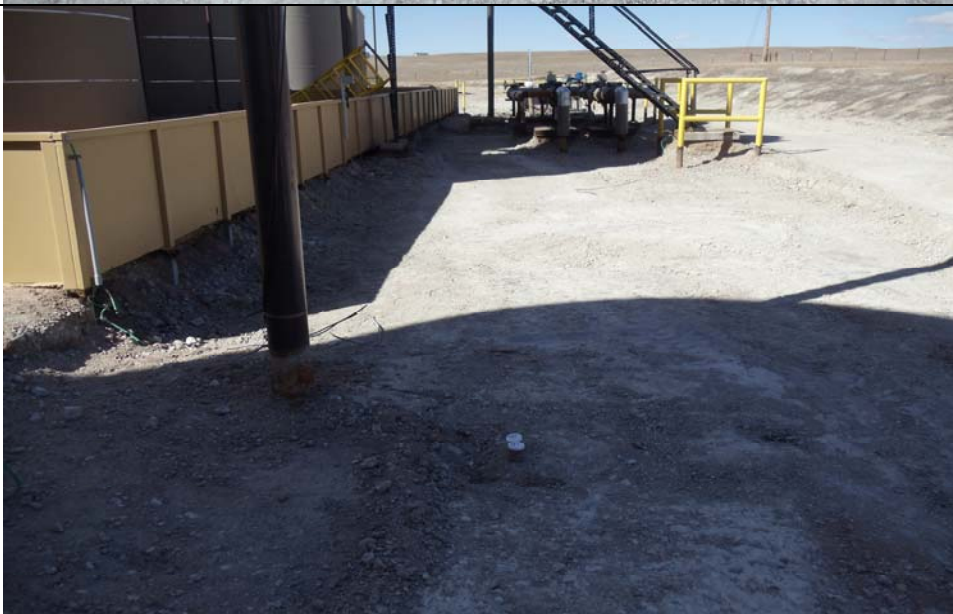
**Subject:** Photograph shows the location of confirmation soil sample HT19N-12 looking back toward the point of release, and the locations of soil samples HT19N-11, and HT19N-13.
