Interim Reclamation Inspection

Operator: EWS 1 DJ BASIN LLC - #10640

API: 05-123-39891

Inspection Photos
Location Name: EWS #1A
API: 05-123-39891

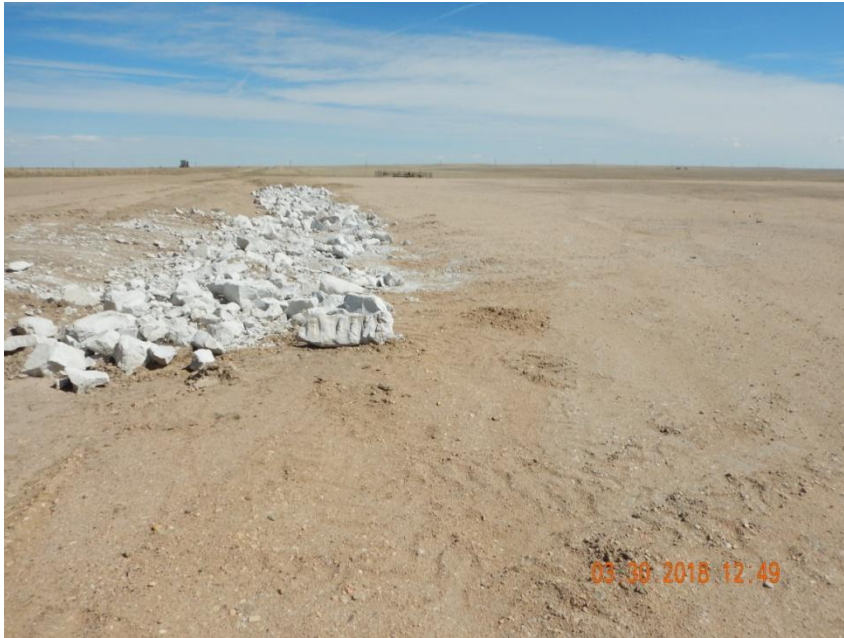
Photo 1. Photo taken from the northwest perimeter of the location, facing East. Waste on location from recent drilling operations needs to be removed per Rule 603.f.

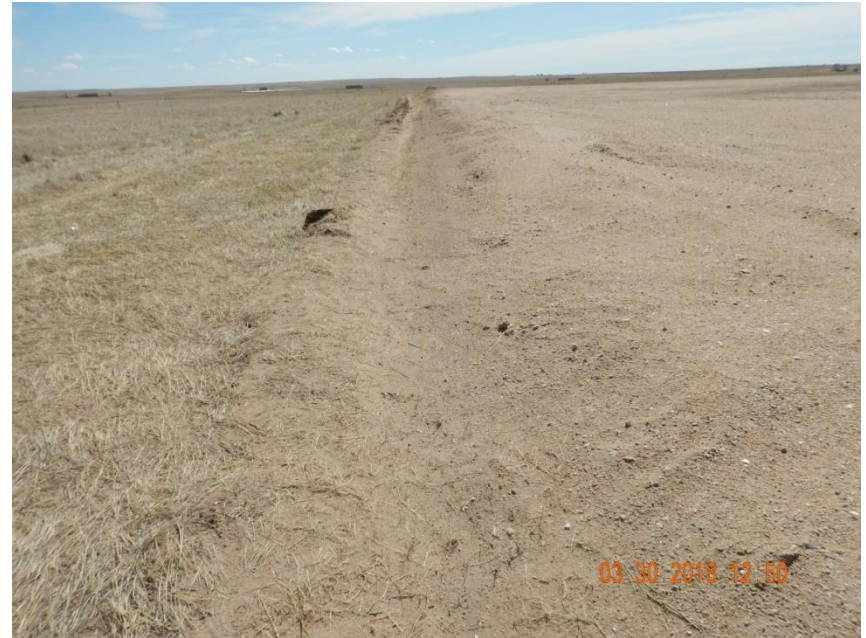
Photo 2. Photo taken from the northeast perimeter of the location, facing South. Appears to be a ditch installed along the eastern perimeter of the location. This was the only observed stormwater BMP, other than gravel at the location.

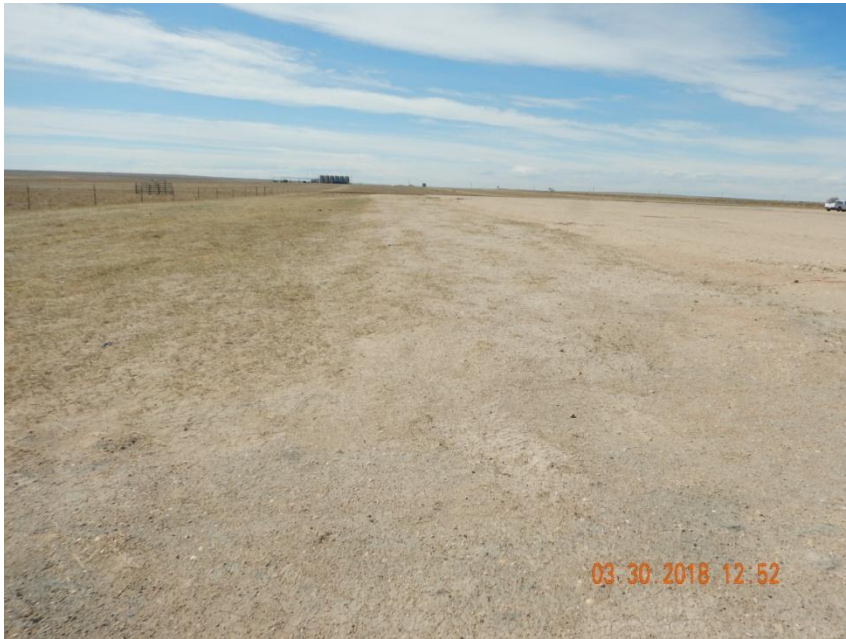
Photo 3. Photo taken from the southeast perimeter of the location, facing West. There was no observed perimeter stormwater BMP along the southern location.

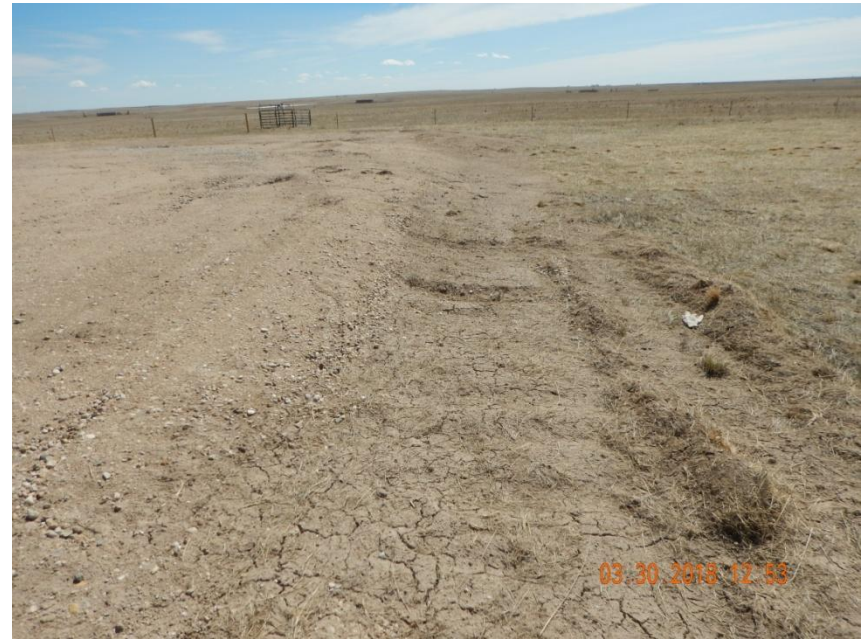
Photo 4. Photo taken from the southwest perimeter of the location, facing South. See comments under Photo 3.
