Interim Reclamation and Stormwater Inspection

April 11, 2018

Operator: SRC ENERGY INC- #10311

Location ID: 448368

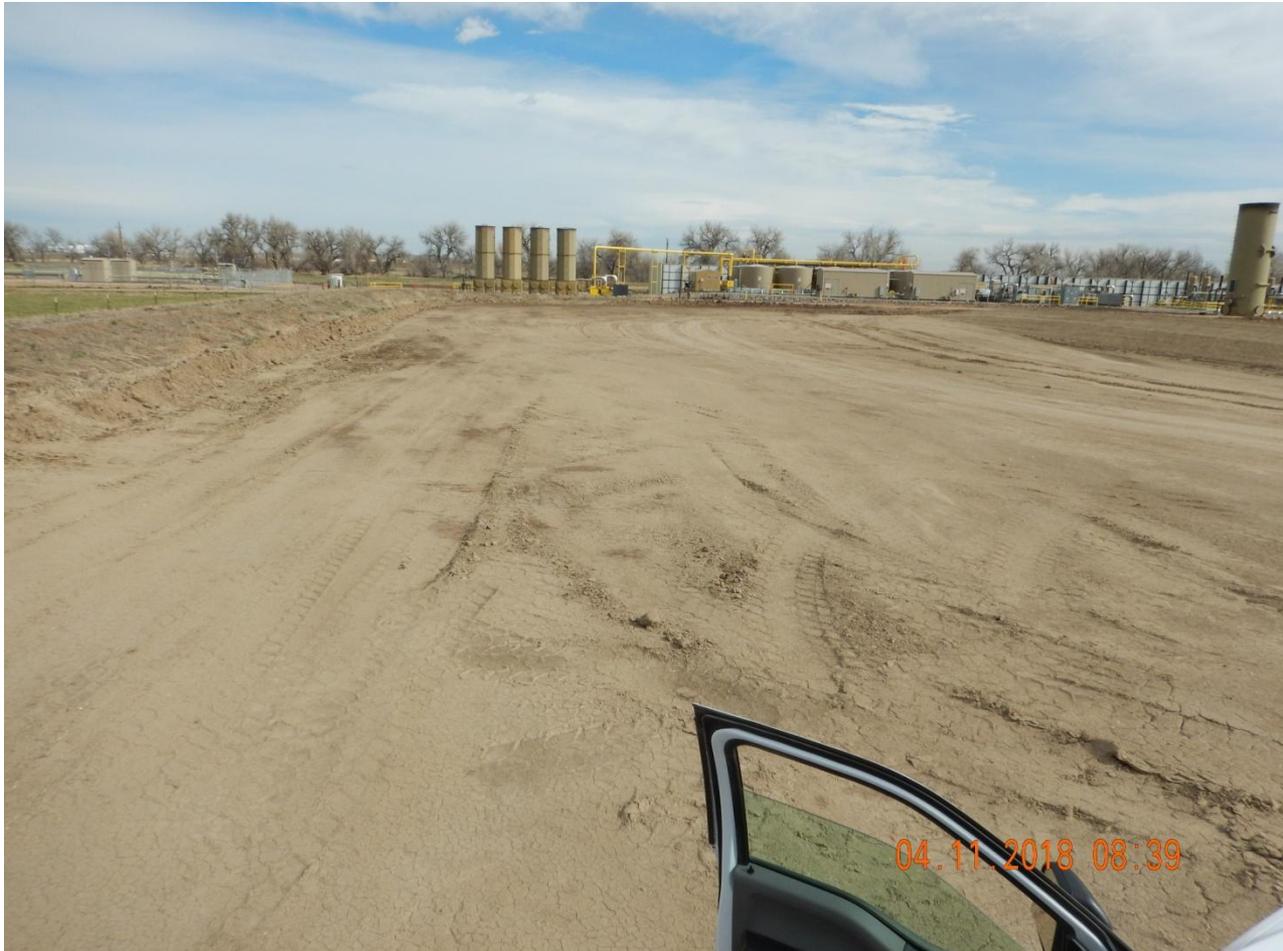
Photo 1. Photo taken from the western location, facing North. Photo illustrates the Operator has started interim reclamation activities but has failed to complete interim reclamation by the due date of 12/2/2017.

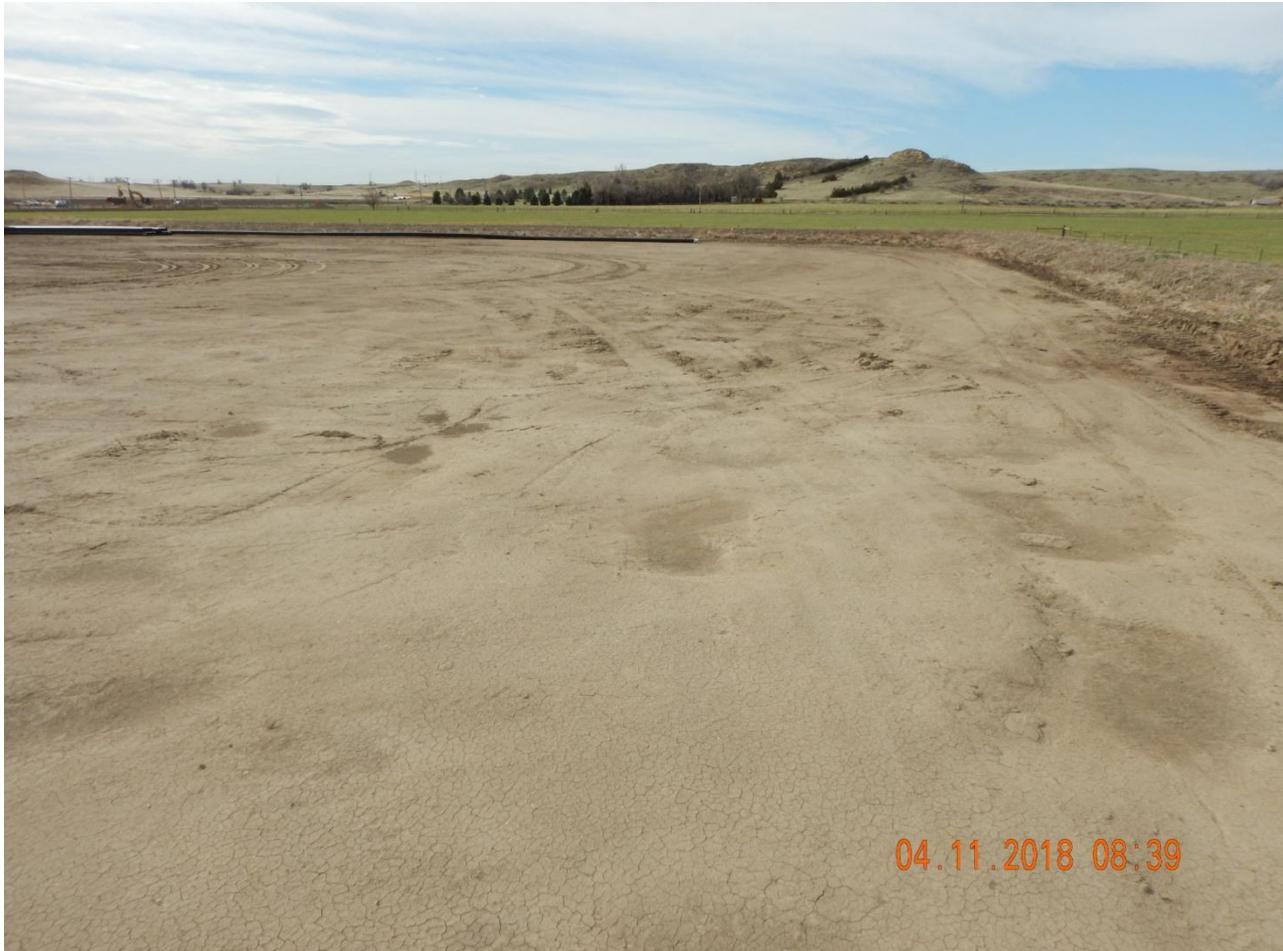
Photo 2. Photo taken from the western location, facing South. See comments under Photo 1.

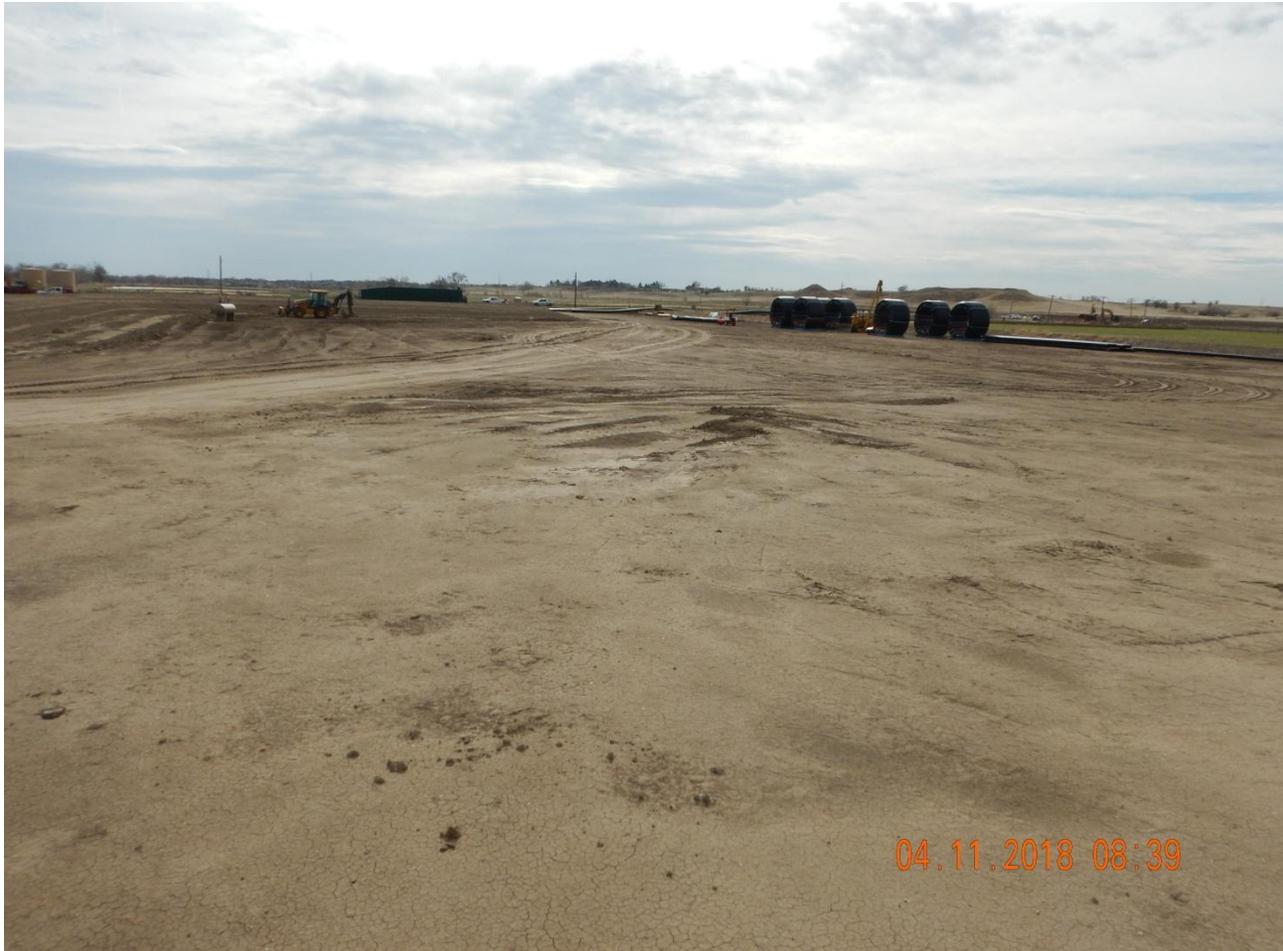
Photo 3. Photo taken from the western location, facing East. See comments under Photo 1. Operator claims that a pipeline being installed along the eastern location and supplies/equipment being stored on location is the reason for holding up reclamation.

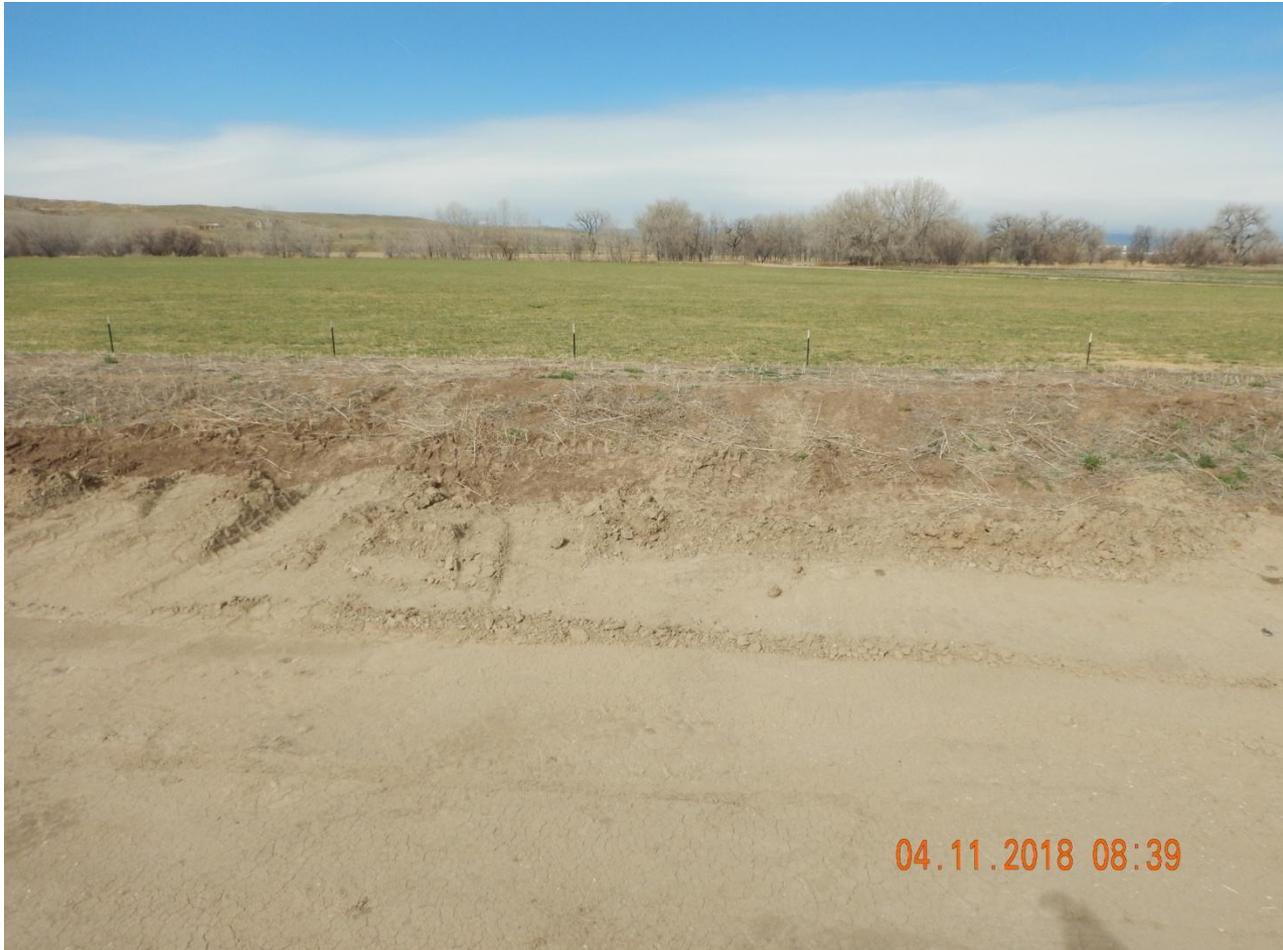
Photo 4. Photo taken from the western location, facing West. Photo illustrates reference areas beyond the Orr State location.

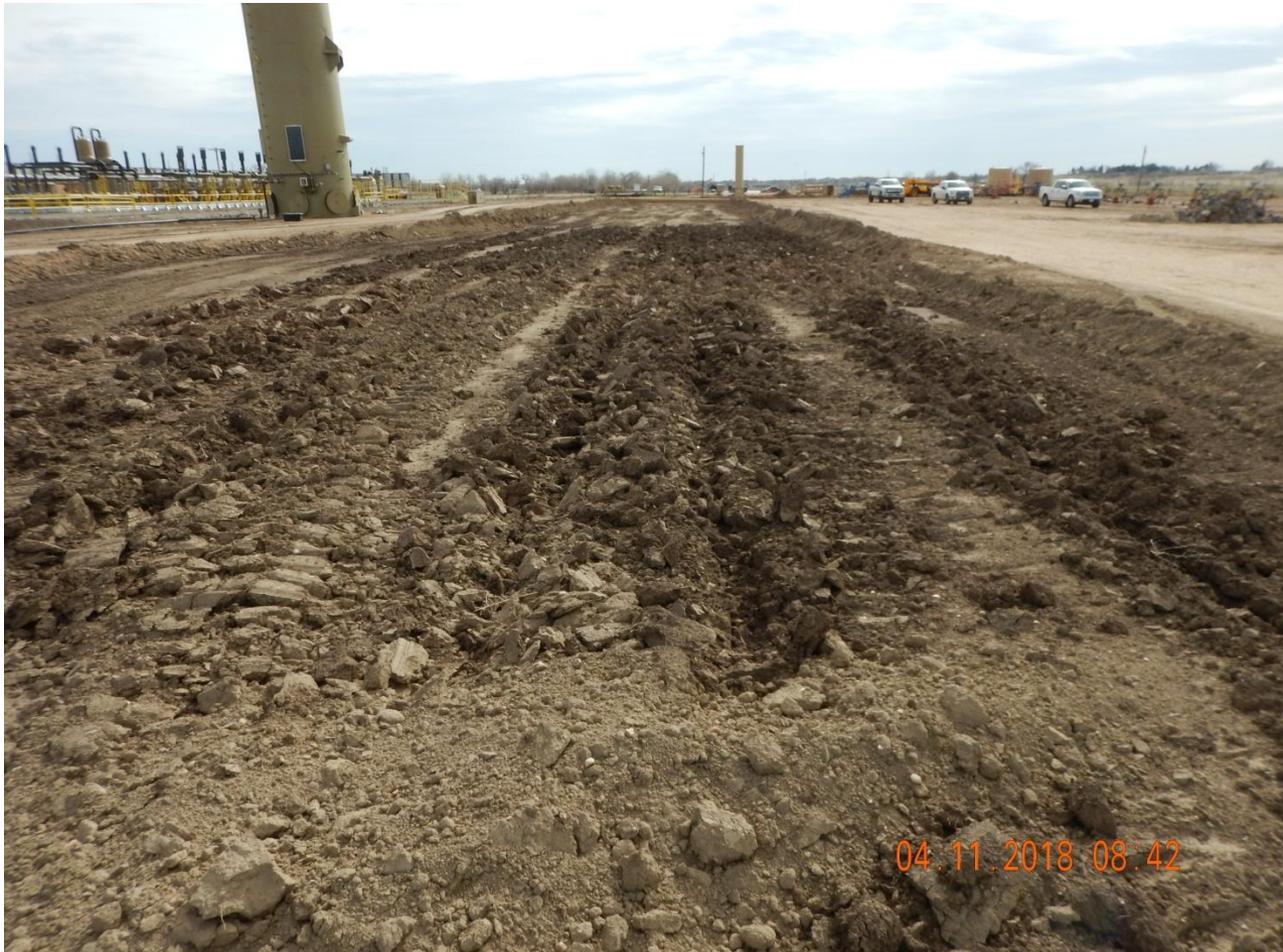
Photo 5. Photo taken from the northwest well pad location, facing East. See comments under Photo 1.

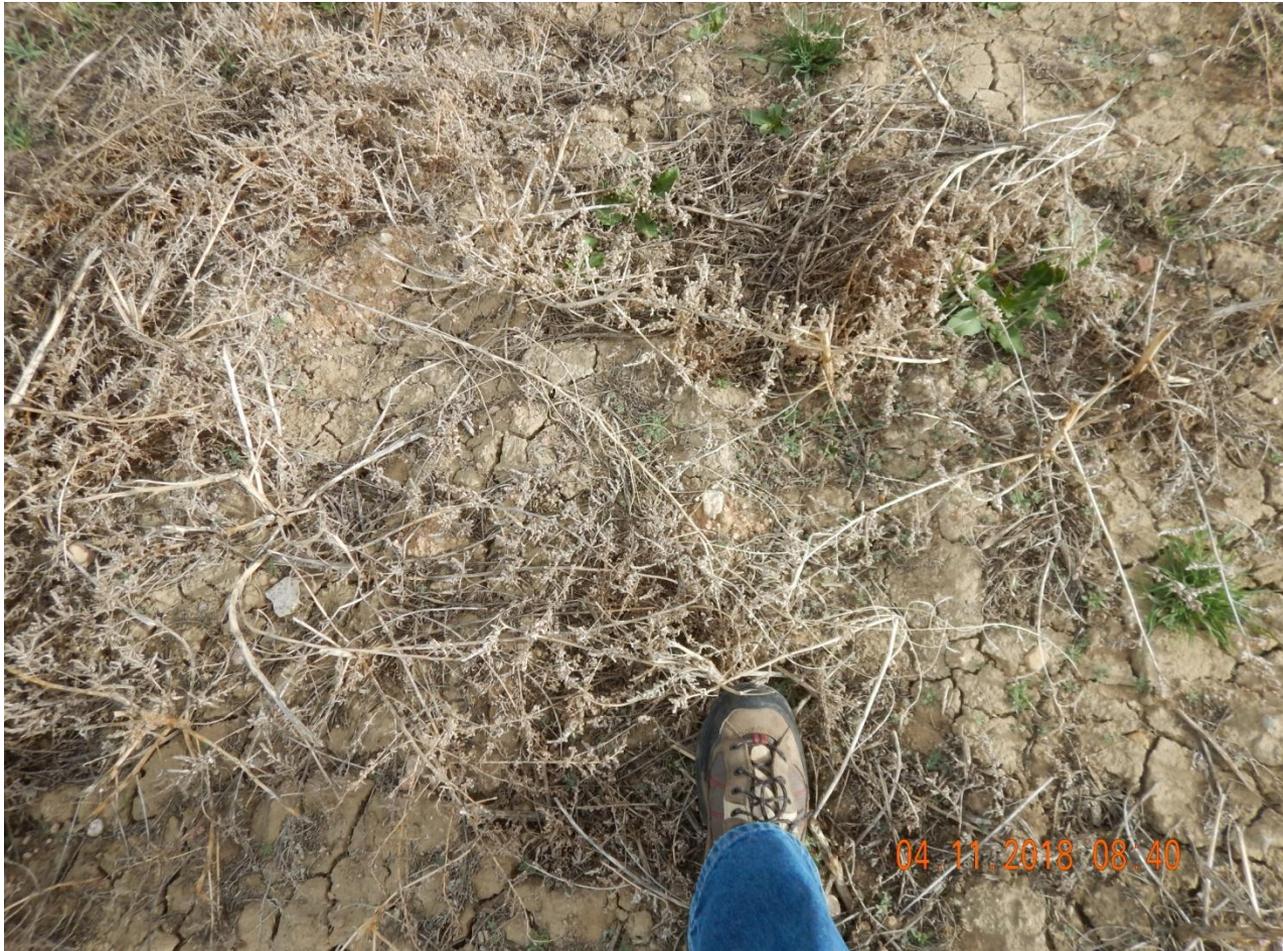
Photo 6. Photo taken of the topsoil stockpile along the western location. Operator has failed to prevent weed establishment per Rule 1002.c.
