Final Reclamation Inspection

Operator: NOBLE ENERGY INC- #100322

API: 05-123-17233

Inspection Photos
Location Name: DOERING #28-16
API: 05-123-17233

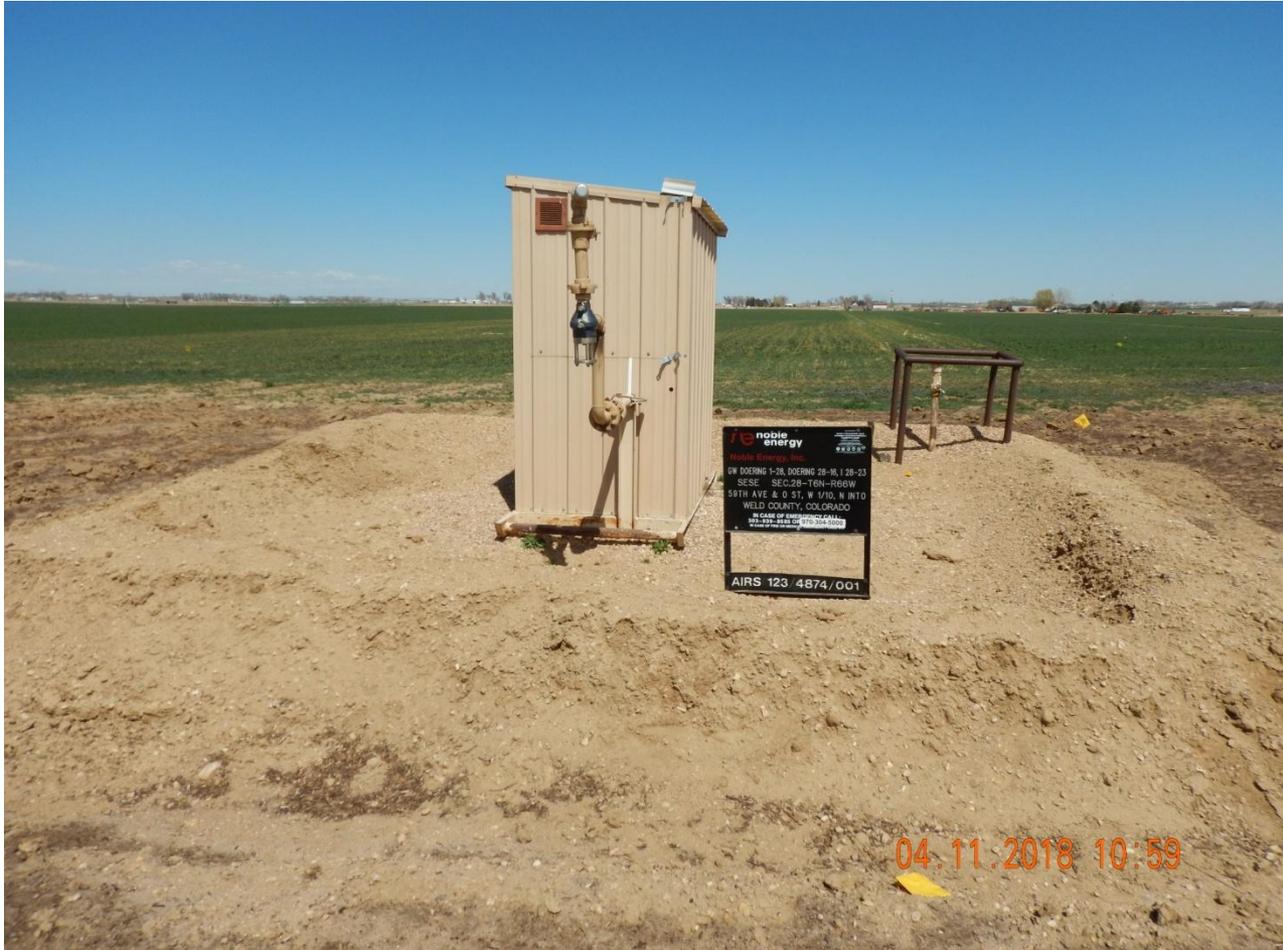
Photo 1. Photo taken from the battery location, facing North. Operator has failed to remove equipment within three months of plugging (meter house and riser).

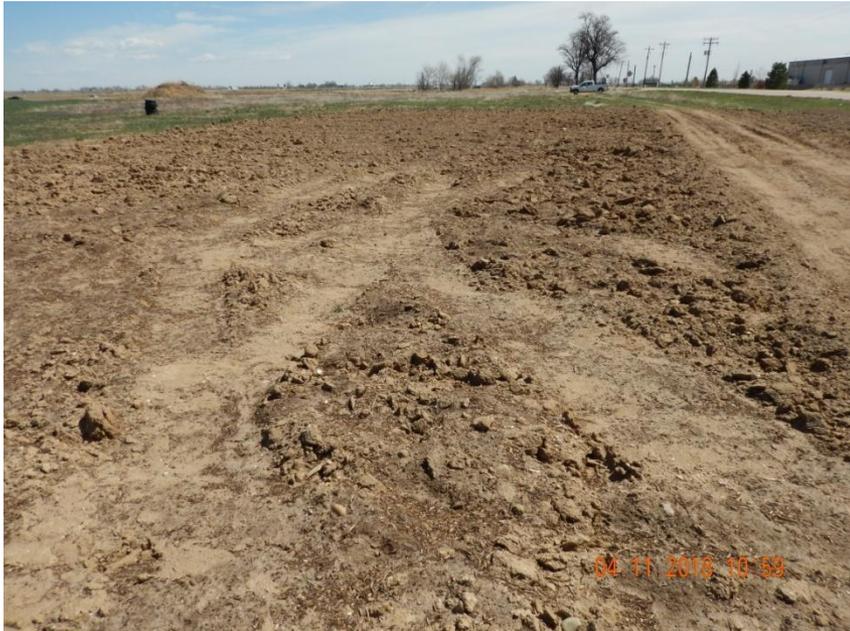
Photo 2. Photo taken from the battery location, facing East. Operator has performed a seedbed prep throughout the battery location.

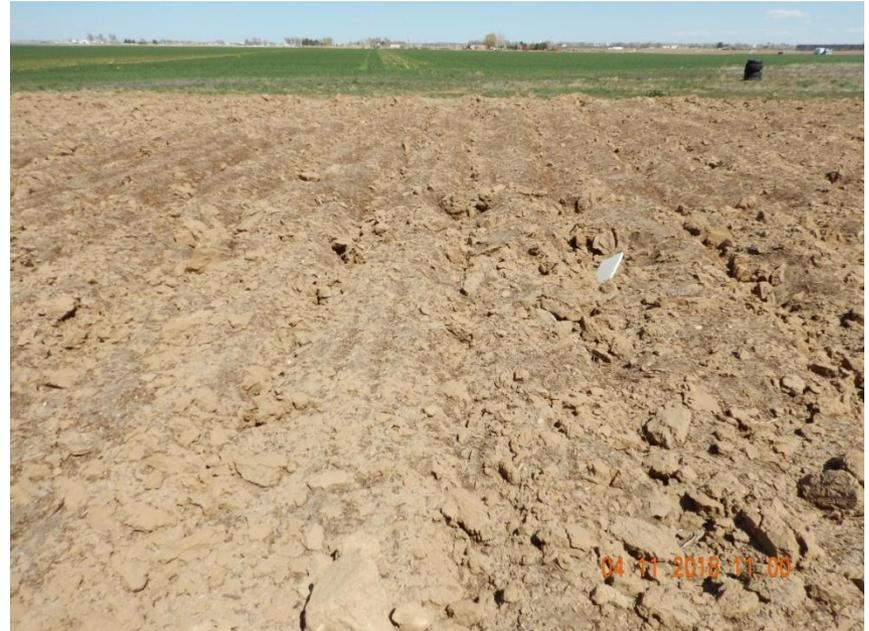
Photo 3. Photo taken from the battery location, facing North. See comments under Photo 2.

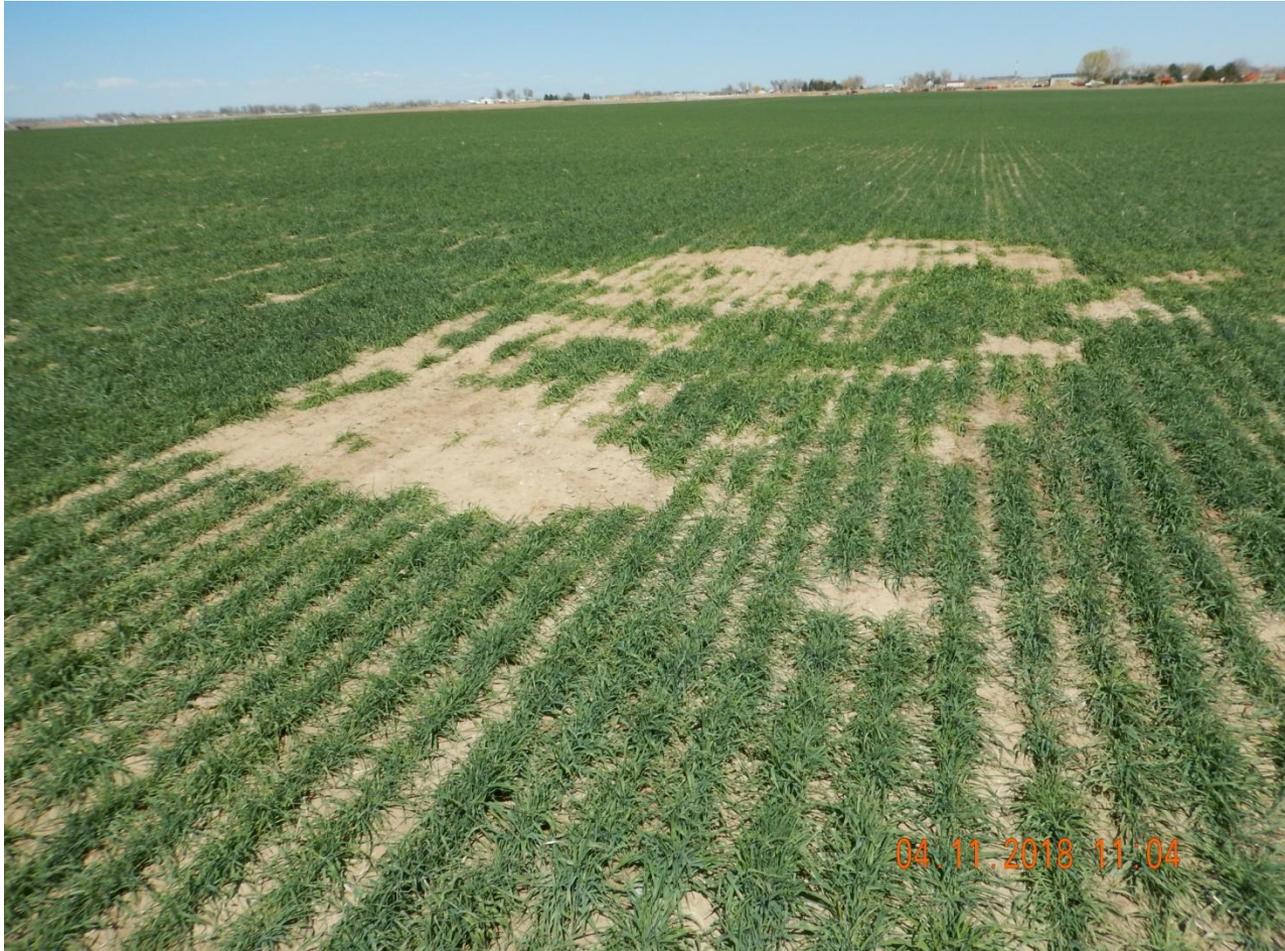
Photo 4. Photo taken from the well location, facing North. Well location is not reflective of reference crop areas and subsidence is evident.

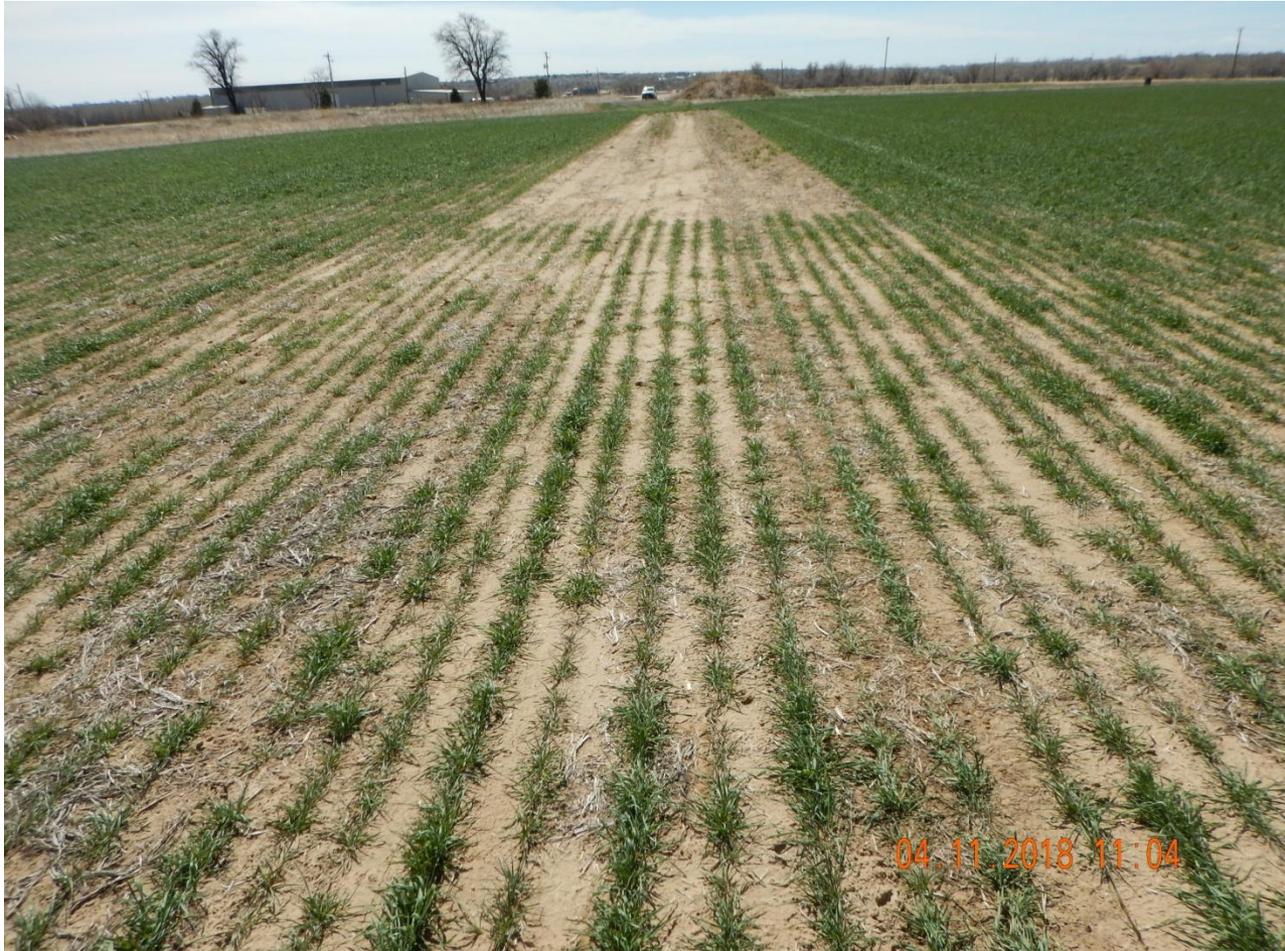
Photo 5. Photo taken from a portion of the well location access road, facing South. Access road is not reflective of reference crop areas (no growth at all along a portion of the access road).
