Inspection Photos

Operator: NOBLE ENERGY INC - 100322

Location ID: 327399

Inspection Doc. Number: 682503245

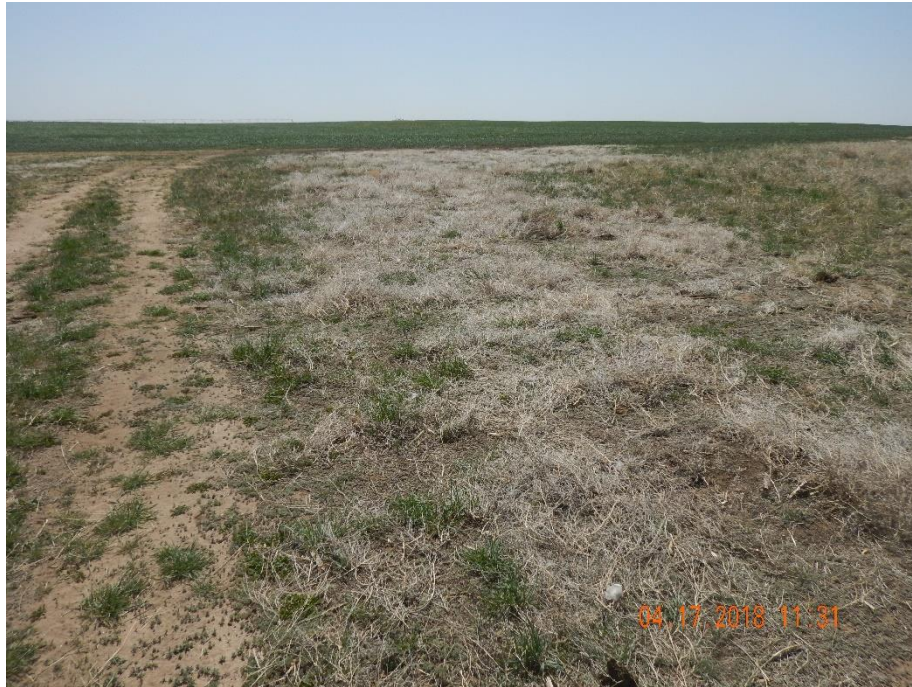
Photo 1: Photo taken from the north end of the well location, facing south. Photo shows vegetation at well is predominately undesirable weedy plant species and is not reflective of the adjacent reference area. Unable to find evidence that additional reclamation activities have been conducted.

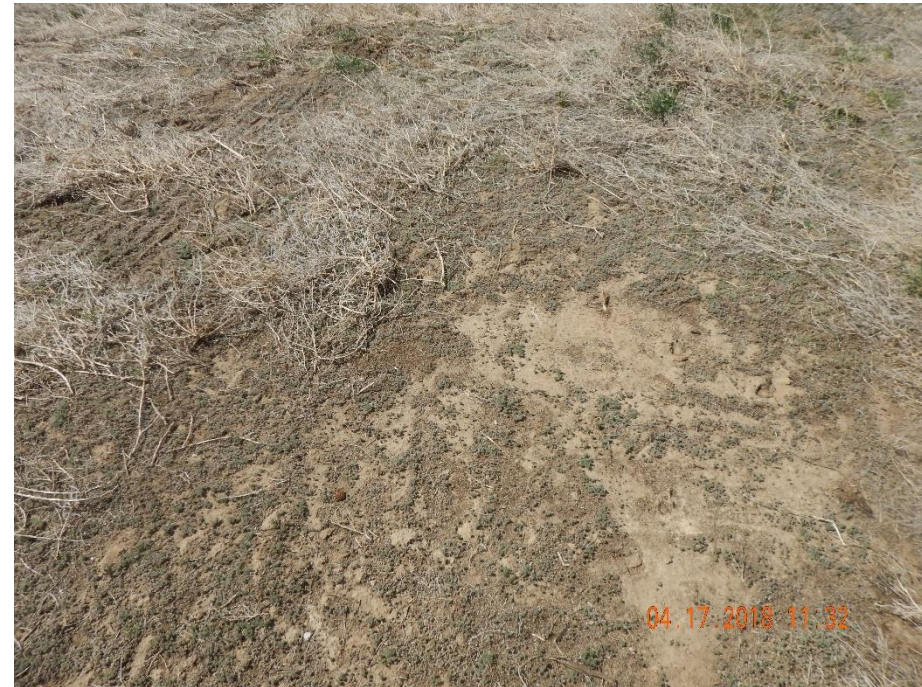
Photo 2: Photo taken from the well location south. Photo shows vegetation at well is predominately undesirable weedy plant species and is not reflective of the adjacent reference area. Unable to find evidence that additional reclamation activities have been conducted.

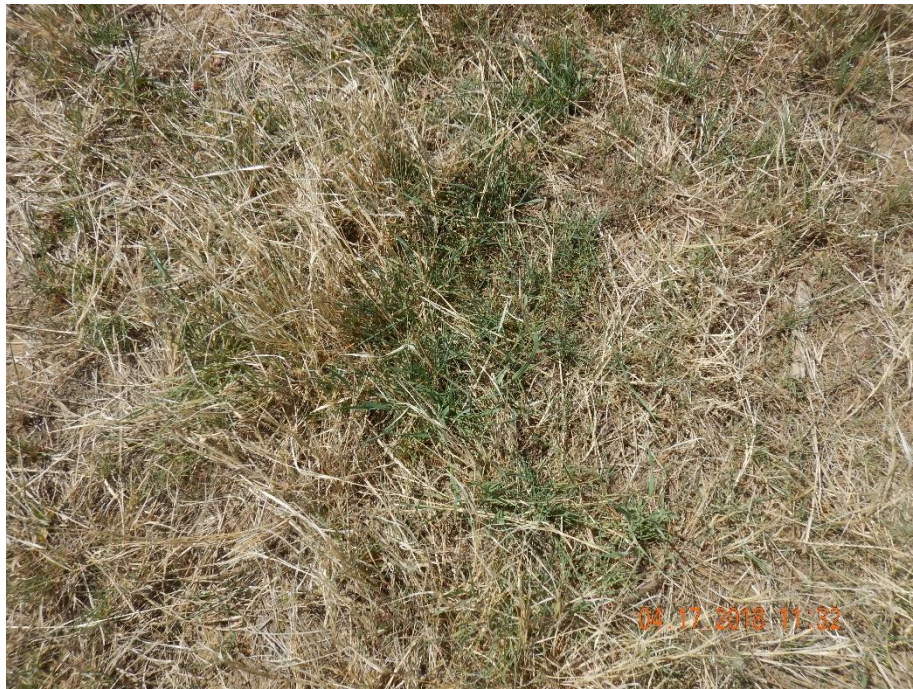
Photo 3: Photo taken from the adjacent reference area. Photo shows vegetation is predominantly perennial grass species such as sand dropseed, wheatgrass, etc..

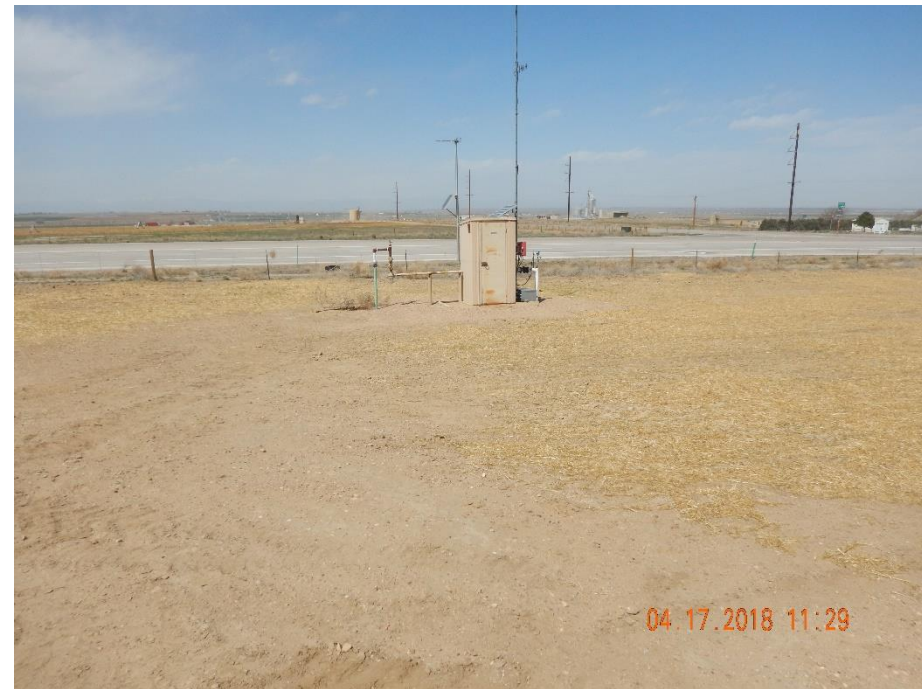
Photo 4: Photo taken from former tank battery. Photo shows meter shed remaining. Operator indicated metershed is active and was required to submit documentation. No documents have been submitted.
