# Inspection Photos

Operator: NOBLE ENERGY INC - 100322

Location ID: 329551

Inspection Doc. Number: 682503247

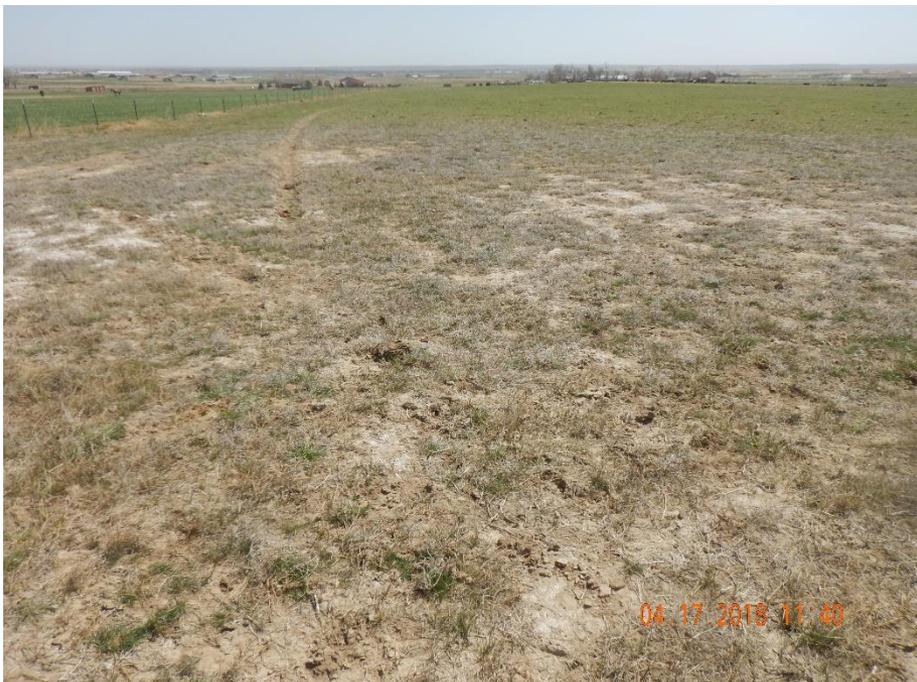
**Photo 1:** Photo taken from the west end of the well location, facing east. Photo shows well location is predominantly undesirable weedy plant species or bare and exposed soil, and is not reflective of the adjacent reference area. Unable to find evidence that additional reclamation activities have been conducted.

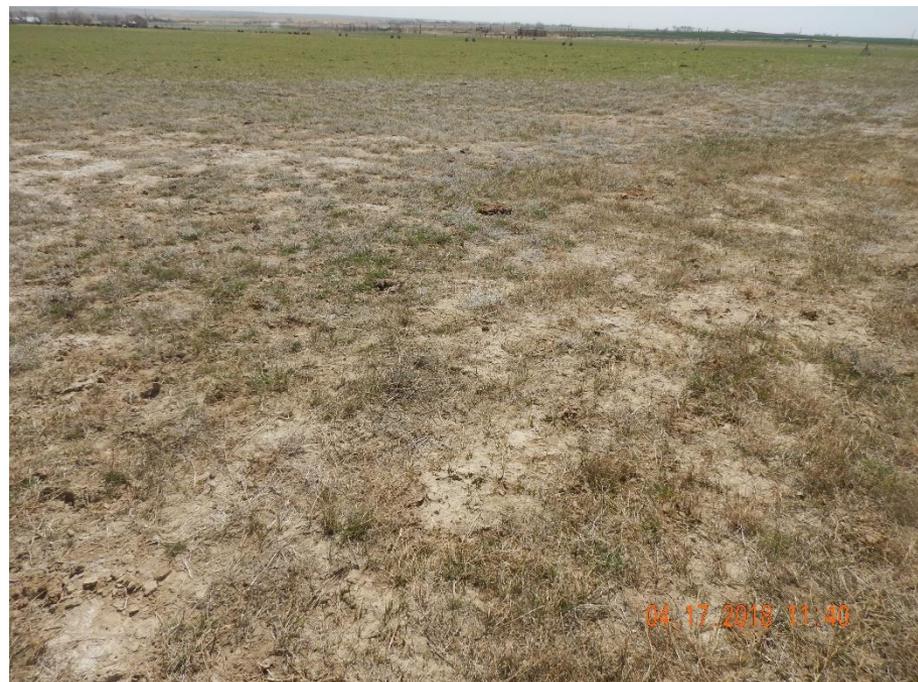
**Photo 2:** Photo taken from the west end of the well location, facing southeast. Photo shows well location is predominantly undesirable weedy plant species or bare and exposed soil, and is not reflective of the adjacent reference area. Unable to find evidence that additional reclamation activities have been conducted.

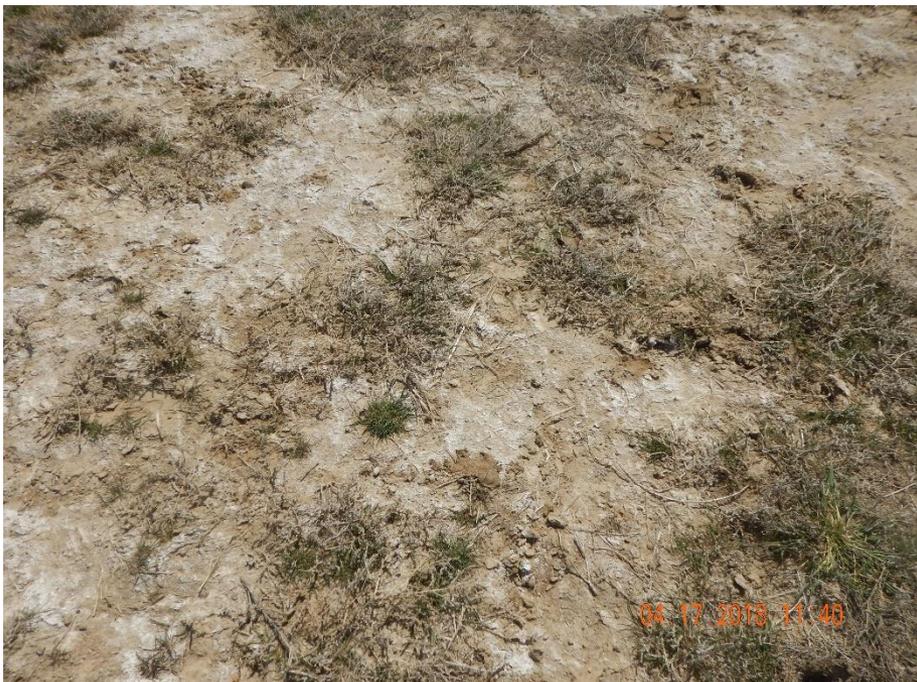
**Photo 3:** Photo of the well location. Photo shows well location is predominantly undesirable weedy plant species or bare and exposed soil, and is not reflective of the adjacent reference area. Unable to find evidence that additional reclamation activities have been conducted.

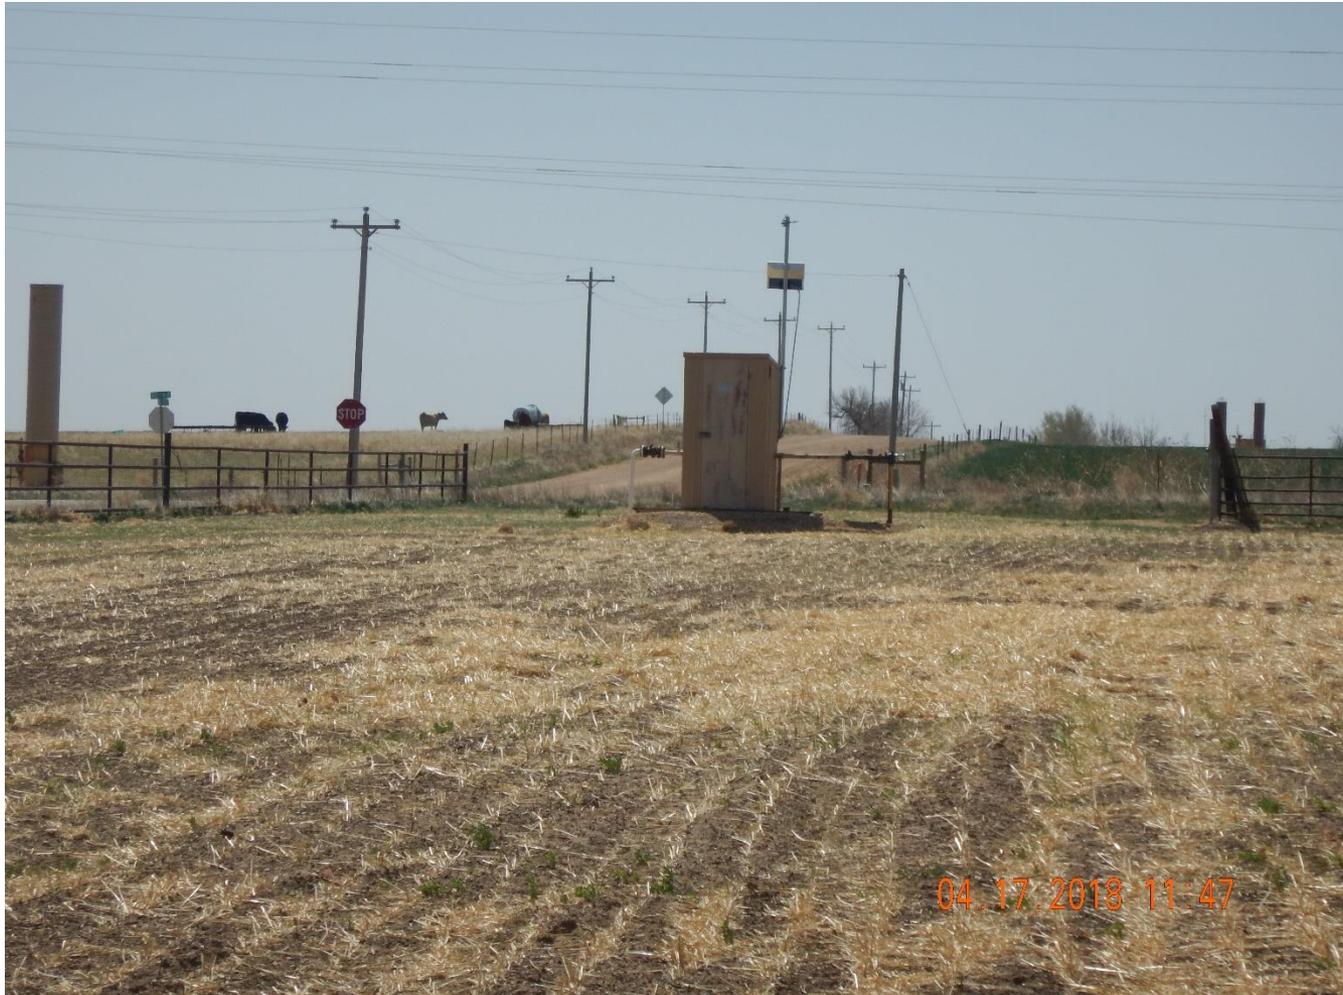
**Photo 5:** Photo taken from former tank battery. Photo shows meter shed remaining. Operator indicated meter shed is active and was required to submit documentation. No documents have been submitted.
