GOLDEN EAGLE MINE E-1A API# 05-071-06411 – TIMBER CREEK
OGCC OPERATOR NUMBER 10672 – INSPECTION DATE: APRIL 19, 2018
CORRECTIVE ACTIONS COMPLETED REGARDING COGCC FIR DOCUMENT # 680102745

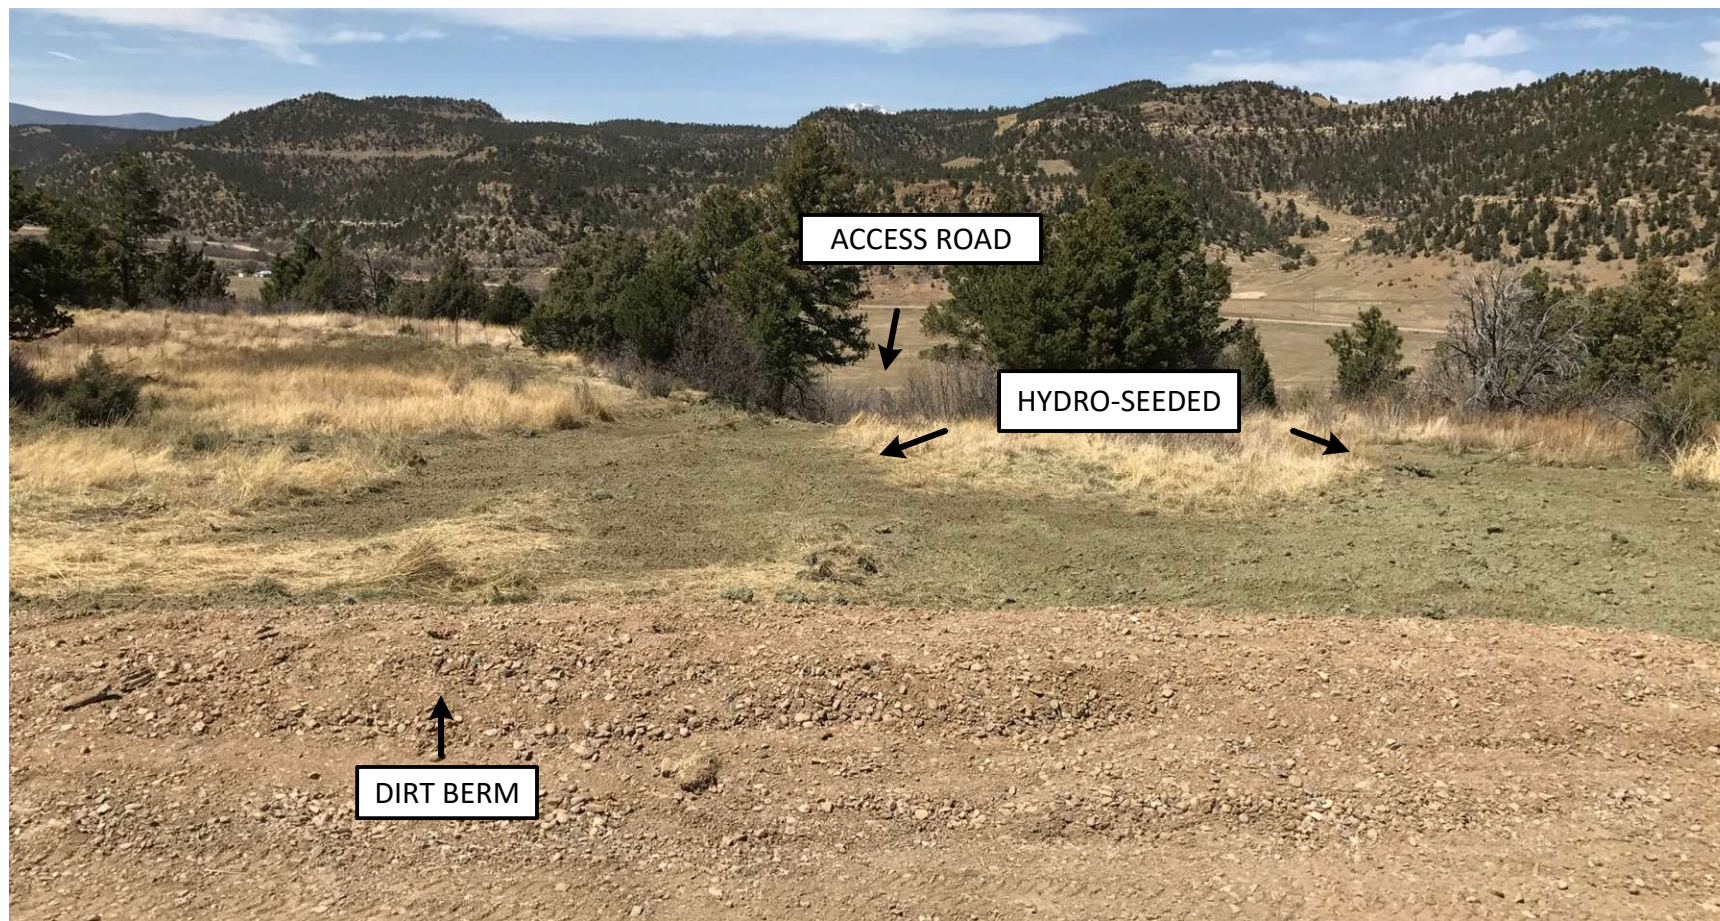
PHOTO 1: FACING NORTH TOWARD THE GOLDEN EAGLE MINE E-1A PAD RECLAMATION. A DIRT BERM WAS INSTALLED PARALLEL TO THE EXISTING LEASE ROAD TO RE-DIRECT THE RUN ON FROM THE LEASE ROAD UPGRADIENT OF LOCATION AWAY FROM THE RECLAMATION AREA. IT'S POSSIBLE THAT GRAVEL FROM THE ACCESS ROAD MAY HAVE MIGRATED ONTO LOCATION. SOME COMMON MULLEIN ROSETTES WERE FOUND AND REMOVED FROM THE LOCATION. THE EARTH DISTURBANCE WAS HYDRO-SEEDED WITH AN APPROVED COLORADO PARKS AND WILDLIFE (CPW) SEED MIX TO PROMOTE THE ESTABLISHMENT OF VEGETATION.

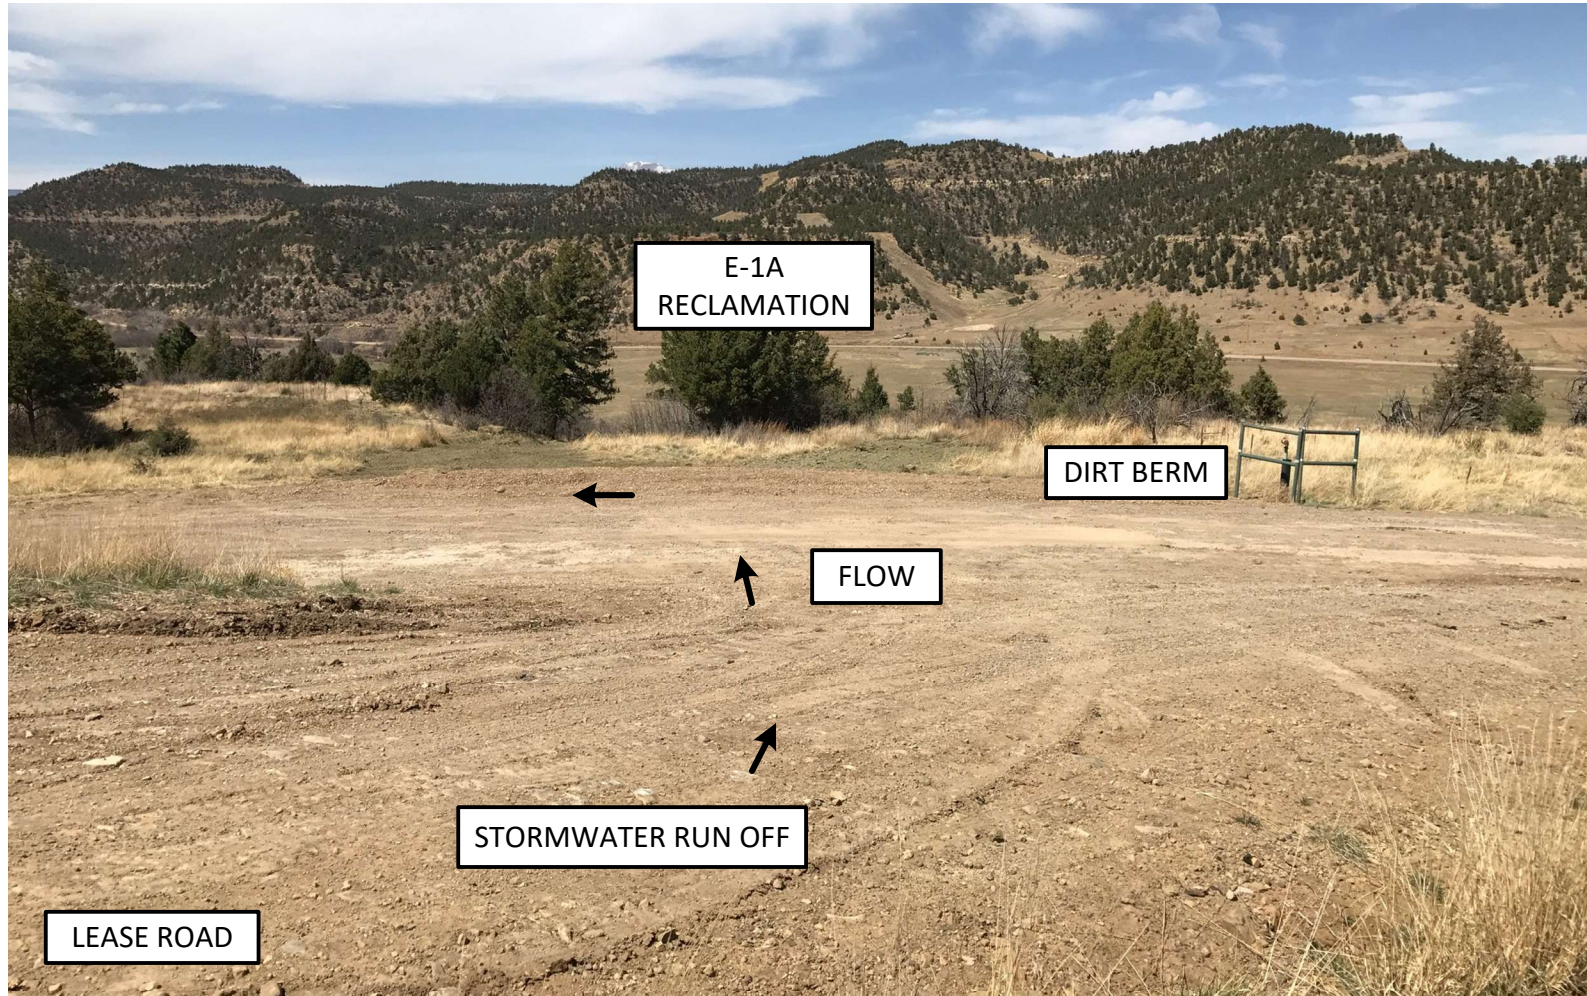
PHOTO 2: FACING NORTH TOWARD THE GOLDEN EAGLE MINE E-1A PAD RECLAMATION. RUN OFF FROM THE UPGRADE LEASE ROAD FLOWS TOWARD THE RECLAMATION AREA. THE DIRT BERM RE-DIRECTS RUN OFF.

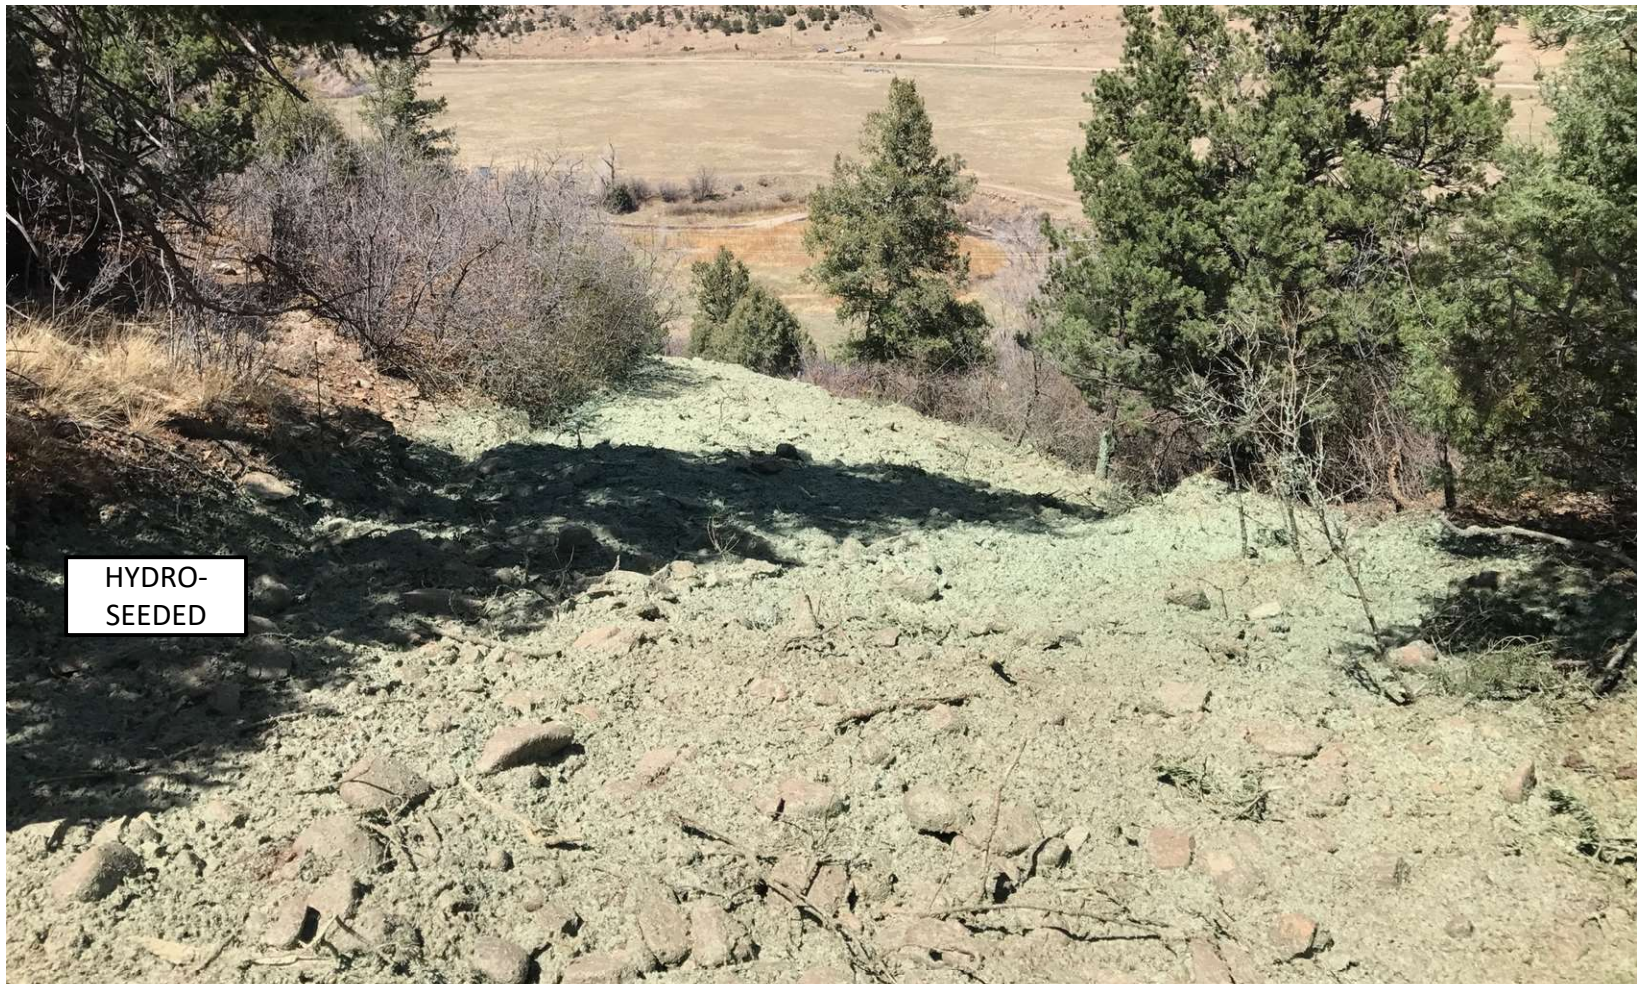
PHOTO 3: FACING NORTH, THE ACCESS ROAD TO GOLDEN EAGLE MINE E-1A PAD WAS RECONTOURED TO MATCH THE SURROUNDING TERRAIN. GRADING TECHNIQUES WERE INSTALLED ON THE CONTOUR. THE EARTH DISTURBANCE WAS HYDRO-SEEDED WITH AN APPROVED COLORADO PARKS AND WILDLIFE (CPW) SEED MIX TO PROMOTE THE ESTABLISHMENT OF VEGETATION.

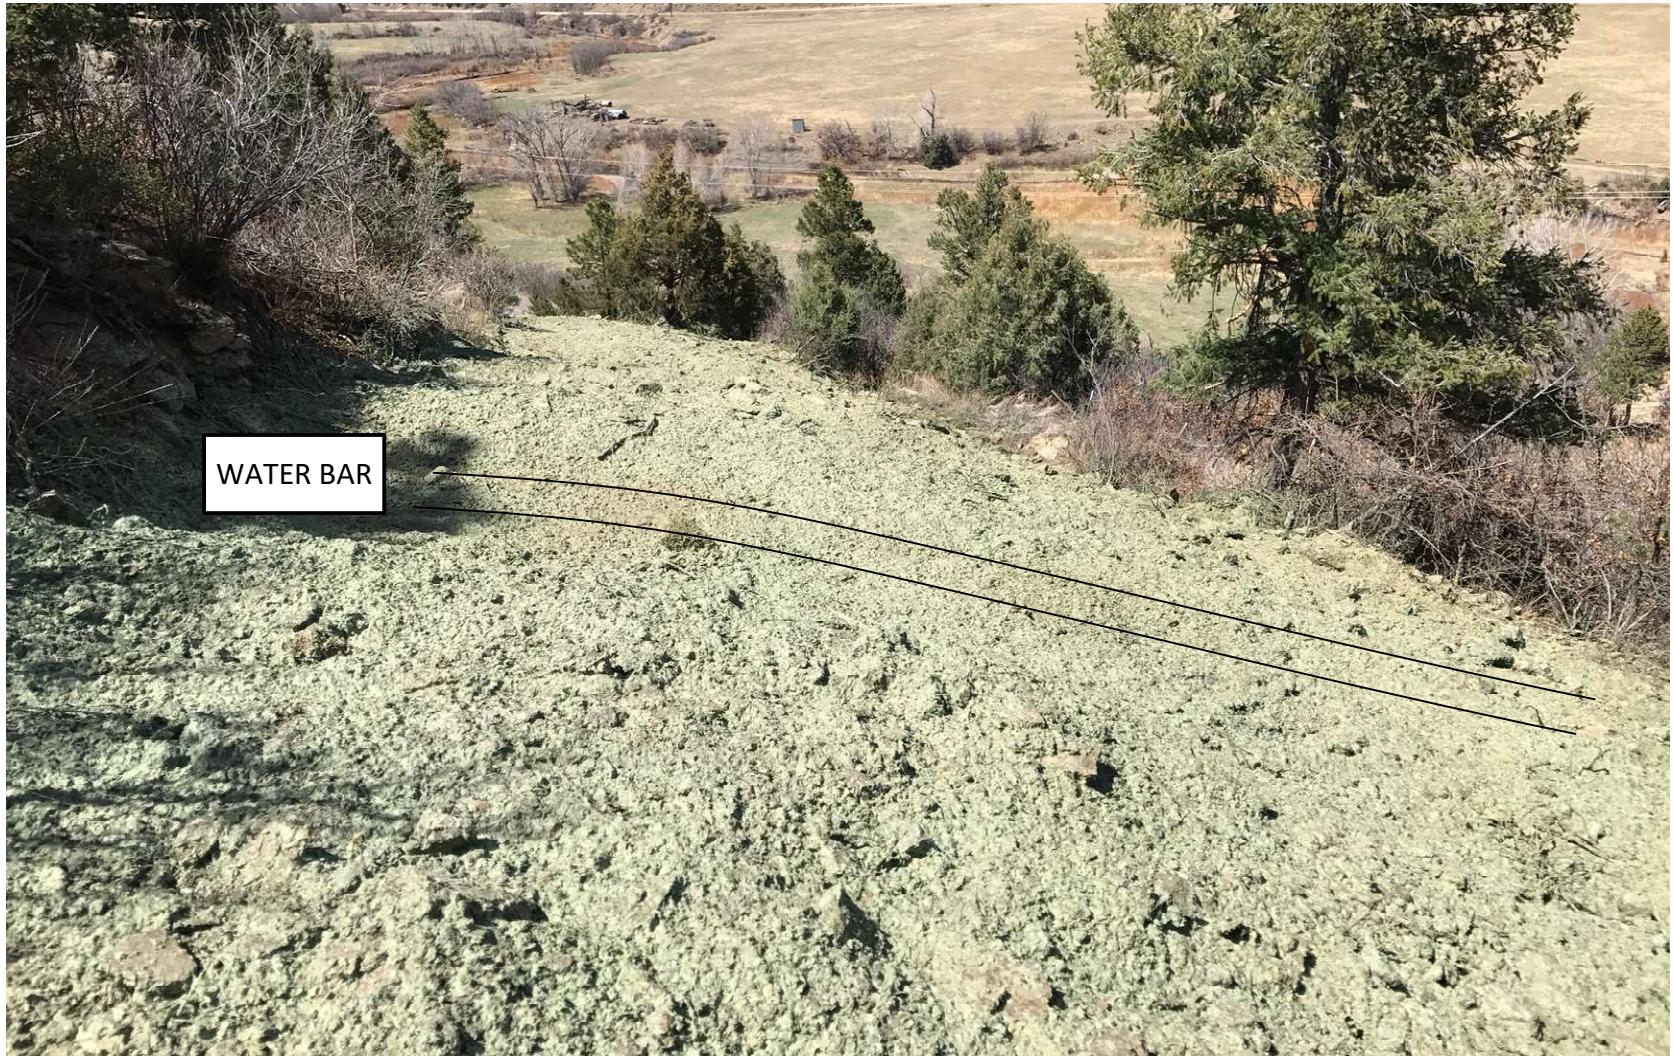
PHOTO 4: FACING NORTHWEST, THE ACCESS ROAD TO GOLDEN EAGLE MINE E-1A PAD WAS RECONTOURED TO MATCH THE SURROUNDING TERRAIN. GRADING TECHNIQUES WERE INSTALLED ON THE CONTOUR. (4) WATER BARS WERE INSTALLED TO DIVERT WATER OFF THE R.O.W. THE EARTH DISTURBANCE WAS HYDRO-SEEDING WITH AN APPROVED COLORADO PARKS AND WILDLIFE (CPW) SEED MIX TO PROMOTE THE ESTABLISHMENT OF VEGETATION.

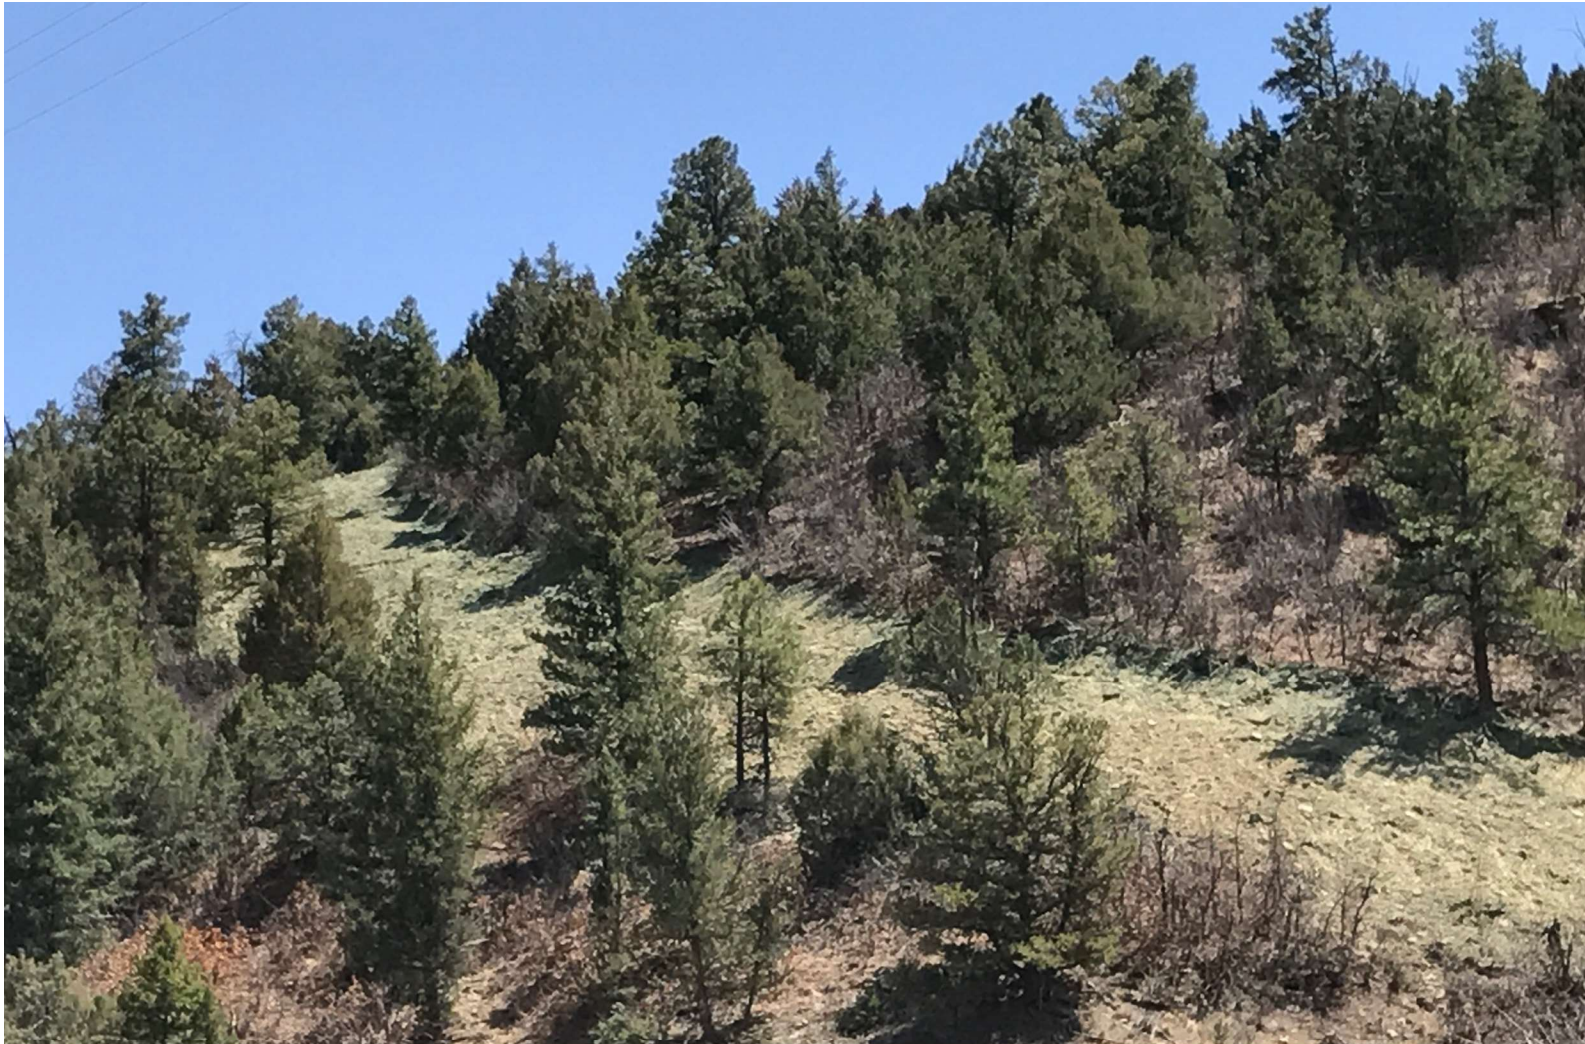
PHOTO 5: FACING SOUTHEAST FROM RAIL LINE, THE ACCESS ROAD TO GOLDEN EAGLE MINE E-1A PAD WAS RECONTOURED TO MATCH THE SURROUNDING TERRAIN. GRADING TECHNIQUES WERE INSTALLED ON THE CONTOUR. (4) WATER BARS WERE INSTALLED TO DIVERT WATER OFF THE R.O.W. THE EARTH DISTURBANCE WAS HYDRO-SEEDING WITH AN APPROVED COLORADO PARKS AND WILDLIFE (CPW) SEED MIX TO PROMOTE THE ESTABLISHMENT OF VEGETATION.
