# Final Reclamation Inspection

Operator: SRC ENERGY INC- #10311

API: 05-123-12976

Location Name: HERGENREDER #32-9

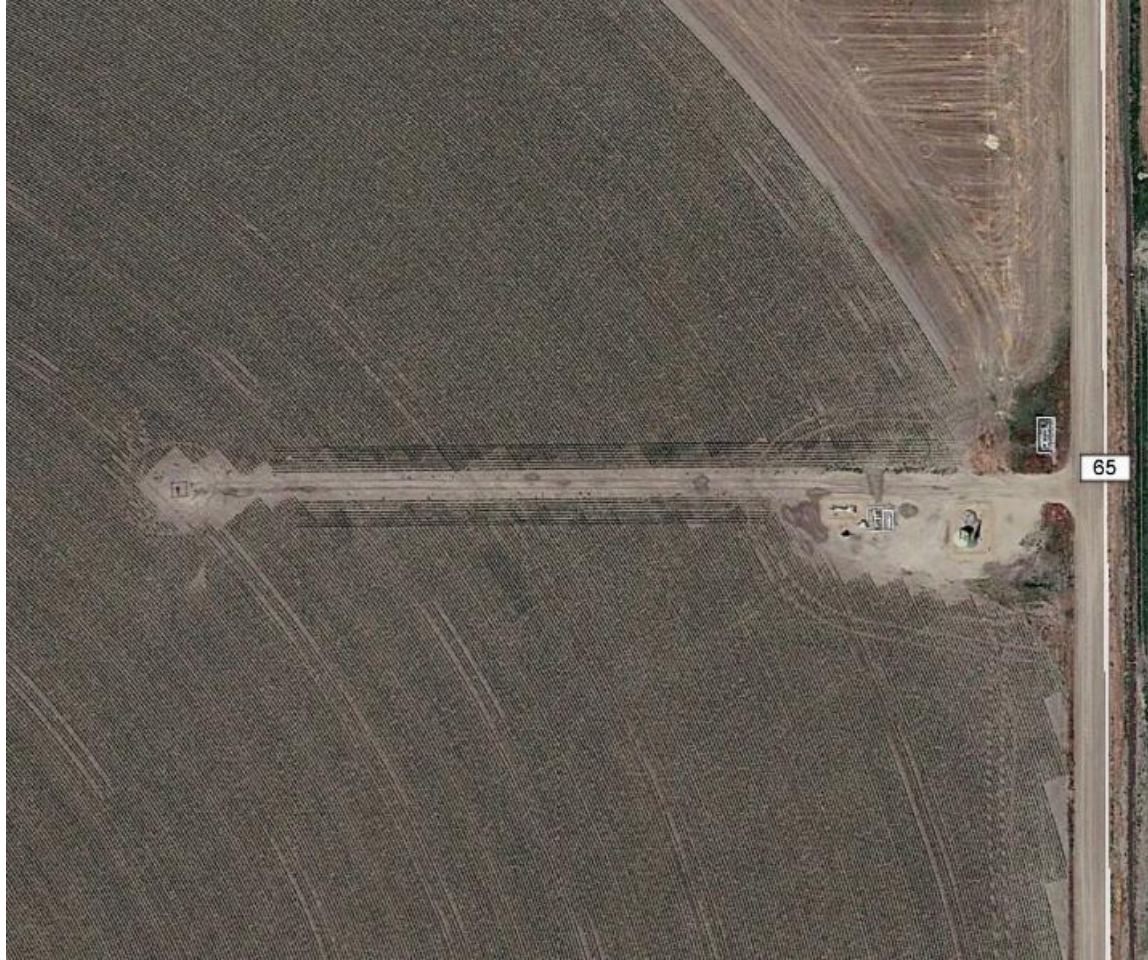
Google Earth aerial imagery taken June 14, 2016. Photo illustrates the HERGENREDER #32-9 location during active operations.

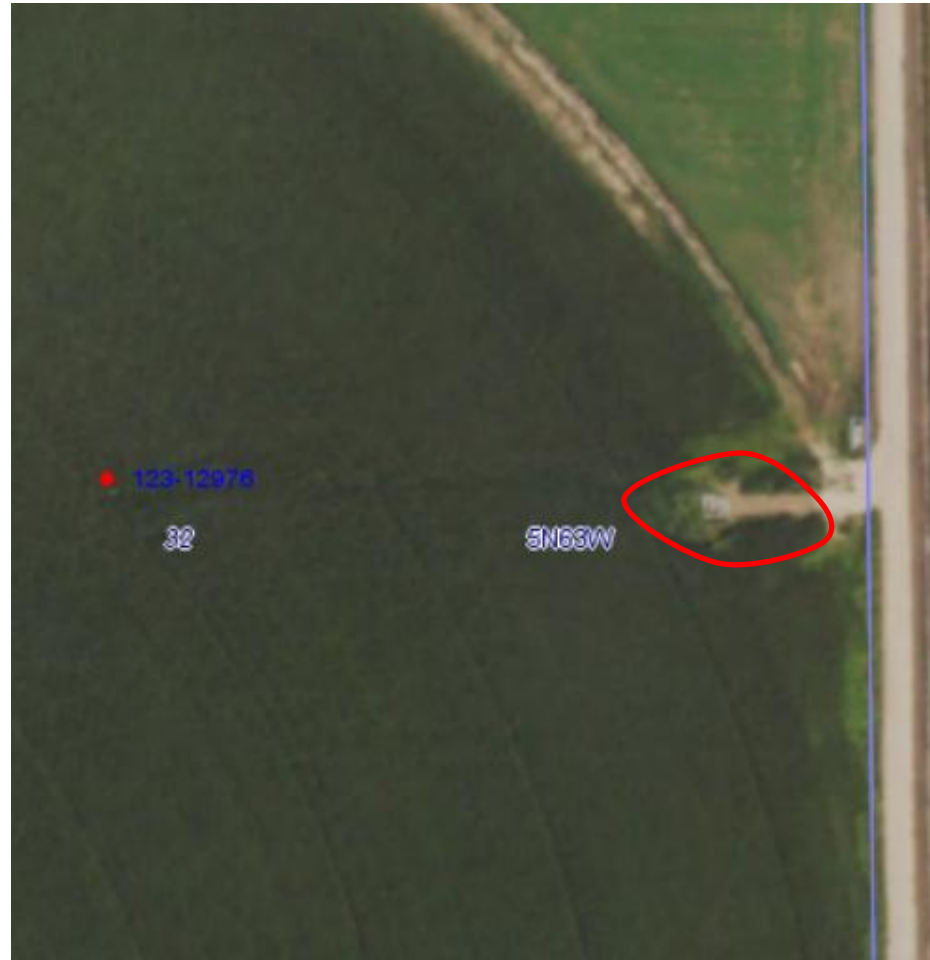
COGCC COGIS aerial imagery taken in 2017. A portion of the access road and risers remain at the location.

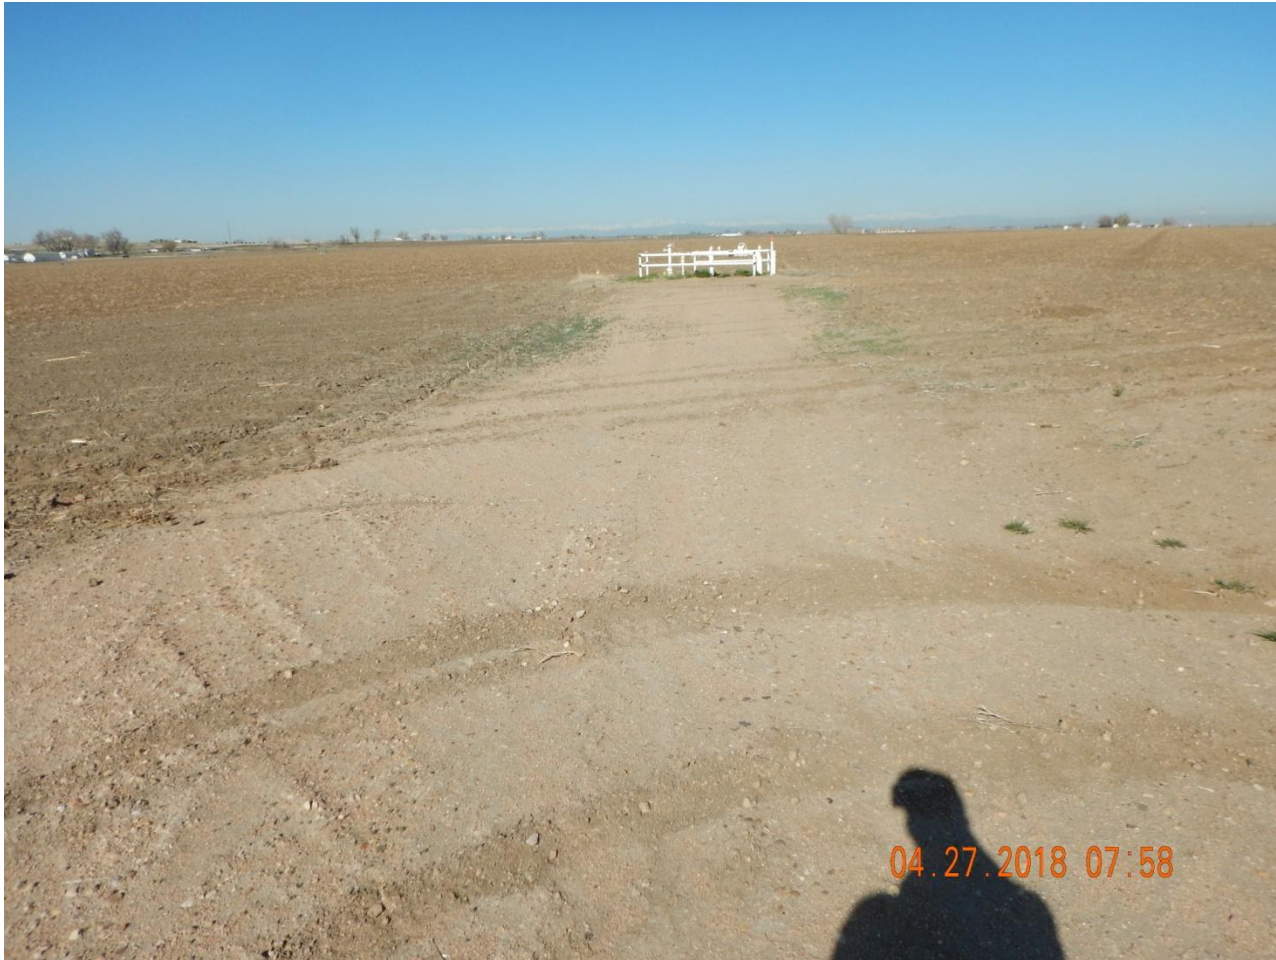
**Photo 1.** Photo taken from the entrance of the location, facing West. Operator has failed to reclaim a portion of the access road and failed to remove risers from the location per Rule 1004.a.

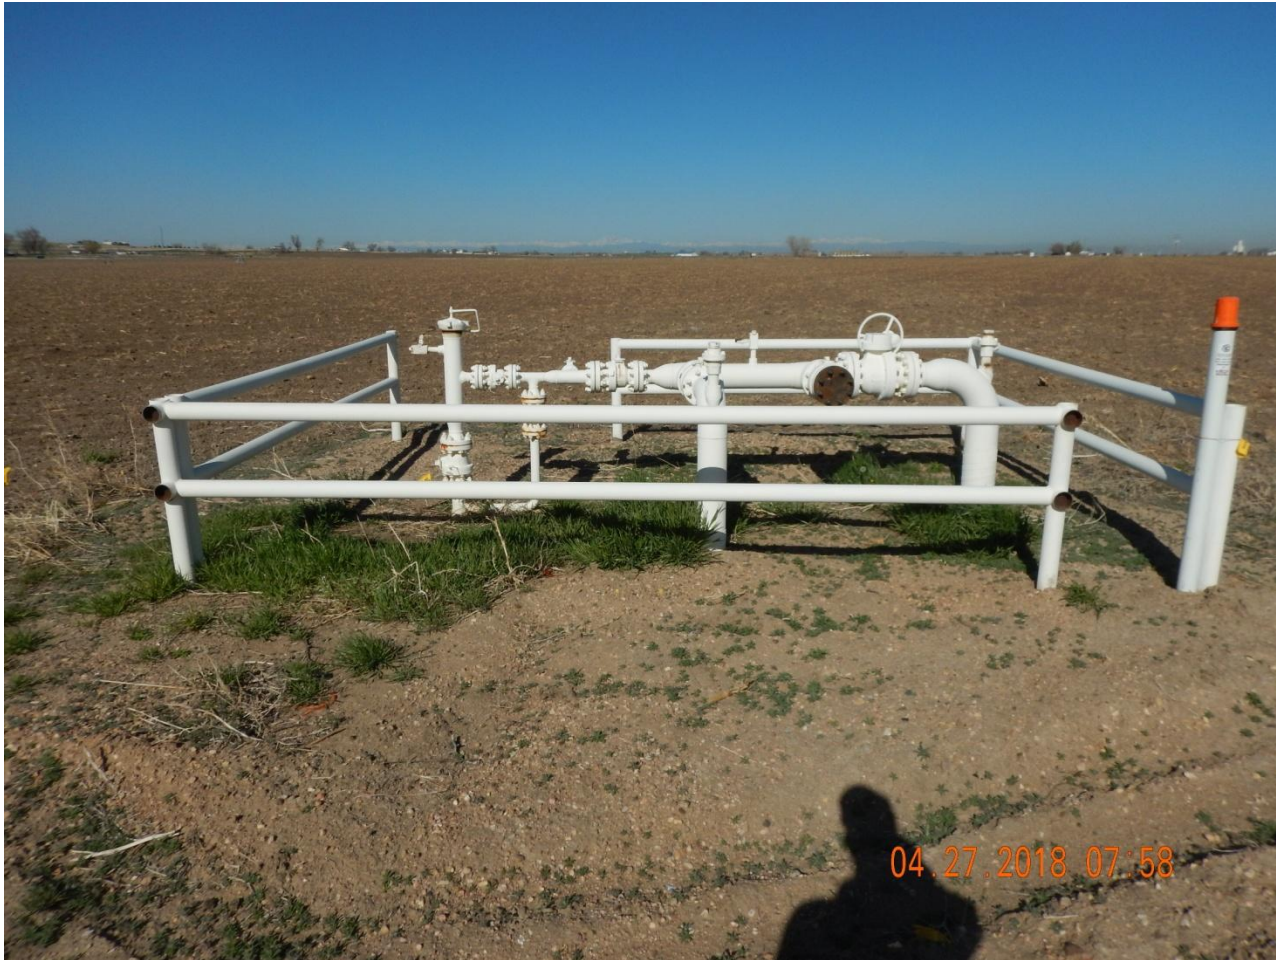
**Photo 2.** Photo taken of the risers that remain at the location. Operator shall comply with Rule 1004.a.
